**OFFICE OF DEFECTS INVESTIGATION
1998 FORD CROWN VICTORIA POLICE INTERCEPTOR REAR IMPACT CRASH**

VERIDIAN CASE NO: CA02-034

<p>15. <i>Sponsoring Agency Code</i></p>	
<p>16. <i>Supplementary Notes:</i> On-site investigation of a rear impact crash of a 1998 Ford Crown Victoria resulting in a fire.</p>			
<p>17. <i>Abstract</i></p> <p>This investigation focused on identifying the cause of a crash induced fire in a 1998 Ford Crown Victoria Police Interceptor and the identification of any associated potential mechanical defect(s). The Ford Crown Victoria was involved in a rear-end crash with a 2002 Chevrolet K2500 pick-up truck towing a 5th wheel gooseneck cattle trailer. The Ford Crown Victoria was stopped on the road straddling the fog line at the time of the crash with his emergency lights illuminated. The 78 year old driver of the Chevrolet failed to recognize that the police vehicle was stopped and braked too late to avoid the crash. The New York State Trooper seated in the Ford struck the posterior aspect of his head on the intruding rear sheet metal and was incapacitated. He was removed from the vehicle by some witnesses to the crash. The Ford Crown Victoria was then consumed

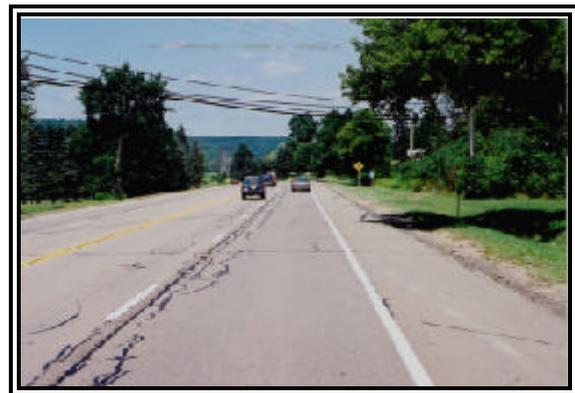
This two-vehicle crash occurred during the afternoon hours of August, 2002. At the time of the crash, it was daylight and the weather was clear. The road surface was dry. The crash occurred in the outboard northbound lane on a north/south, four lane state highway, **Figure 1**. The roadway was straight and level in the area of the crash with approximately 275 m (900 ft) of sight distance. The travel lanes were bordered by a 2.4 m (8.0 ft) wide shoulder. A shallow ditch was located 4.6 m (15.0 ft) east of the shoulder and had a estimated depth of 0.6 m (2.0 ft). A large area of small diameter trees and brush began

Figure 1: Northbound trajectory view approaching the impact.

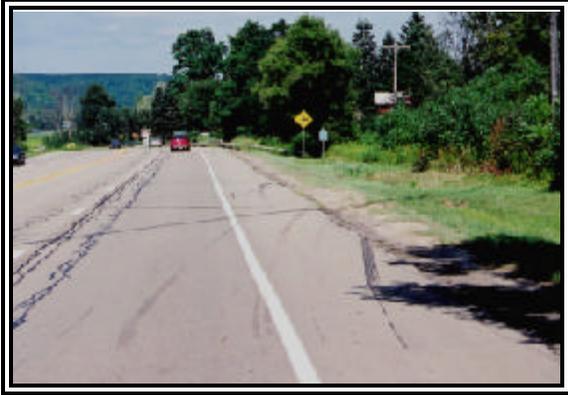
approximately 9 m (30 ft) east of the road edge. An overhead utility line crossed the road immediately north of the crash and was hanging down. The height of the downed wires measured approximately 3 m (10 ft) and were being clipped by passing tractor/semi-trailer trucks. **Figures 2 and 3** are views of the post-crash tire and gouge marks and the final rest location of the Ford, respectively.

Figure 2: Post-crash trajectory of the vehicles.

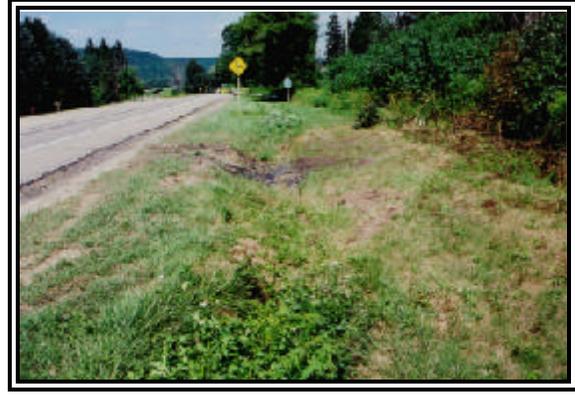
Figure 3: Final rest area of the Ford.

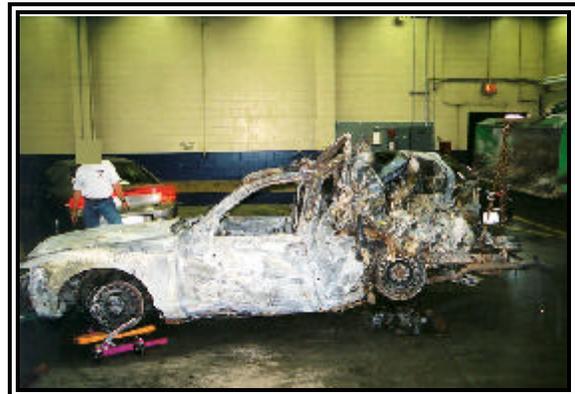
The 1998 Ford Crown Victoria, **Figure 5**, was identified by the partial Vehicle Identification Number (VIN): 2FAFP71W5WX (Production sequence deleted). The VIN plate at the left forward aspect of the windshield was partially destroyed by the fire. The State Police reported the vehicle's odometer had recorded approximately 175,424 km (109,000 miles). The 4-door, body-on-frame, sedan was equipped with the Police Interceptor Package. A class II trailer hitch with a 3.2 cm (1-1/4 in) receiver was mounted between the frame rails below the rear bumper.

Figure 5: Left side view of the Ford.

The rear plane of the vehicle sustained severe impact damage that extended across its entire 142.2 cm (56.0 in) end-width. The damage was indicative of an override with the above bumper damage biased to the left side and extending longitudinally forward to the left B-pillar. The left rear door was crushed against the B-pillar and the left C-pillar was crushed forward within 18 cm (7 in) of the left B-pillar. The left front door was jammed shut. The right rear door was fully intact and was jammed shut due to the deformation of the vehicle's frame. The right front door was operational and was used to remove the injured Trooper. The trunk space collapsed and its contents crushed forward due to the impact. The deformation extended forward through the rear occupant space, forward to approximately the front seat backs. The fire consumed everything that was combustible in the vehicle and it was a total burn, **Figure 6**.

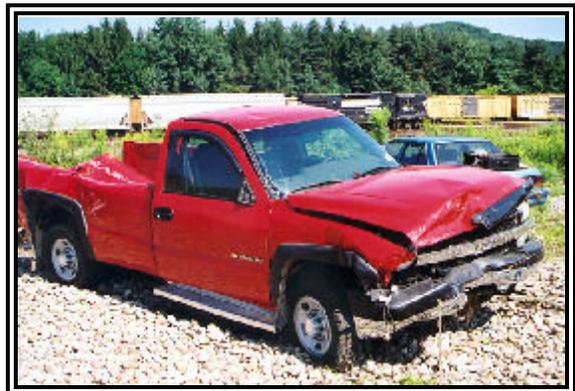
The 2002 Chevrolet K2500 pick-up truck, **Figure 10**, was identified by the Vehicle Identification Number (VIN): 1GCHK24U62F (production sequence deleted). The 3/4 ton, regular cab, 4x4 truck was designed with a 338 cm (133 in) wheelbase and had a gross vehicle weight rating of 4173 kg (9200 lb). The power train consisted of a 5.9 liter V-8 engine linked to a 4-speed automatic transmission. The service brakes were a 4-wheel anti-lock system.

Figure 10: View of the damaged Chevrolet.

was hitched to the truck by a hitch ball welded to a steel plate. The plate was fastened to the pick-up bed by a four bolt pattern. Upon impact with the Ford, the plate-to-hitch ball weld fractured allowing the trailer to separate from the pick-up truck. The trailer moved forward relative to the pick-up and the trailer coupling penetrated the forward aspect of the pick-up bed. The penetration of the coupling recaptured the trailer and the unit remained attached through the course of the collision to final rest. The State police investigation determined the combined weight of the pick-up truck, trailer and cattle was 5670 kg (12,500 lb). The trailer was not available for inspection.

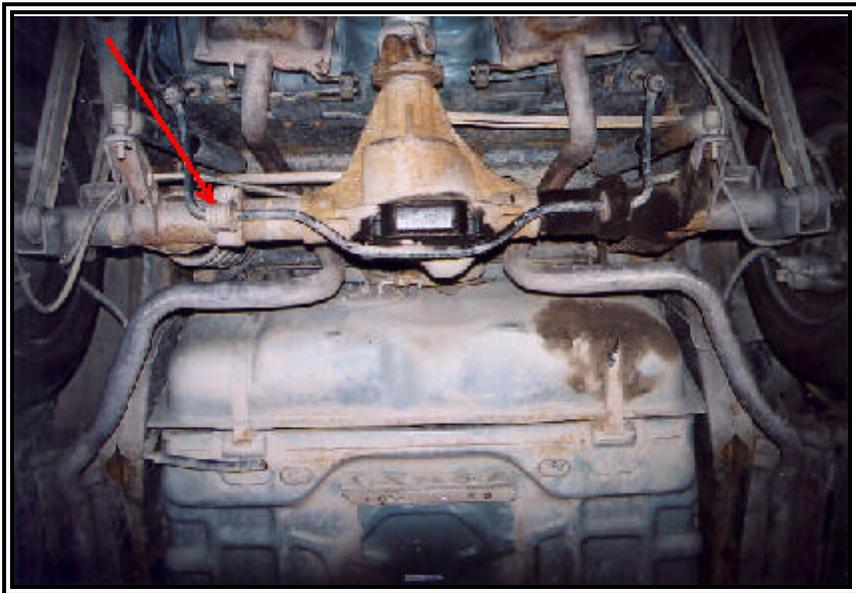
Figure 12 is a view of the rear undercarriage of an exemplar Ford Crown Victoria. The front of the vehicle is toward the top of the figure. The fuel tank was located immediately forward of the trunk well and approximately 25 cm (10 in) behind the rear axle. The carry straps securing the tank were attached to the upper and lower aspects of the trunk well. The left sway bar bracket is denoted by the red arrow. **Figure 13** is a right lateral view depicting the distance between the sway bar bracket and the tank.

Figure 12: View of the fuel tank and rear axle components of an exemplar Ford Crown Victoria.

During the deformation of the vehicle, the forward side of the tank contacted the rear axle and left rear sway bar bracket and shock absorber mount. The mechanism that caused the puncture of the fuel tank was contact between the fuel tank, the tank's left carry strap and the left sway bar bracket. Refer to **Figure 19**. Two impressions from the outer edges of the bracket were visible in the tank as a result of the contact. Additionally, the edge of the carry strap in the area of the hole was rolled over and there was a sharp burr. It should be noted, the inboard side (right edge) of the bracket caused the tank puncture. The Technical Safety Bulletin (TSB) issued by Ford on October 21, 2001 addressed grinding the tabs on the outboard (left side) of the bracket (relative to the vehicle). This service was performed on the subject vehicle. The evidence of compliance with the TSB can be seen on the left edge of the bracket in Figure 19.

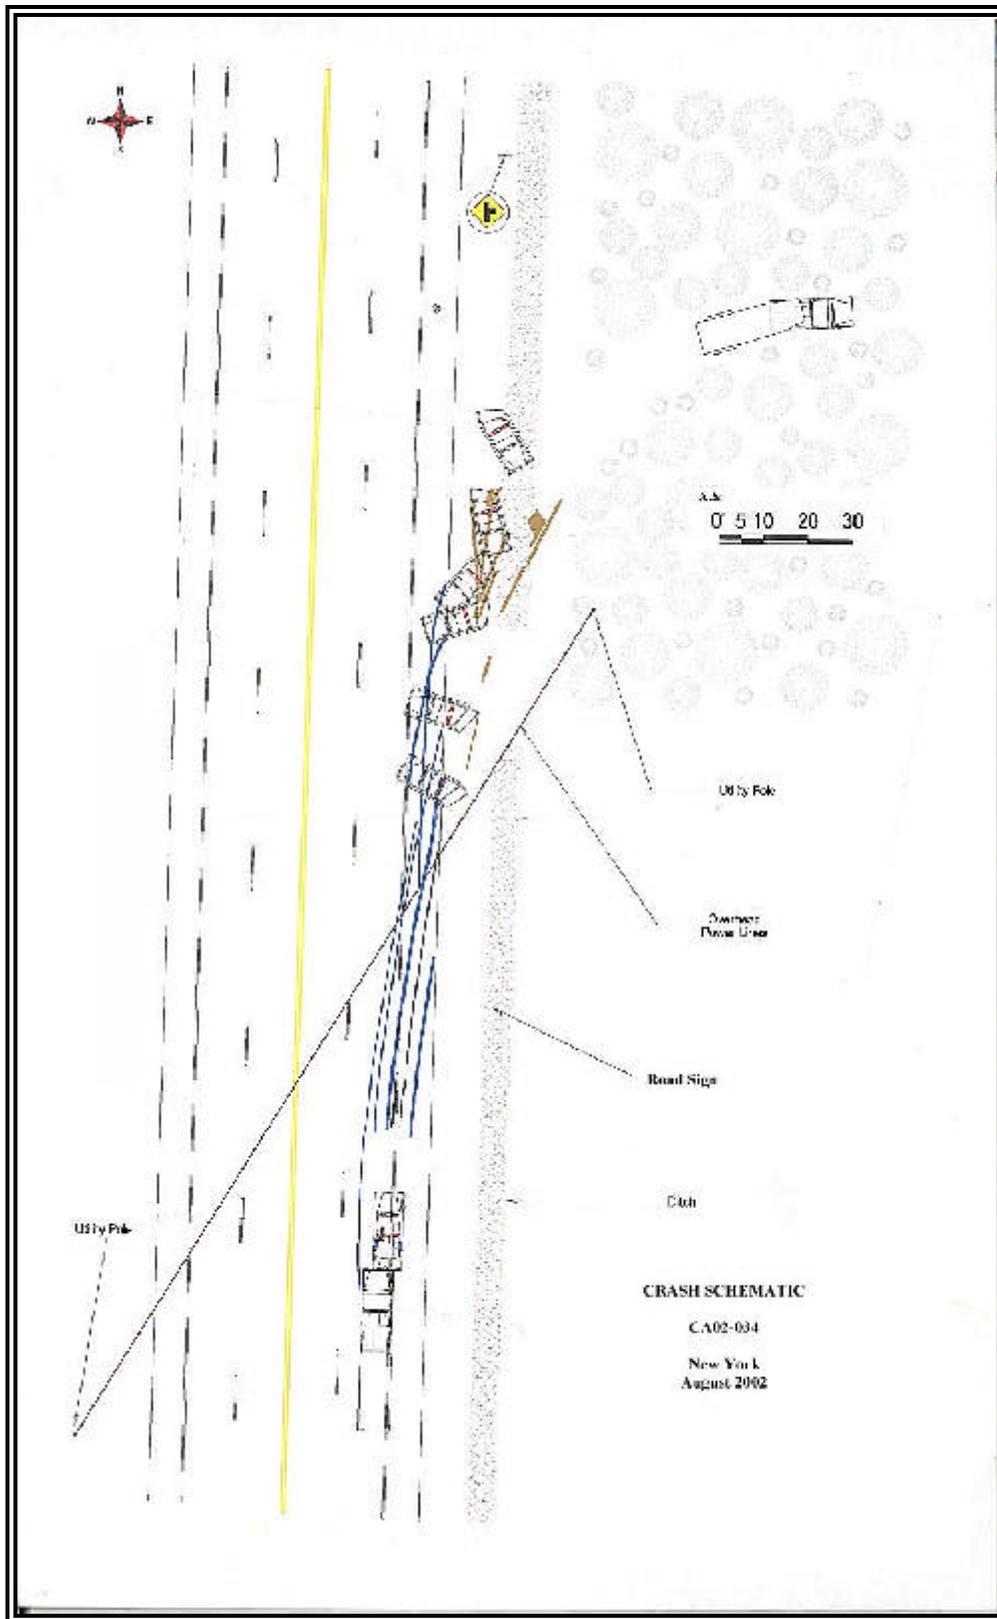
Figure 20: Crash schematic.

The front plane of the Chevrolet struck the rear plane of the Ford in a 12/6 o'clock impact configuration. The northbound momentum of the Chevrolet caused it to then override the rear aspect of the Ford as it was accelerated forward. The vehicles remained in sustained contact and traveled north approximately 36 m (120 ft) at which time the vehicles began to depart the eastside of the road. The Ford separated from the Chevrolet by a counterclockwise rotation and came to rest facing southeast in the roadside ditch approximately 56 m (183 ft) north of the point of impact. The Ford was reportedly on fire as the vehicles separated, as reported by witnesses to the crash. A small puncture to the Ford's fuel tank from contact with the left rear sway bar support bracket was identified during the vehicle inspection. The Chevrolet continued its northeastward trajectory and came to rest in an area of brush and small diameter trees approximately 73 m (240 ft) north of the impact.
