**GENERAL DYNAMICS ON-SITE ADVANCED OCCUPANT PROTECTION (AOPS)
INVESTIGATION
SCI TECHNICAL SUMMARY REPORT**

CASE NO. CA02-040

VEHICLE – 2001 HONDA ACCORD

CRASH DATE – AUGUST 2002

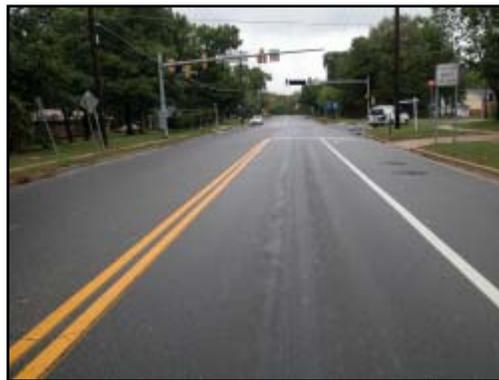
Figure 2. Westbound approach for the Honda Accord

The 24-year-old female driver was operating the Honda Accord westbound on the two-lane roadway on approach to the three-leg intersection (**Figure 2**). She steered the Accord into the inboard westbound lane in preparation to proceed straight through the intersection, as the traffic signal was in the green phase. The 38-year-old male driver of the 2002 Mazda 626 was operating the vehicle in a southbound direction on approach to the intersection (**Figure 3**). The driver of the Mazda steered into the southbound left turn lane as the vehicle approached the intersection. Although the traffic signal was in the red phase for southbound traffic, the Mazda 626 proceeded into the intersection across the path of the Accord. It was not known if either driver attempted any avoidance maneuvers.

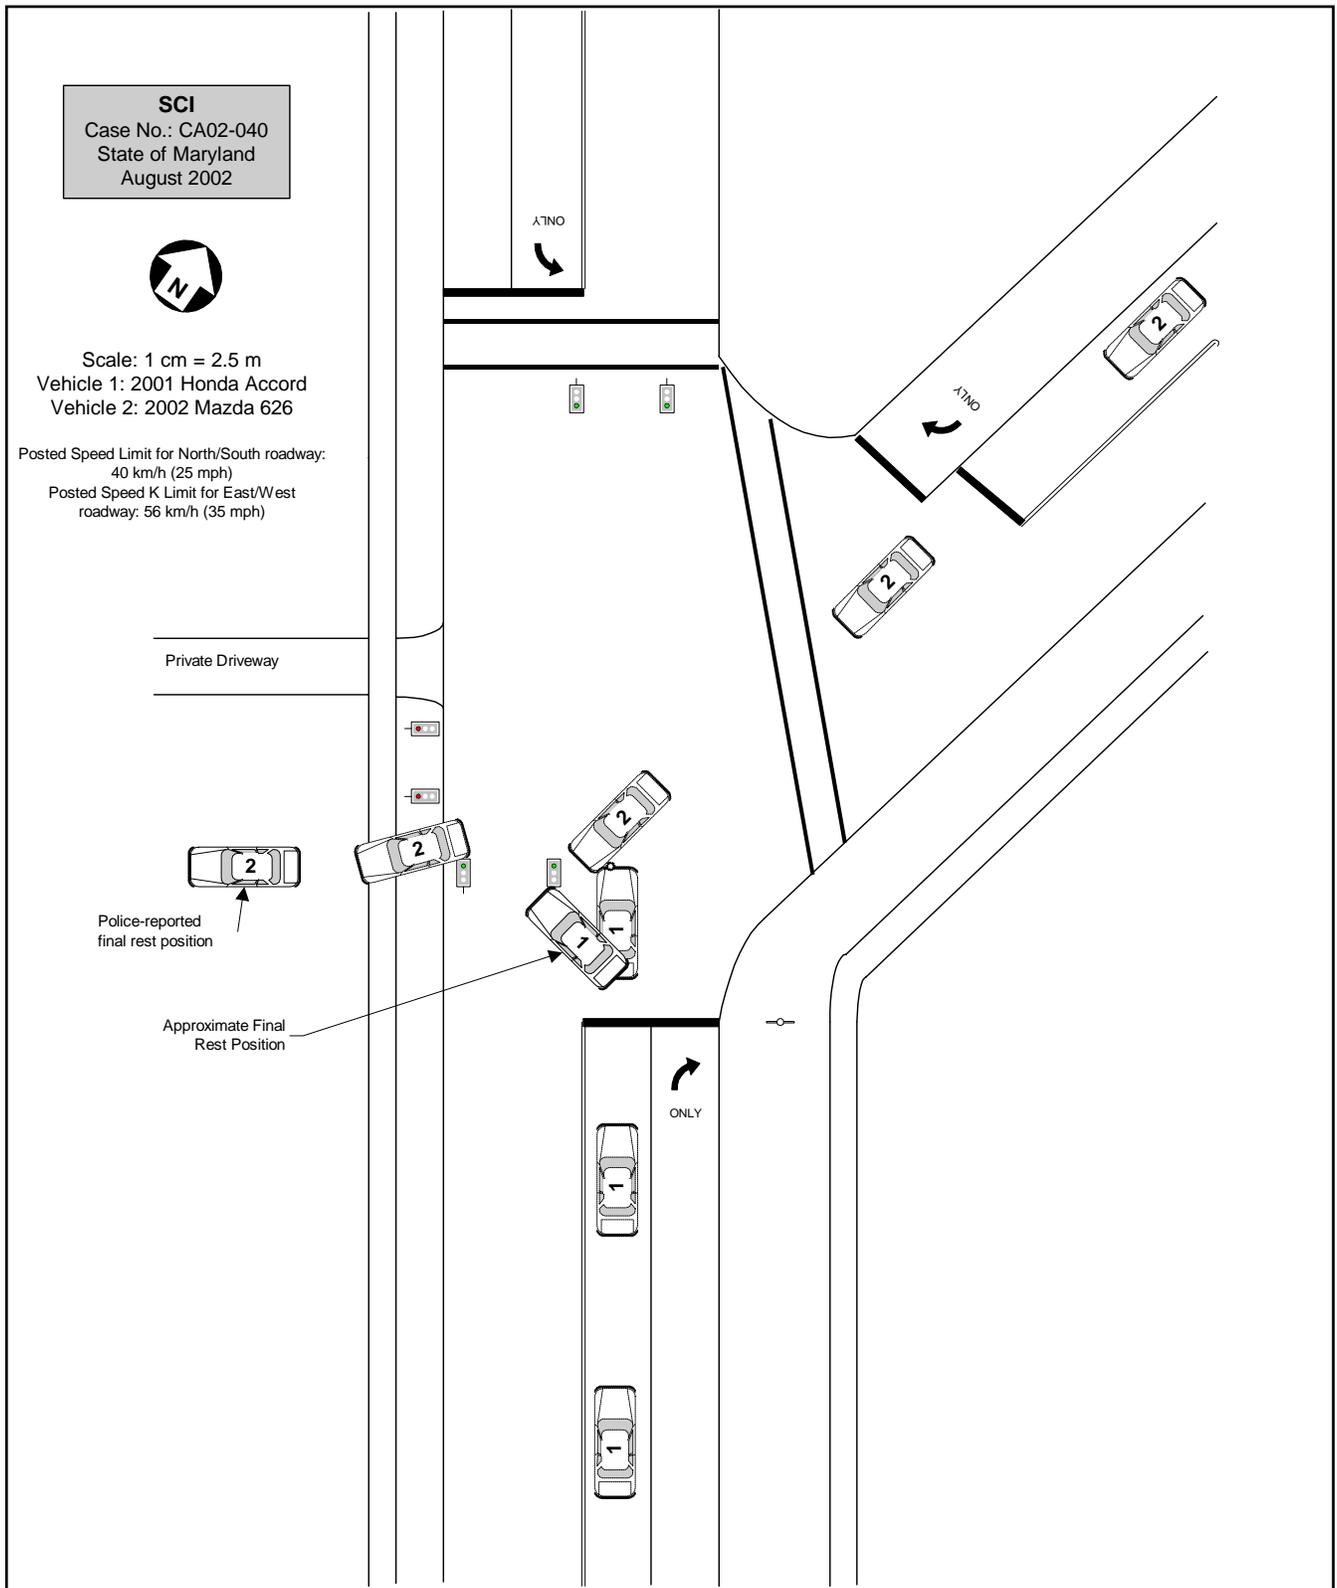
Figure 9. Scene schematic

environment was residential in nature. Traffic flow through the intersection was controlled by overhead three-phase traffic signals that were configured with left turn arrows. White solid “Stop” lines were present on each leg of the intersection. The posted speed limit for the east/west roadway was 56 km/h (35 mph), however, the posted speed limit decreased to 48 km/h (30 mph) west of the intersection. The posted speed limit for the north/south roadway was 40 km/h (25 mph). The scene schematic is included as **Figure 9** of this report.
