ON-SITE AIR BAG RELATED CHILD FATALITY INVESTIGATION

VEHICLE: 1996 CHEVROLET CAVALIER

CASE NO: CA02-041

CRASH DATE: SEPTEMBER, 2002

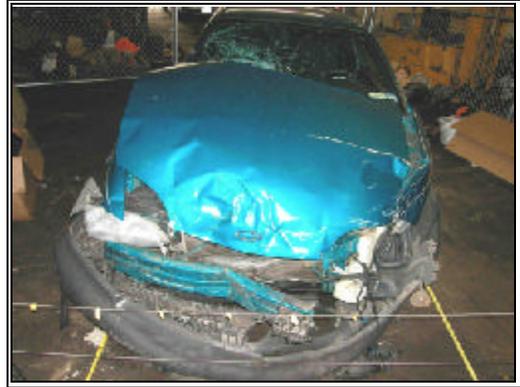
This on-site investigation focused on the severity of the crash, the injuries, and the injury mechanisms that resulted in the death of a 3 year female child passenger who was seated on the lap of an adult passenger in the front right position of a 1996 Chevrolet Cavalier. The Cavalier, **Figure 1**, was equipped with frontal air bags for the driver and right passenger positions. The frontal air bag system deployed as a result of an intersection crash with a 2000 Volvo S80. The Volvo was equipped with a frontal air bag system and a side impact air bag system that included front seat mounted air bags and side curtains. The Volvo's right side impact air bag system and frontal air bag system deployed as a result of the impact. The Chevrolet's child passenger was transported by ambulance to a local hospital where she was evaluated and prepared for helicopter transferral to a regional children's trauma center due to the severity of her injuries. She was admitted comatose with a high cervical spinal cord injury, quadriplegia and a brain injury as a direct result of contact with the deploying front right passenger air bag. The child was supported on a ventilator, however, she expired upon removal of the life-support nine days following the crash. The driver and front right adult passenger sustained police reported minor injuries. The occupants of the Volvo were not injured in the crash.

Figure 1: Chevrolet Cavalier front view.

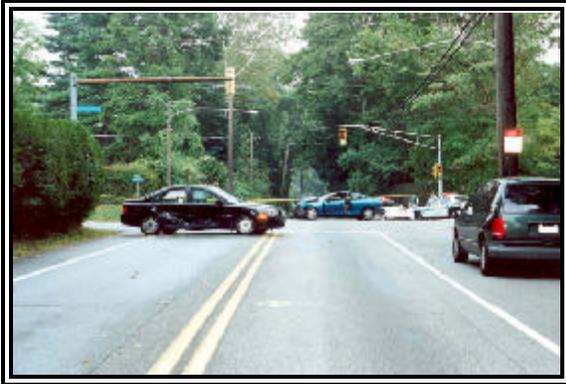
Figure 2: On-scene police photograph looking east.

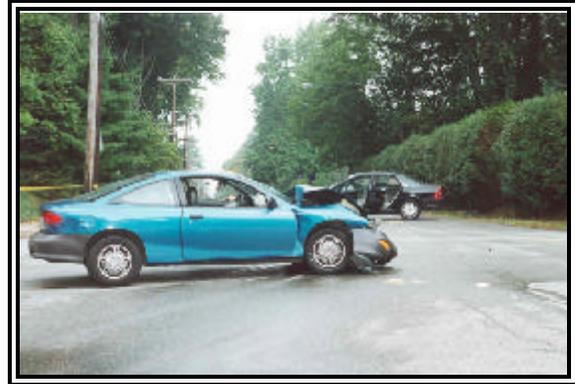
Figure 3: On-scene police photograph looking west.

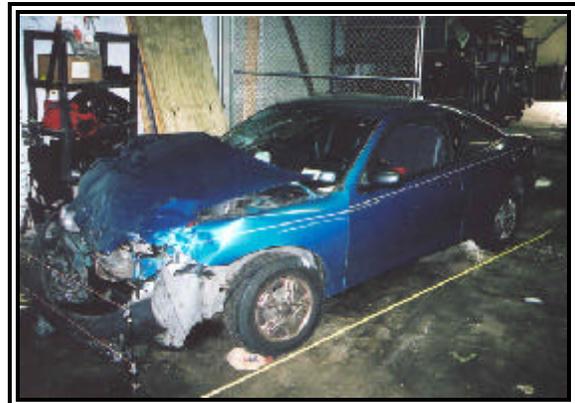
The 1996 Chevrolet Cavalier 2-door coupe, **Figure 4**, was identified by the Vehicle Identification Number (VIN): 1G1JC1244TM (production sequence deleted). The vehicle's power train consisted of a 2.2 liter/I-4 engine linked to a 4-speed automatic transmission. The service brakes were a front disc/rear drum system with ABS. The manual restraint system consisted of 3-point lap and shoulder belts in the four outboard positions and a center rear lap belt. The Supplemental Restraint System consisted of driver

Figure 4: Left front view of the Chevrolet.

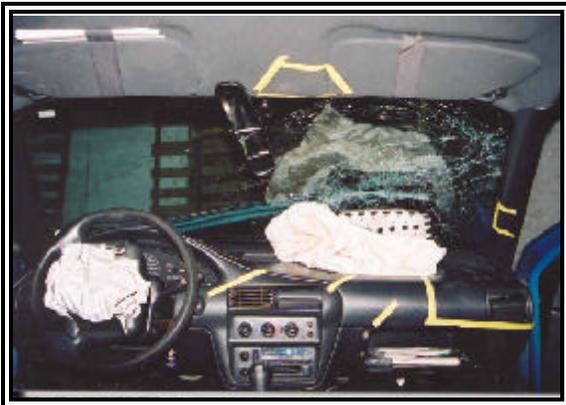
Figure 7 is an overall view of the Chevrolet's interior. Multiple areas of contact evidence were identified on the upper surface of the instrument panel's right aspect. These contacts were attributed to contact from the impeded expansion of the front right passenger air bag due to the forward position of the lap seated child passenger. A 25 cm x 18 cm (10 in x 7 in), width by height, area of air bag scuffing was located on the right corner of the instrument panel, **Figure 8**. This contact pattern measured 13 cm (5 in) on the vertical face of the panel and wrapped 5 cm (2 in) onto its horizontal surface. The heating vent louvers were fractured by this contact. A 10 cm x 8 cm (4 in x 3 in) air bag scuff was identified on the vertical face of the instrument panel in its right center aspect. This scuff began 36.8 cm (14.5 in) left of the panel's outboard edge. An 8.0 cm (3.0 in) air bag scuff was located on the trim panel covering the right A-pillar. This scuff began 15 cm (6 in) above the instrument panel. The right door interior trim panel exhibited a 14.0 cm (5.5 in) air bag scuff on its upper aspect at the intersection with the glazing. The pattern began 24.1 cm (9.5 in) rear of the forward edge of the glazing. The trim panel was fractured within this pattern from probable occupant contact.

Figure 7: Overall forward interior view.

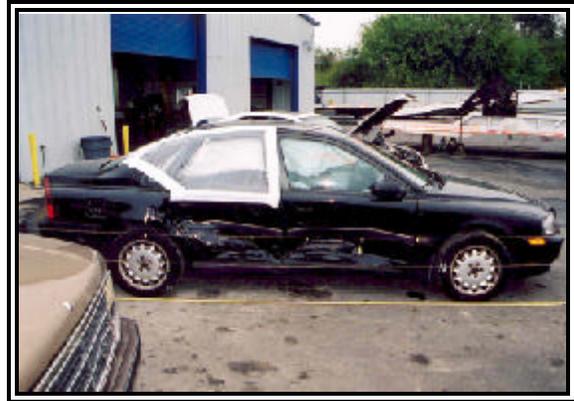
The 2000 Volvo S80, 4-door sedan, **Figure 13**, was identified by the Vehicle Identification Number (VIN): YV1TS94DXY1 (production sequence deleted). The vehicle was equipped with a 2.9 liter/I-6 engine linked to a 4-speed automatic transmission. The services brakes were 4-wheel disc with ABS. The Volvo was equipped with a power package including power steering, power brakes, and 8-way adjustable driver and front passenger seats. The manual restraint system consisted of 3-point lap and shoulder belts with retractor pretensioners in the five seat positions. The vehicle's Advanced Occupant Protection System (AOPS) consisted of dual stage driver and front right passenger air bags, seat back mounted side impact air bags for the front occupants and inflatable side curtains. The vehicle was manufactured in September 1999. The odometer had registered 40,616 km (25,328 miles) at the time of the inspection.

Figure 13: Right side view of the Volvo S80.

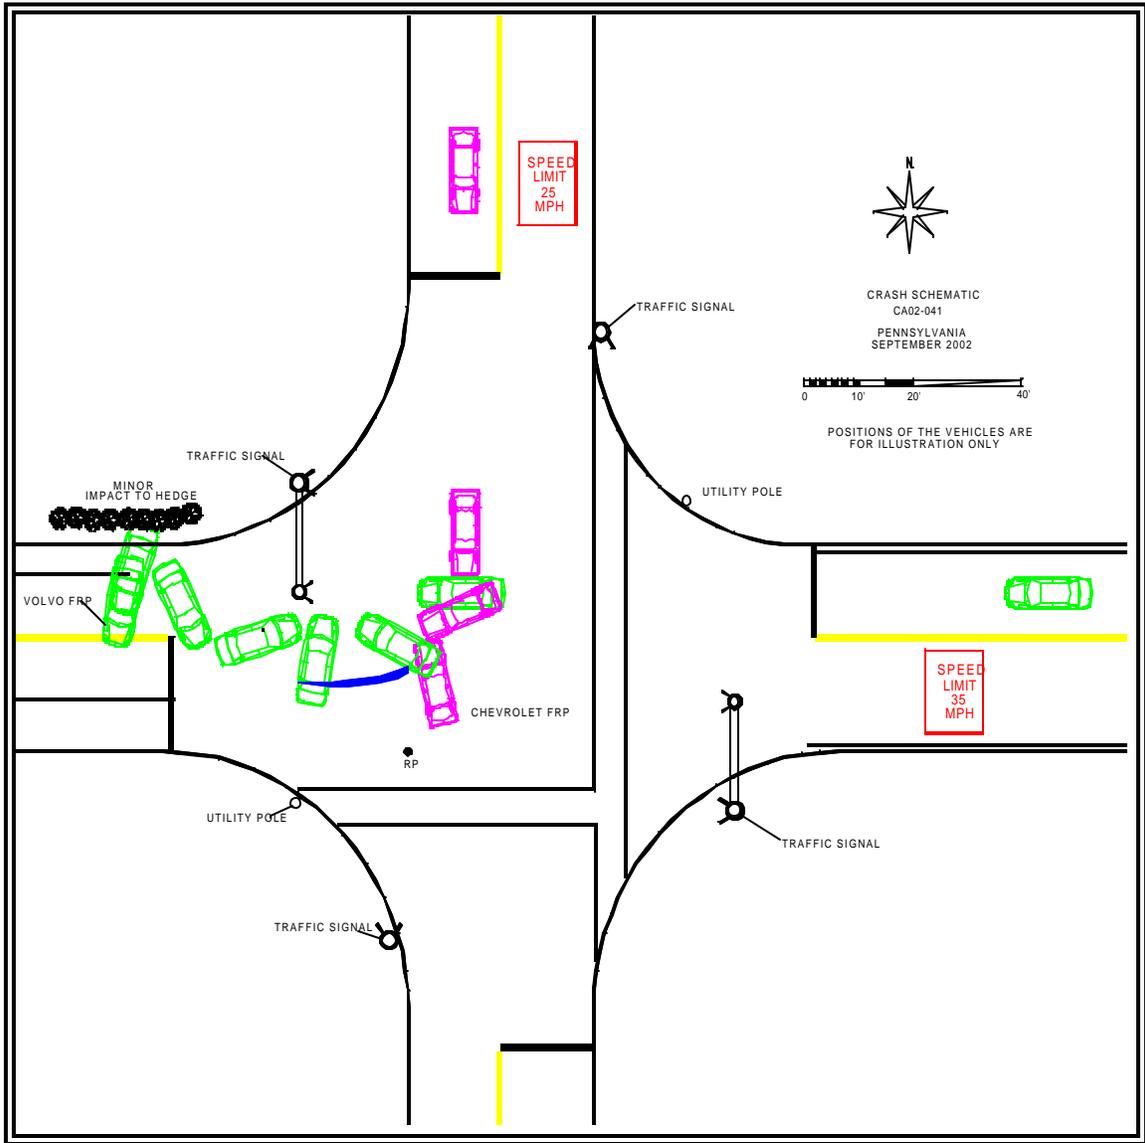
The lateral momentum of the Volvo (relative to the Chevrolet) caused the Chevrolet to rotate approximately 180 degrees clockwise upon separation from the Volvo. The Chevrolet came to rest facing north within the center of the intersection approximately 7.6 m (25.0 ft) south of the impact. The Chevrolet's impact was centered approximately 25 cm (10 in) aft of the Volvo's right B-pillar. The force of the impact rearward of the Volvo's center of gravity caused the vehicle to rotate approximately 270 degrees clockwise during its slide to rest. The Volvo came to rest facing south 18.9 m (62.0 ft) west of the point of impact. A 6 m (20 ft) scuff mark attributed to the right rear tire of the Volvo defined its post-crash trajectory. In the late stages of the Volvo's post-impact trajectory the back plane of the vehicle contacted the road side hedge and then rolled forward to final rest. **Figure 22**, at the end of this narrative report, is a schematic of the crash.

Figure 22: Crash schematic.

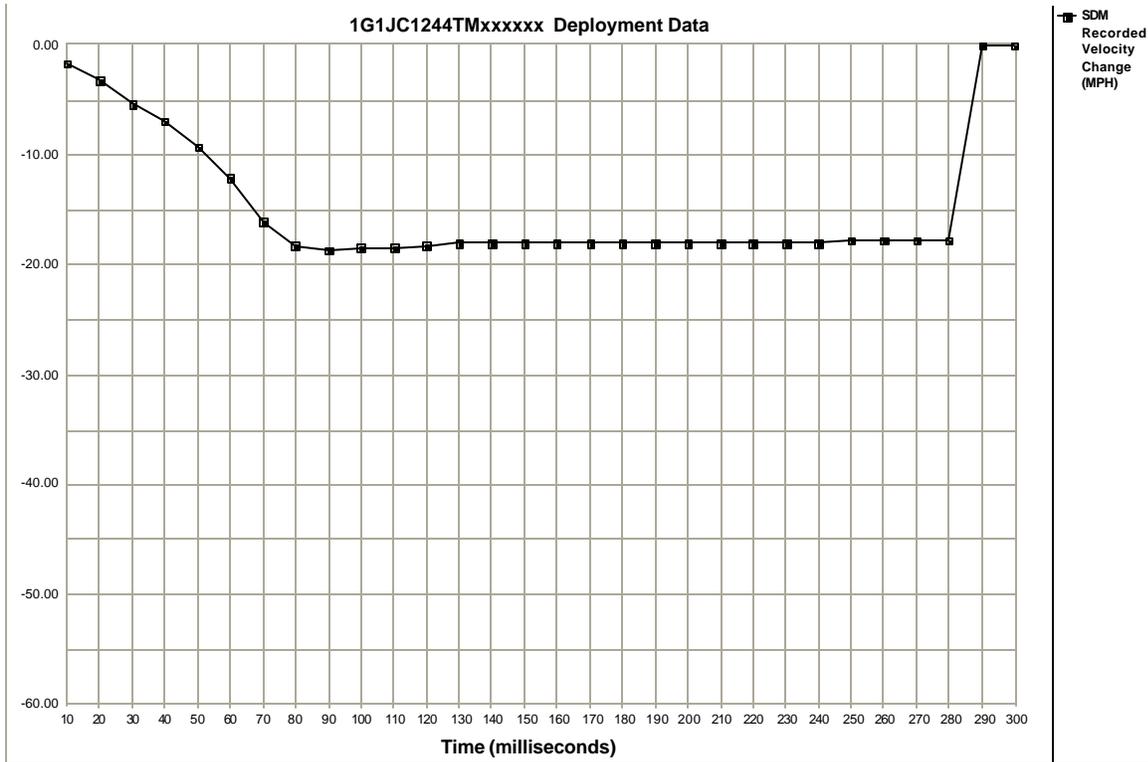
SIR Warning Lamp Status	OFF
Driver's Belt Switch Circuit Status	UNBUCKLED
Ignition Cycles At Deployment	0
Ignition Cycles At Investigation	22897
Time From Algorithm Enable To Deployment Command (msec)	12.5
Time Between Near Deployment And Deployment Events (sec)	N/A

Time (milliseconds)	10	20	30	40	50	60	70	80	90	100	110	120	130	140	150
Recorded Velocity Change (MPH)	-1.54	-3.07	-5.27	-6.80	-9.21	-12.07	-16.02	-18.21	-18.65	-18.43	-18.43	-18.21	-17.99	-17.99	-17.99
Time (milliseconds)	160	170	180	190	200	210	220	230	240	250	260	270	280	290	300
Recorded Velocity Change (MPH)	-17.99	-17.99	-17.99	-17.99	-17.99	-17.99	-17.99	-17.99	-17.99	-17.77	-17.77	-17.77	-17.77	0.00	0.00
