**SCI 1 REMOTE CERTIFIED ADVANCED 208-COMPLAIANT VEHICLE CRASH
INVESTIGATION**

SCI 1 TECHNICAL SUMMARY REPORT

NASS/SCI COMBO CASE NO. 03-43-022G

VEHICLE – 2003 CHEVROLET SILVERADO

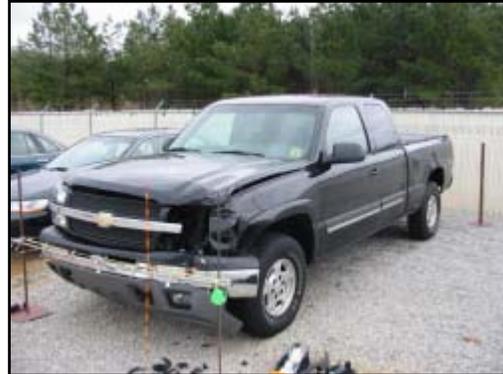
Figure 1. 2003 Chevrolet Silverado.

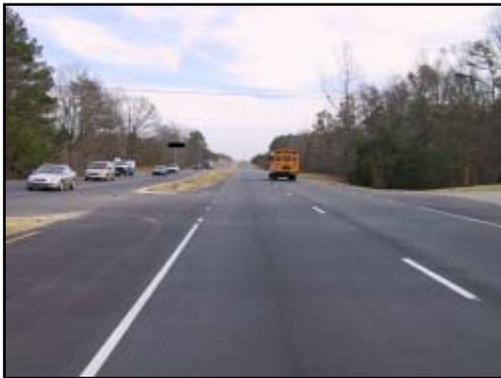
The restrained 33-year-old male driver of the Chevrolet was operating the vehicle eastbound in the left through lane on approach to the “T” intersection (**Figure 2**). A restrained 28-year-old male front right occupant also occupied the Chevrolet. The driver of the Freightliner was operating the vehicle northbound on approach to the “T” intersection (**Figure 3**) where he was intending to turn left. The 53-year-old female driver of the Freightliner failed to detect the Chevrolet and turned left across the path of the Chevrolet. It was unknown if the driver of the Freightliner came to a complete stop before entering the intersection. There was no physical evidence at the crash site. The EDR data indicated the Chevrolet was traveling at 106.0 km/h (66.0 mph) five seconds prior to Algorithm Enable (AE) and had slowed to 51.5 km/h (32.0 mph) one second prior to AE. The EDR also indicated that the brake switch status was in the on-position from four to one second prior to the crash. The police reported travel speed for the Chevrolet was 89 km/h (55 mph) and 8 km/h (5 mph) for the Freightliner. The NASS scene schematic is included as **Figure 18** of this report.

Figure 2. Chevrolet's eastbound approach.

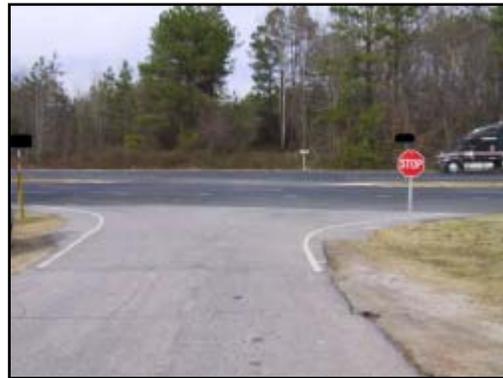
Figure 3. Freightliner's northbound approach.

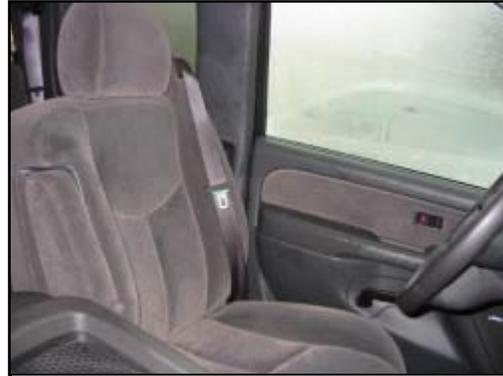
The 2003 Chevrolet Silverado was equipped with integrated manual 3-point lap and shoulder belts for the outboard seating positions. The front safety belts were integrated into the seats. The driver's safety belt was configured with a sliding latch plate and a belt-sensitive Emergency Locking Retractor (ELR). The driver and front right passenger utilized their safety belts. The front right and two rear outboard safety belts were configured with sliding latch plates and switchable ELR/Automatic Locking Retractor (ALR). The rear center safety belt was manual a 2-point lap belt that was configured with a locking latch plate.

Figure 8. Integrated driver's safety belt.
