**GENERAL DYNAMICS REMOTE SIDE IMPACT INFLATABLE OCCUPANT
PROTECTION SYSTEM CRASH INVESTIGATION**

SCI TECHNICAL SUMMARY REPORT

NASS/SCI COMBO CASE NO. 03-43-270A

VEHICLE – 2001 BMW 325i

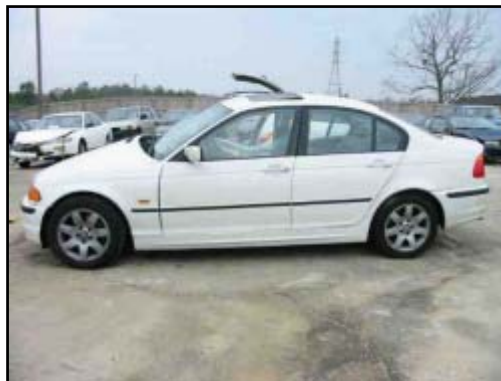
This remote investigation focused on the performance of the Side Impact Inflatable Occupant Protection system in a 2001 BMW 325i (**Figure 1**) and the resulting injury mechanism for the 9-year-old female front right occupant. The BMW was equipped with front door panel mounted side impact air bags and a Head Protection System (HPS) that consisted of roof side rail mounted tubular air bags for the front seating positions. In addition, the BMW was equipped with dual stage frontal air bags and buckle mounted safety belt pretensioners. The 2001 BMW 325i was occupied by a restrained 34-year-old female driver, a 9-year-

Figure 1. Subject vehicle 2001 BMW 325i.

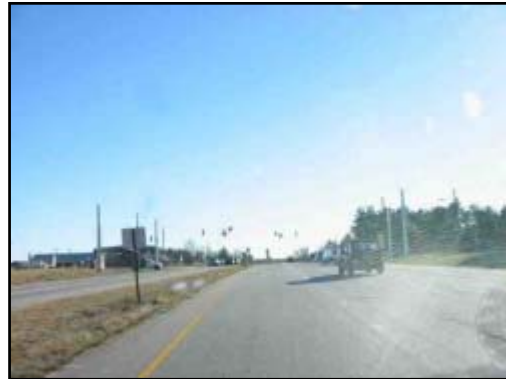
The restrained 34-year-old female driver of the BMW was operating the vehicle southbound approaching the four-leg intersection (**Figure 2**) where the driver was intending to turn left. The driver of the GMC was operating the vehicle northbound in the left through lane approaching the same intersection ahead of the Honda. The driver of the Honda was operating the vehicle northbound in the left through lane behind the GMC approaching the same intersection. The Honda changed lanes to the left and entered the left turn lane and passed the GMC. The Honda reentered the inboard through lane prior to the intersection. No pre-impact evidence [i.e. skid marks] were present at the crash site. The NASS scene schematic is included as **Figure 11** of this report.

Figure 2. BMW's approach to the intersection.
