**GENERAL DYNAMICS REMOTE CERTIFIED ADVANCED 208-COMPLIANT
VEHICLE CRASH INVESTIGATION**

SCI TECHNICAL SUMMARY REPORT

NASS/SCI COMBO CASE NO. 03-43-285H

VEHICLE – 2004 LEXUS RX330

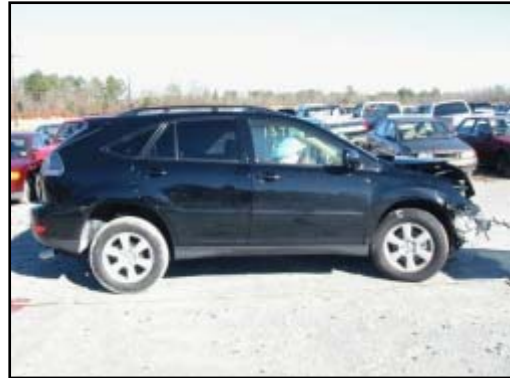
This remote investigation focused on the performance of the Certified Advanced 208-Compliant (CA208-C) safety system (**Figure 1**) in a 2004 Lexus RX330. The manufacturer of this vehicle has certified that this 2004 Lexus RX330 meets the advanced air bag requirements of Federal Motor Vehicle Safety Standard (FMVSS) No. 208. The safety system included multi-stage frontal air bags, seat track position sensors for the front seats, an occupant presence sensor for the front right seat, and retractor mounted pretensioners for the front safety belts. In addition, the Lexus was

Figure 1. Subject 2004 Lexus RX330.

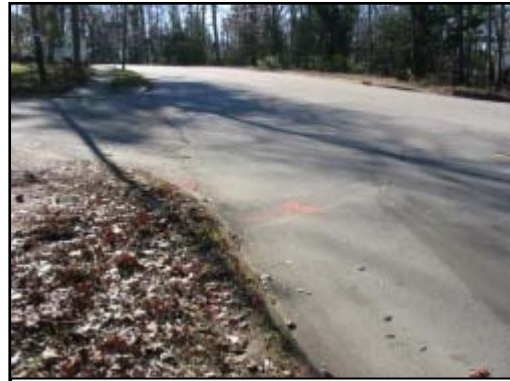
Figure 2. Southwest view of the crash site.

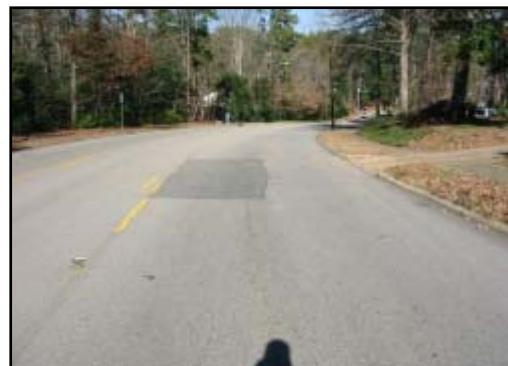
The restrained 31-year-old pregnant female driver of the Lexus was operating the vehicle northbound, negotiating the right curve on approach to the intersection (**Figure 3**). The 37-year-old male driver of the Ford was operating the vehicle eastbound approaching the same intersection. The driver of the Ford stated to the

Figure 3. Lexus northbound travel to the intersection.
