**GENERAL DYNAMICS REMOTE CHILD SAFETY SEAT INVESTIGATION**

**NASS/SCI COMBO CASE NO. 03-45-065K**

**VEHICLE – 1999 CHEVROLET SILVERADO**

**CRASH DATE – APRIL 2003**

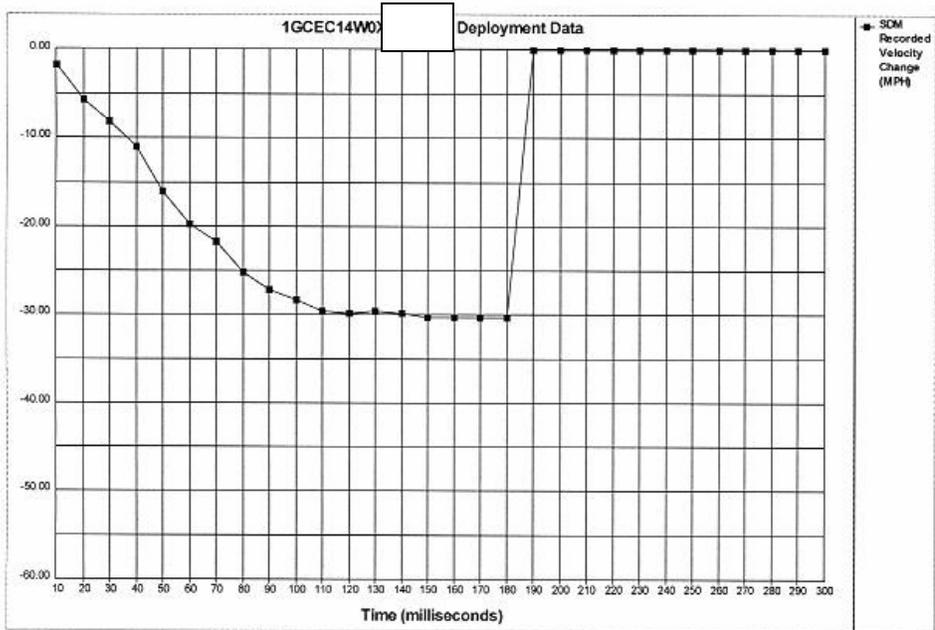
Time (milliseconds)	10	20	30	40	50	60	70	80	90	100	110	120	130	140	150
Recorded Velocity Change (MPH)	-1.76	-5.70	-8.12	-10.97	-16.02	-19.75	-21.72	-25.23	-27.21	-28.30	-29.62	-29.84	-29.82	-29.84	-30.28
Time (milliseconds)	160	170	180	190	200	210	220	230	240	250	260	270	280	290	300
Recorded Velocity Change (MPH)	-30.28	-30.28	-30.28	0.00	0.00	0.00	0.00	0.00	0.00	0.00	0.00	0.00	0.00	0.00	0.00
