SCI/NASS COMBINATION SIDE IMPACT INFLATABLE OCCUPANT PROTECTION REPORT

CASE NUMBER - NASS-2003-50-110C

VEHICLE - 2000 BMW 323i

CRASH DATE - December 2003

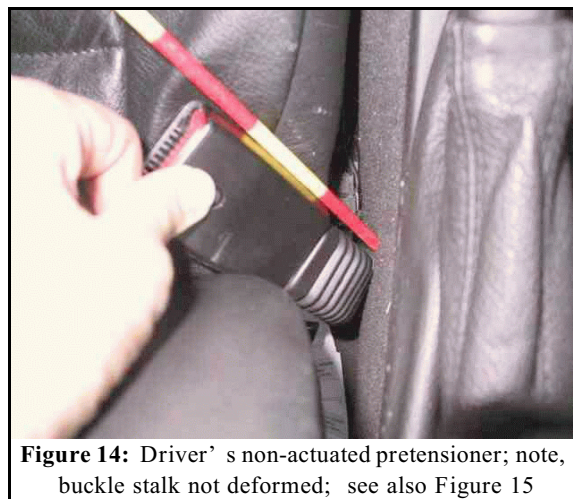
The driver did not attempt any avoidance maneuvers and her posture did not change prior to the first impact. The front of the case vehicle struck the right side of the other vehicle, causing the case vehicle' s frontal air bags to deploy and causing the driver to move forward and leftward, toward the 10:00 o' clock direction of force. The driver' s safety belt system was equipped with a buckle pretensioner that did not actuate because the buckle was not fastened (**Figure 14**). She probably encountered the air bag with her face and chest and did not sustain any injuries. The case vehicle rotated clockwise and its left rear area impacted the right rear area of the other vehicle, causing the case vehicle' s left door-mounted side impact air bag and left roof rail-mounted tubular head protection air bag to deploy and causing the driver to move leftward, toward the 9:00 o' clock direction of force. The case vehicle driver probably encountered the side impact air bag with the left side of her thorax and may have contacted the head protection air bag with the left side of her head, but there was no evidence of contact readily apparent on any of the air bags that deployed into the driver' s seating area. The case vehicle was redirected in a southeasterly direction, ran over a traffic island and the case vehicle' s front impacted a concrete wall. The case vehicle driver was jostled erratically as the vehicle bumped across the traffic island and the driver pitched forward, toward the 12:00 o' clock direction of force, compressing and deflating the steering wheel-mounted frontal air bag. She sustained contusions as her forehead impacted the windshield, her chest impacted the steering wheel hub/spoke and both thighs impacted the steering wheel rim. Her limbs flailed and she sustained contusions when her right forearm contacted the instrument panel and her right ankle contacted the foot controls. Her posture at final rest is not known.
