### SCI/NASS COMBINATION SIDE IMPACT INFLATABLE OCCUPANT PROTECTION REPORT

CASE NUMBER - NASS-2003-72-078K

VEHICLE - 2003 AUDI QUATTRO

CRASH DATE - July 2003

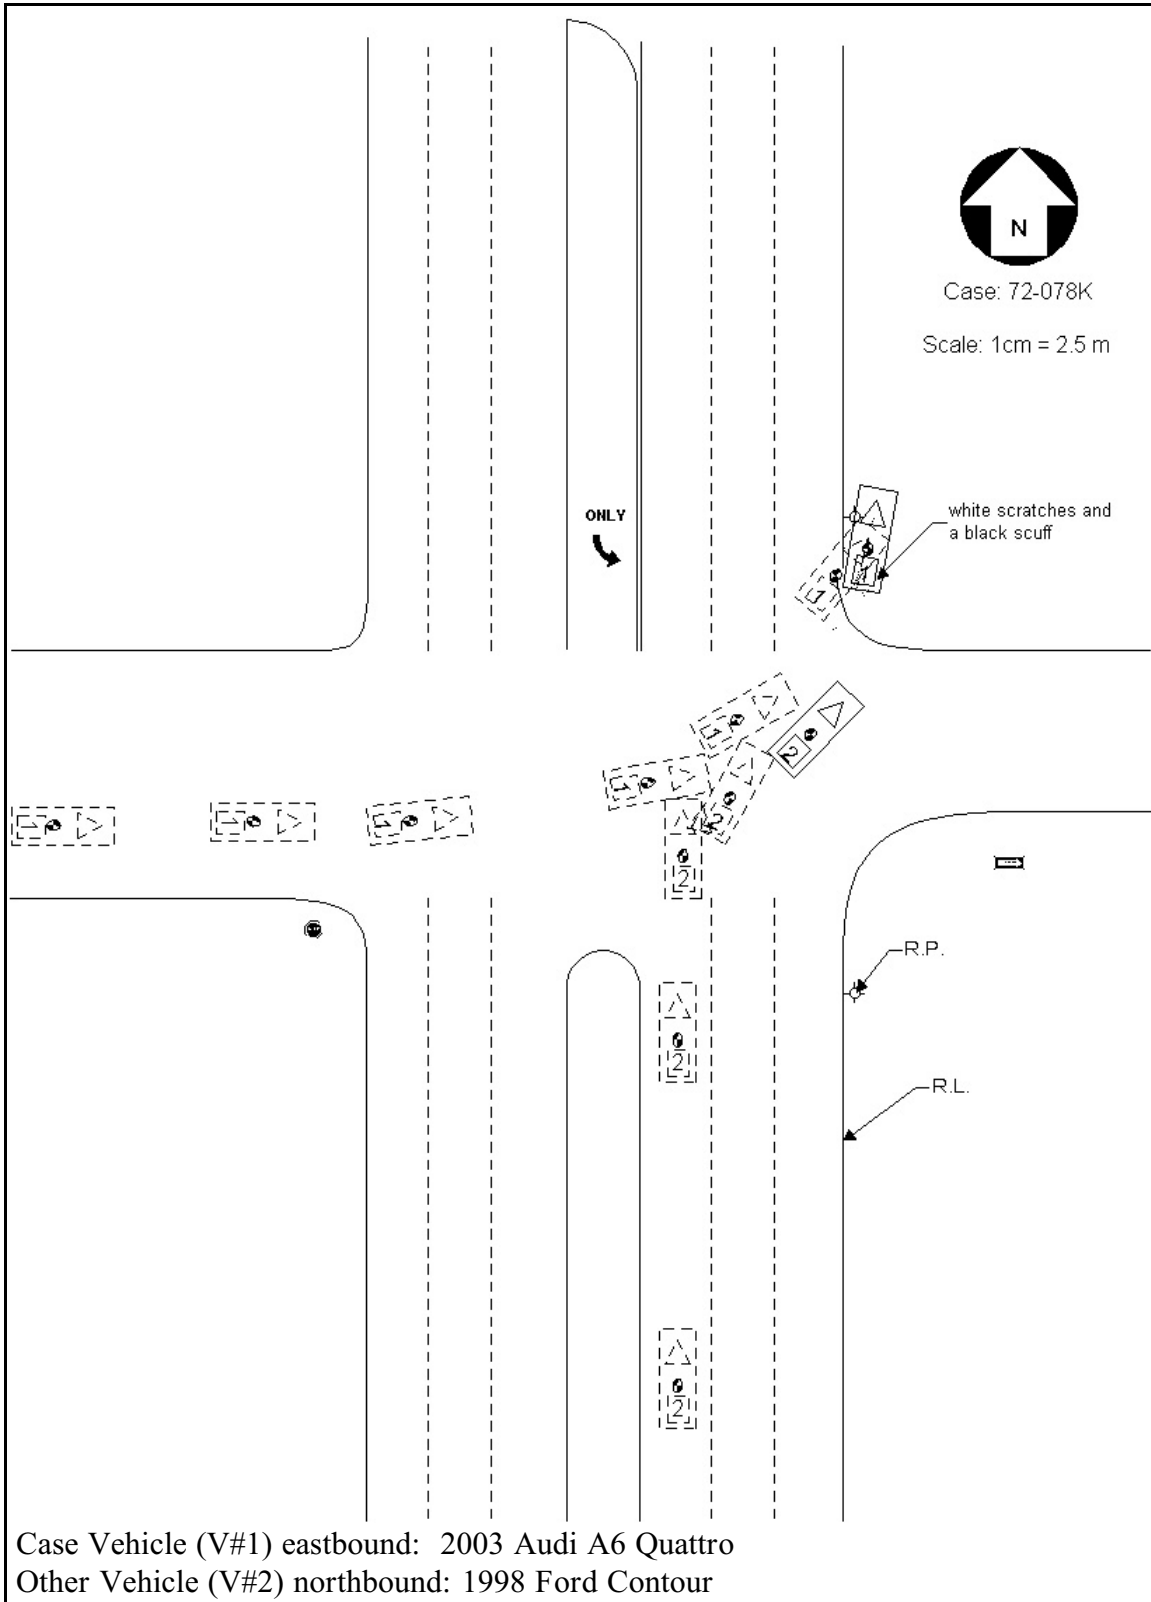
SCENE DIAGRAM

The case vehicle was traveling east in the eastbound lane of a two-lane local street, approaching a four-leg intersection and intending to continue east (**Figure 1**). The other vehicle was traveling north in the inside northbound through lane of the intersecting two-lane roadway that was part of a divided trafficway, and was intending to continue north (**Figure 2**). It was daylight, the weather was clear, the road surface was dry and with no apparent defects. The speed limit on both roadways was 56 km.p.h. [35 m.p.h.]. There was a stop sign for the case vehicle and no traffic control for the other vehicle. The case vehicle entered the intersection across the other vehicle's path. The case vehicle driver observed the other vehicle and braked at the last moment.

driver and front right passenger frontal air bags to deploy. The case vehicle rotated a few degrees counterclockwise and came to rest on the sidewalk heading slightly east of north. The other vehicle rotated clockwise and came to rest within the intersection, heading northeast. Both vehicles were towed due to damage.
