SCI/NASS COMBINATION CASE REPORT

CASE NUMBER - NASS-2003-73-059A
LOCATION - Indiana
VEHICLE - 2001 CHEVROLET MONTE CARLO
CRASH DATE - April 2003

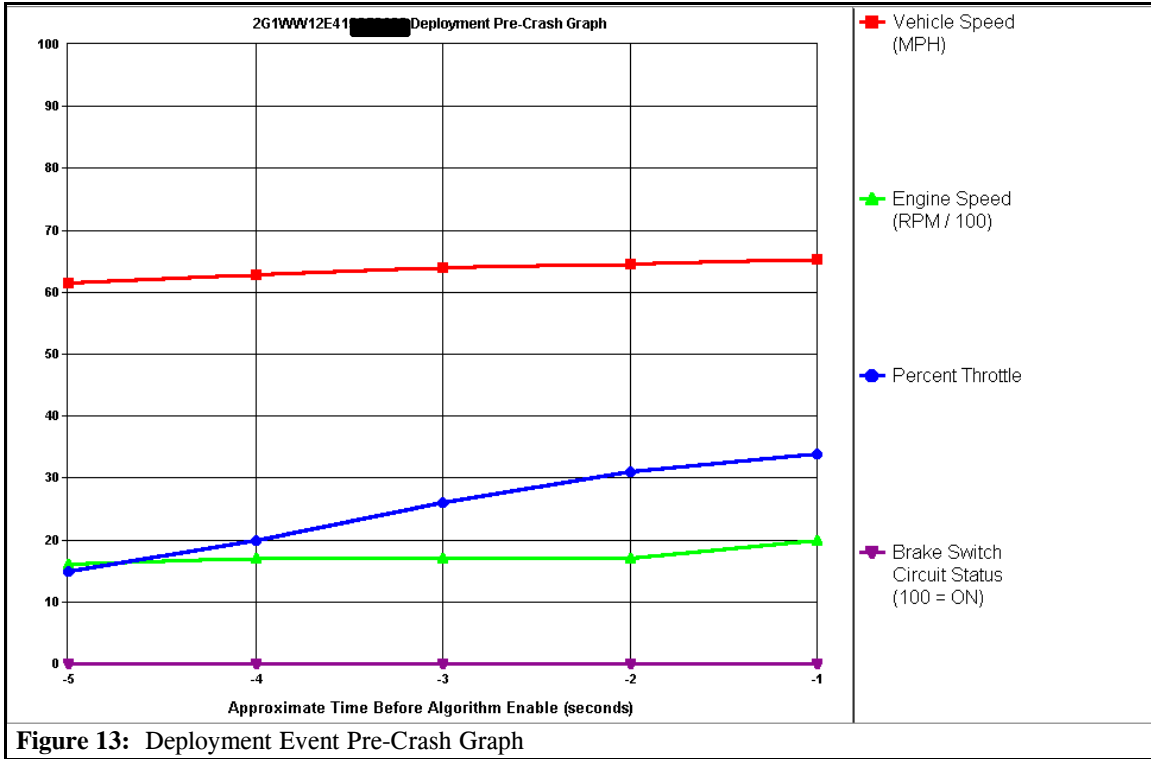
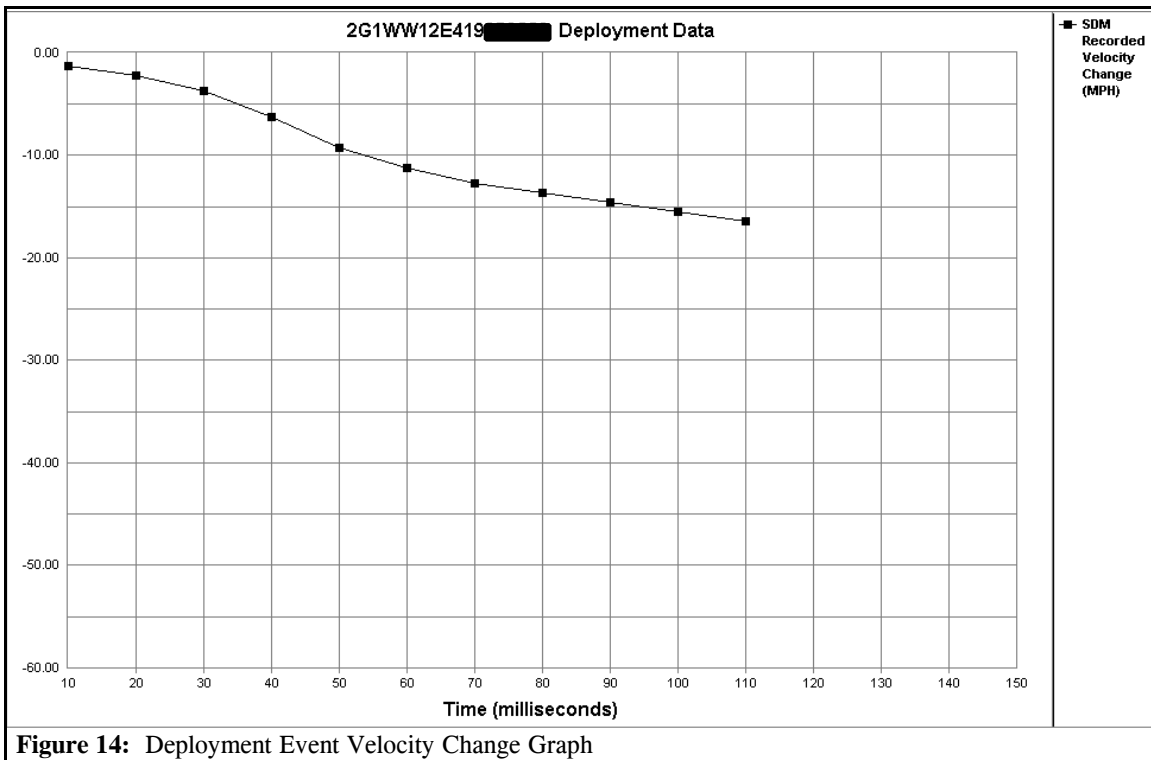
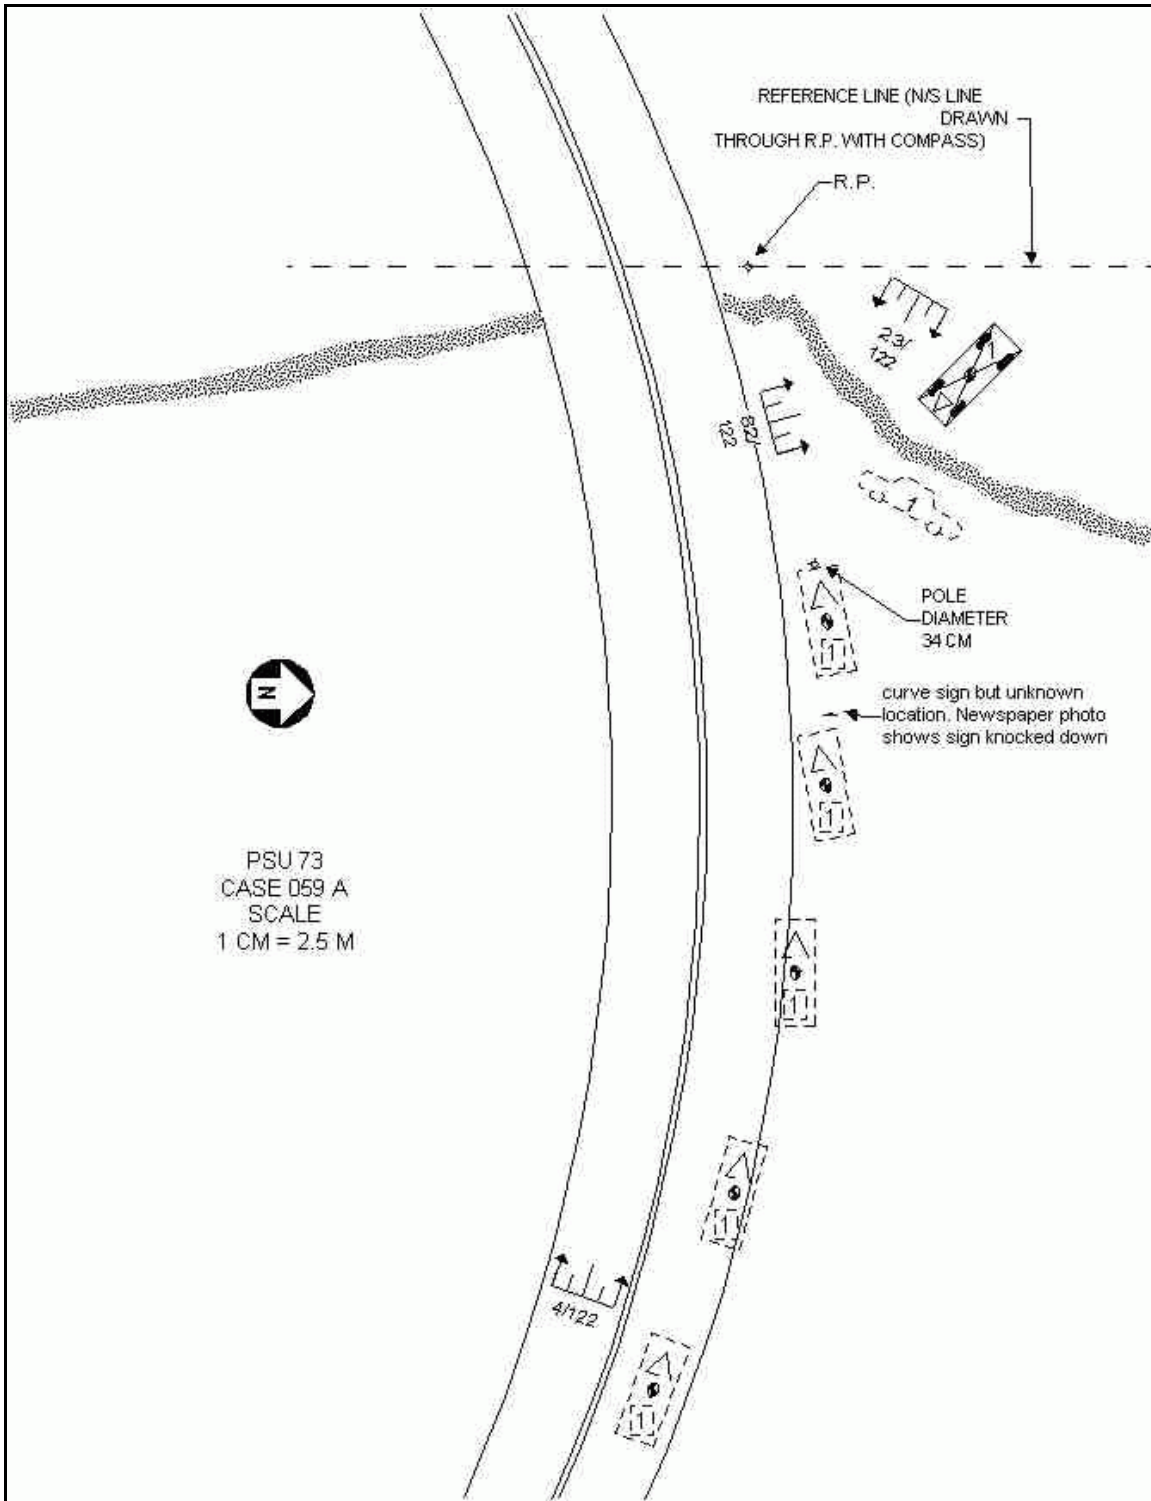
Figure 12: Deployment Event System Status Report

The case vehicle's event data recorder was successfully downloaded. The Sensing and Diagnostic Module (SDM) reports are included at the end of this document. The EDR recorded a non-deployment event (**Figures 9 - 11**) associated with event #1 (the sign post impact), and a deployment event (**Figures 12 - 14**) associated with event #2 (the utility pole impact).
