**GENERAL DYNAMICS ON-SITE AMBULANCE CRASH INVESTIGATION
SCI TECHNICAL SUMMARY REPORT**

CASE NO. CA03-004

VEHICLE – 1997 FORD E-350 TYPE III AMBULANCE

CRASH DATE – JANUARY 2003

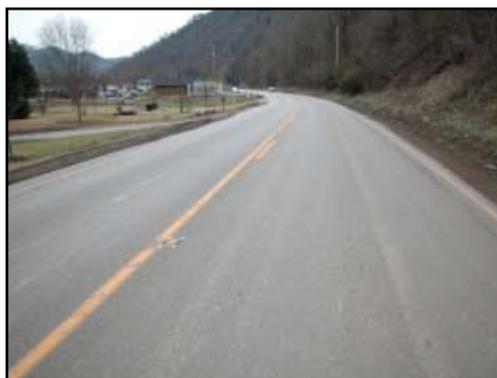
As the ambulance was in the left curve approaching the straight section of the roadway (**Figure 2**), the driver detected a tractor-trailer ahead in the westbound lane traveling well below the posted speed limit. The tractor-trailer was displaying a left turn signal as it slowed, and the driver of the ambulance thought the truck was slowing to let the ambulance pass. The ambulance driver initiated a passing maneuver and crossed the centerline of the roadway. As the ambulance entered the eastbound lane, the tractor-trailer initiated a left turn into a driveway across the path of the ambulance. The driver of the ambulance braked and steered right in an attempt to avoid the collision. He called out to the occupants in the patient compartment during the avoidance maneuver in an attempt to warn them of the impending crash. The ambulance crossed the centerline, initiated a clockwise (CW) yaw across the westbound lane, and departed the right roadside. It traveled through the shallow ditch and ramped up the hillside. At the time of the scene inspection, there were no pre-crash tire marks or other evidence on the roadway surface.

Figure 2. Westbound approach for the ambulance

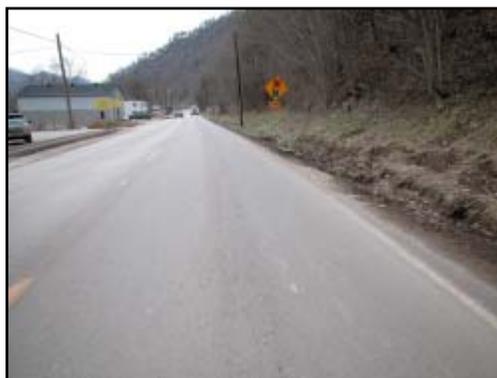
The front wheels of the ambulance furrowed in the hillside and the ditch for approximately 5 m (16'). The furrowing of the wheels and CW yaw caused the ambulance to tip over onto its left side and slide a short distance to final rest on the north roadside (**Figure 3**). Contact with the road surface was limited to the left side aspect of the ambulance cab and patient compartment.

Figure 3. Area of final rest for the ambulance

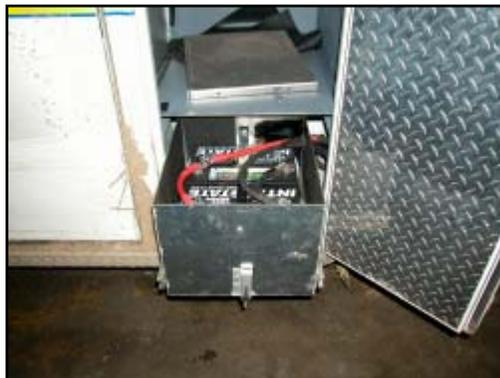
The forward compartment on the right aspect of the patient compartment allowed access to the interior shelves and also housed the vehicle batteries in the bottom aspect. A roll-out drawer housed two batteries that were secured by a single aluminum bracket along the top aspect (**Figure 5**). The drawer measured 42.5 cm (16.8") in length, 34.9 cm (13.8") in width, and 27.3 cm (10.8") in depth. An aluminum cover was secured over the top of the drawer with wing bolts. It was removed post-crash to gain access to the batteries. The drawer was configured with a high-tension spring locking mechanism on the center aspect of the face of the drawer that engaged with a receiver mounted on the interior aspect of the cabinet floor.

Figure 5. View of battery drawer

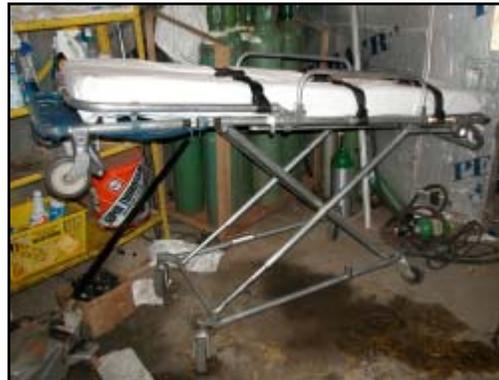
The ambulance cot was a Ferno Model 35-A aluminum cot (**Figure 6**). The cot was rated for a maximum weight of 228 kg (500 lb) and was designed with eight vertical adjustment positions. Its overall length measured 200.1 cm (79.0") and overall width measured 61.0 cm (24.0"). The cot was configured with a fully adjustable gas-assist backrest and three sets of lateral harness straps with locking latch plates for the chest, hips, and legs. A 4-point shoulder harness was available for this ambulance cot, but was not affixed to the cot at the time of the crash.

Figure 6. Ferno ambulance cot

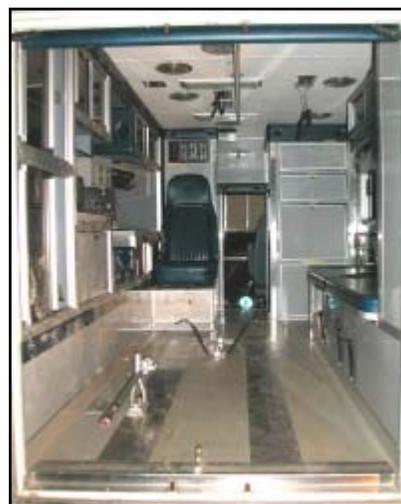
The specific cabinet locations for the patient compartment interior (**Figure 7**) are illustrated in the ambulance interior schematic in **Appendix A**. A non-padded stainless steel assist rail was located on the ceiling above the ambulance cot area. The front right side exterior cabinet was accessible from the interior of the patient compartment by four aluminum doors with spring-loaded cam lock closures that were hinged on the bottom aspects. The doors measured 58.4 cm (23.0") in width and 22.2 cm (8.8"), 22.2 cm (8.8"), 48.3 cm (19.0"), and 45.7 cm (18.0") in height from top to bottom, respectively. The remaining interior cabinetry consisted of sliding plexiglass doors configured with full-length aluminum pull handles. Each cabinet with plexiglass doors was configured with an aluminum trim picture frame with 45 degree angles at the corners. Two cabinets with plexiglass doors were located along the left wall on the rear aspect and measured 45.7 cm (18.0") in depth. The rear left side cabinets were vertically oriented and the combined measurements were 58.4 cm (23.0") in width and 121.9 cm (48.0") in height. Additional cabinets with plexiglass doors were located forward of the rear cabinets at the top and bottom aspects of the wall. The top cabinet was configured with sliding doors and measured 61.0 cm (24.0") in width and 30.5 cm (12.0") in height. An open sheet-metal-constructed shelf that measured 39.4 cm (15.5") in width, 10.8 cm (4.8") in height, and 45.7 cm (18.0") in depth was attached to the bottom aspect of the upper cabinet. The bottom cabinet was hinged at the bottom aspect and constructed of a single aluminum door with a spring-loaded cam lock. The bottom cabinet measured 61.0 cm (24.0") in width and 30.5 cm (12.0") in height. Two additional cabinets that measured 111.8 cm (44.0") in width and 30.5 cm (12.0") in height were located over and under the work space area on the forward aspect of the left wall.

Figure 7. View of patient compartment interior

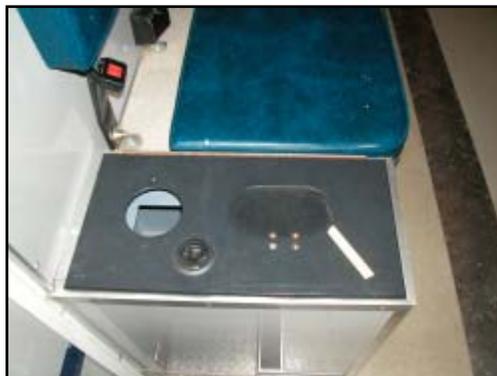
A sharps/waste cabinet (**Figure 8**) was located forward of the leading edge of the squad bench seat that measured 27.3 cm (10.5") in length, 53.3 cm (21.0") in width, and 23.5 cm (9.3") in depth. The cabinet cover was configured with a plastic pull-type latch on the forward aspect and was hinged at the rear aspect, adjacent to the forward edge of the squad bench seat. The inboard aspect was configured with a horizontally oriented spring-hinged plastic flap that measured 8.9 x 16.5 cm (3.5 x 6.5") and outboard aspect with a circular hole that measured 8.9 cm (3.5") in diameter. The outboard aspect of the cabinet was used for disposal of used medical items and the used sharps container was under the inboard aspect under the spring-hinged flap.

Figure 8. Sharps/waste cabinet

The hinged plastic cover of the sharps/waste cabinet forward of the squad bench seat was fractured on the inboard aspect. The fracture measured 10.2 cm (4.0") in length and was oriented at a 45 degree angle. It began below the spring-hinged flap and extended toward the front inboard corner.

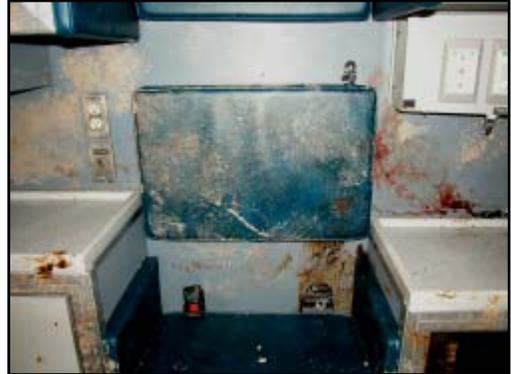
A single seating position was located on the center aspect of the left wall of the patient compartment (**Figure 9**). Commonly called the “CPR seat”, it was configured with a bottom cushion and 3.2 cm (1.3”) thick padding on the outboard side aspects. The padded seat back was located 20.3 cm (8.0”) above the cushion, and was hinged at the bottom aspect, designed to fold onto the outboard padded cushions for use as a shelf. The seat back measured 59.7 cm (23.5”) in width and 40.6 cm (16.0”) in height. It was anchored in the up position by a steel pin-type lock located at the top of the seat cushion at the forward aspect.

Figure 9. Left side "CPR" seat
