TRANSPORTATION RESEARCH CENTER

ON-SITE CERTIFIED ADVANCED 208- COMPLIANT VEHICLE INVESTIGATION

CASE NUMBER - IN-03-005
LOCATION - ILLINOIS
VEHICLE - 2003 CHEVROLET K1500 TAHOE
CRASH DATE - January 2003

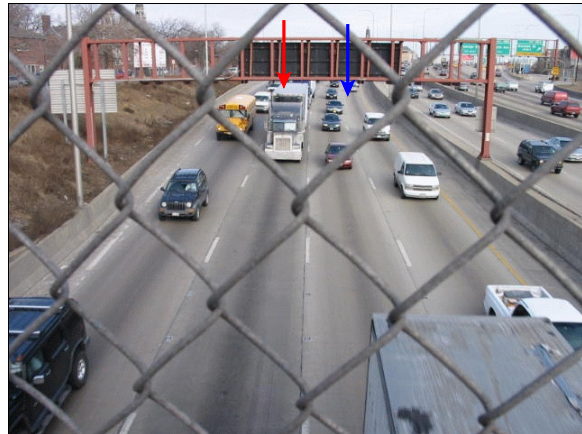
Figure 1: Northward view from perpendicular overpass of interstate trafficway's southbound local roadway; Note: arrows indicate pre-crash travel lanes for case vehicle—blue and Volvo—red (case photo #12)

Pre-Crash: The case vehicle was traveling south in the inside through lane of the four-lane southern roadway and intended to proceed straight ahead (**Figure 1** above). The Volvo was also traveling southward, but it was traveling in the right center through lane and intended to proceed straight ahead (**Figure 2** above). According to the case vehicle's front right passenger, a noncontact vehicle traveling just ahead of the case vehicle in the left center lane swerved from right to left into the same lane as the case vehicle. At this point, in an attempt to avoid any contact, the case vehicle's driver veered to the left and back to the right an undetermined number of times before losing control of the vehicle. According to the Police Crash Report and the occupant's interview, the case vehicle rotated approximately 60-75 degrees clockwise and crossed the left center lane prior to entering the right center lane. The crash took place on the interstate trafficway in the right center lane of the local southern roadway.

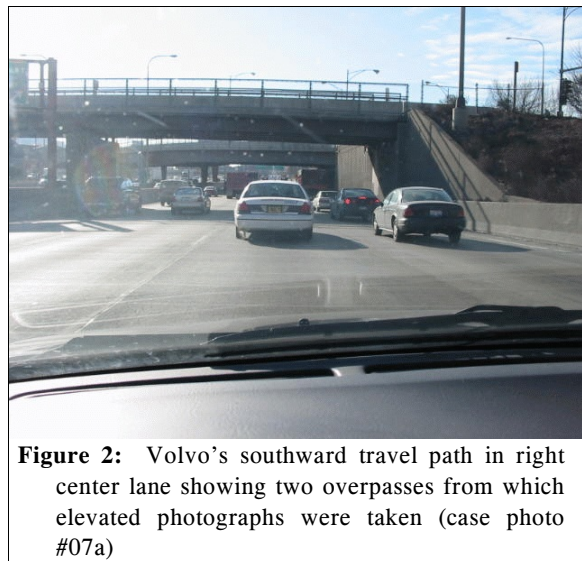
Figure 2: Volvo's southward travel path in right center lane showing two overpasses from which elevated photographs were taken (case photo #07a)

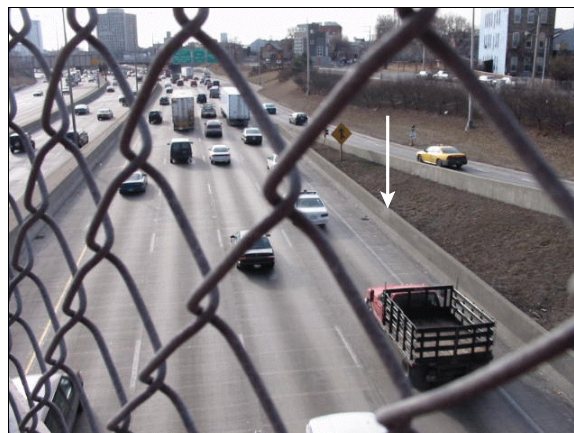
Figure 7: Southward view from oblique overpass showing approximate area of impacts and final rest for both vehicles; Note: arrow indicates suspected impact location between one of the vehicles and longitudinal barrier (case photo #11a)

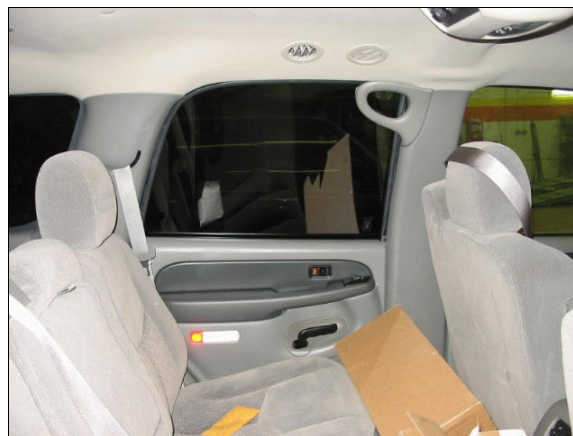
Figure 11: Case vehicle's second seating area showing no apparent contact evidence to the driver's seat back, interior surface of the left rear door, or greenhouse components (case photo #58)

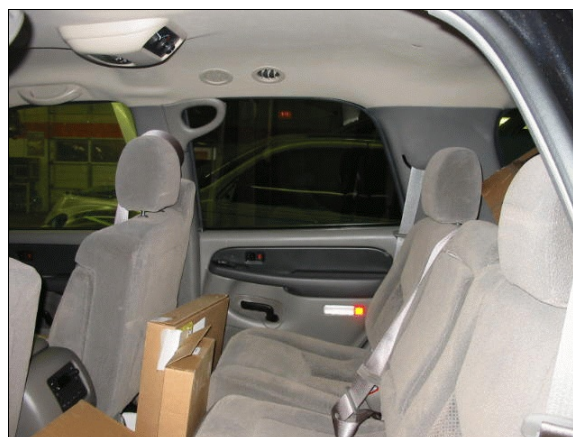
Figure 12: Case vehicle's second seating area showing no apparent occupant contact evidence to the front right passenger's seat back, interior surface of the right rear door, or greenhouse components (case photo #59)

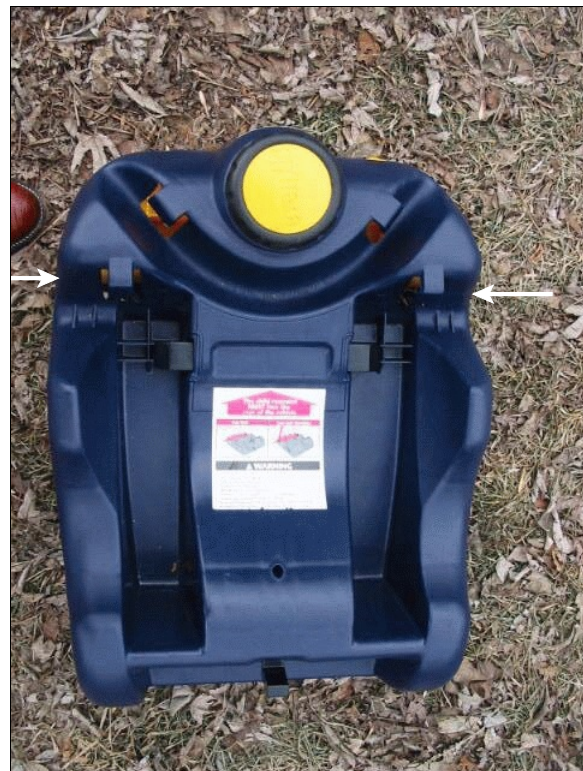
The second seat center passenger was seated in a rear facing infant child safety seat with a separable base (**Figure 15**). The child safety seat was manufactured by Evenflo, on April 18, 2002, and was identified by Model name "Cozy Carry" and Model number **4771273P1**. The infant seat

Figure 15: Overhead view of infant child safety seat's detachable base; arrows indicate where case vehicle's safety belts attach through slots in base (case photo #101)

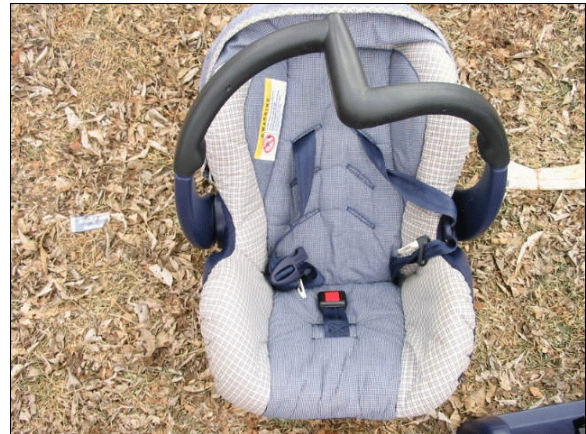
was designed with a five-point harness. There were three slots in the seat's back for positioning the harness straps; the harness was positioned in the top slots (**Figure 16**). The child seat was in the reclined position.

Figure 16: Overhead view of infant child safety seat used by case vehicle's back center passenger; Note: harness straps positioned through top of three provided slots (case photo #103)

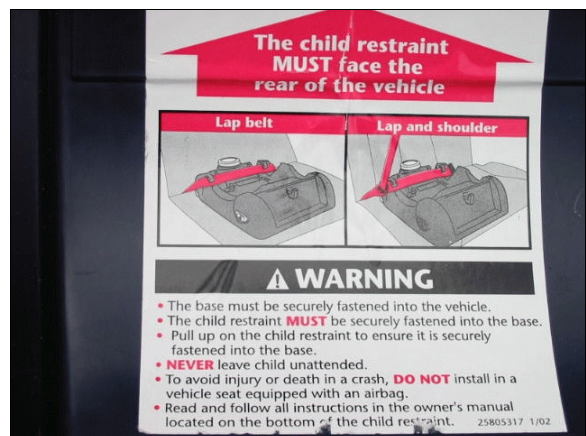
Figure 17: Warning label mounted on top of detachable base of infant child safety seat used in case vehicle (case photo #107)

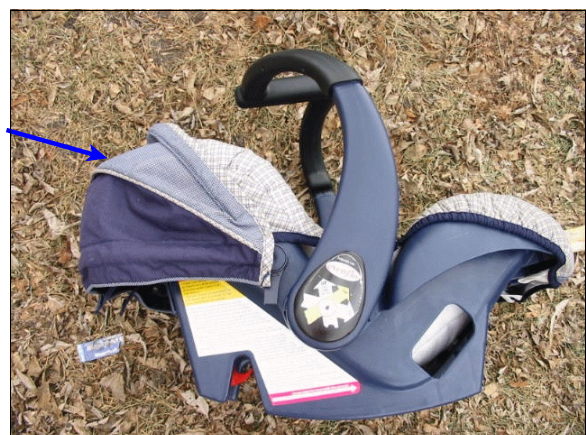
Figure 18: Overhead view of left side of infant child seat used by case vehicle's back center passenger showing warning label and red and white leveling arrow at bottom of label; Note: child's head is positioned toward arrow (case photo #104)

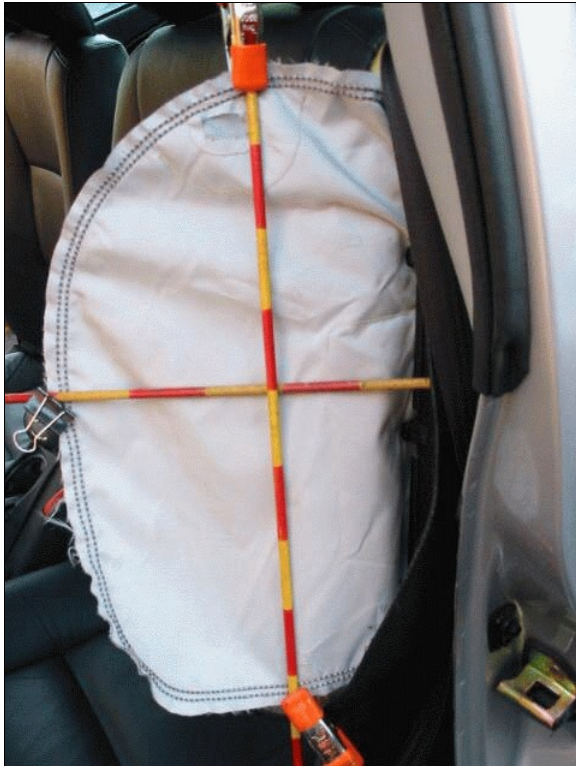
Figure 26: Outboard surface of Volvo's driver seat back-mounted side impact air bag showing no evidence of intrusion or contact (case photo #82)

On the other hand, the driver’s seat back-mounted side air bag (Figures 26 and 27 above) and the left side inflatable curtain (Figures 28 and 29 above and Figures 30 and 31) did deploy as a result of the Volvo’s left side impact with the case vehicle.

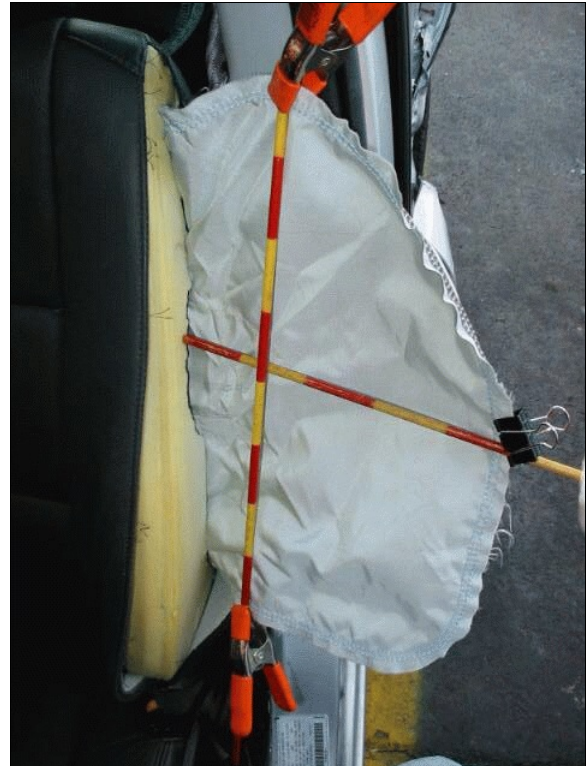
Figure 27: Inboard surface of Volvo's driver seat back-mounted side impact air bag showing no apparent occupant contact evidence (case photo #77)

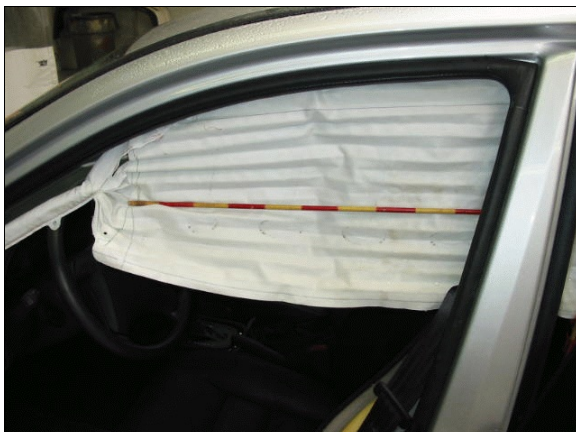
Figure 28: Outboard surface of Volvo's left side inflatable curtain protecting driver's seating area (case photo #78)

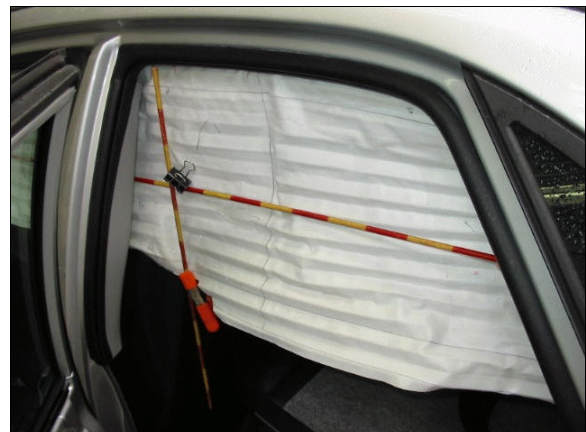
Figure 29: Outboard surface of Volvo's left side inflatable curtain protecting back left seating area (case photo #91)

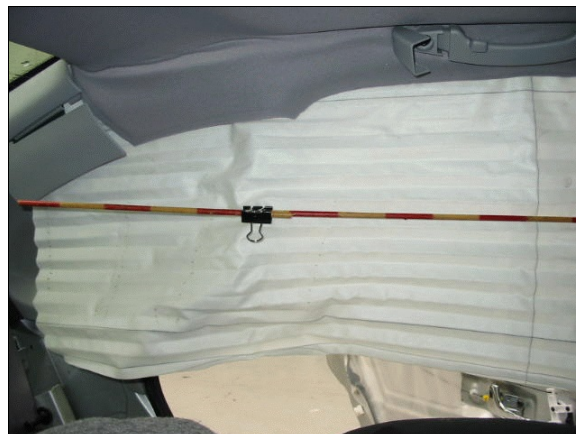
Figure 31: Inboard surface of Volvo’s left side inflatable curtain protecting back left seating area; Note: no apparent evidence of occupant contact (case photo #89)

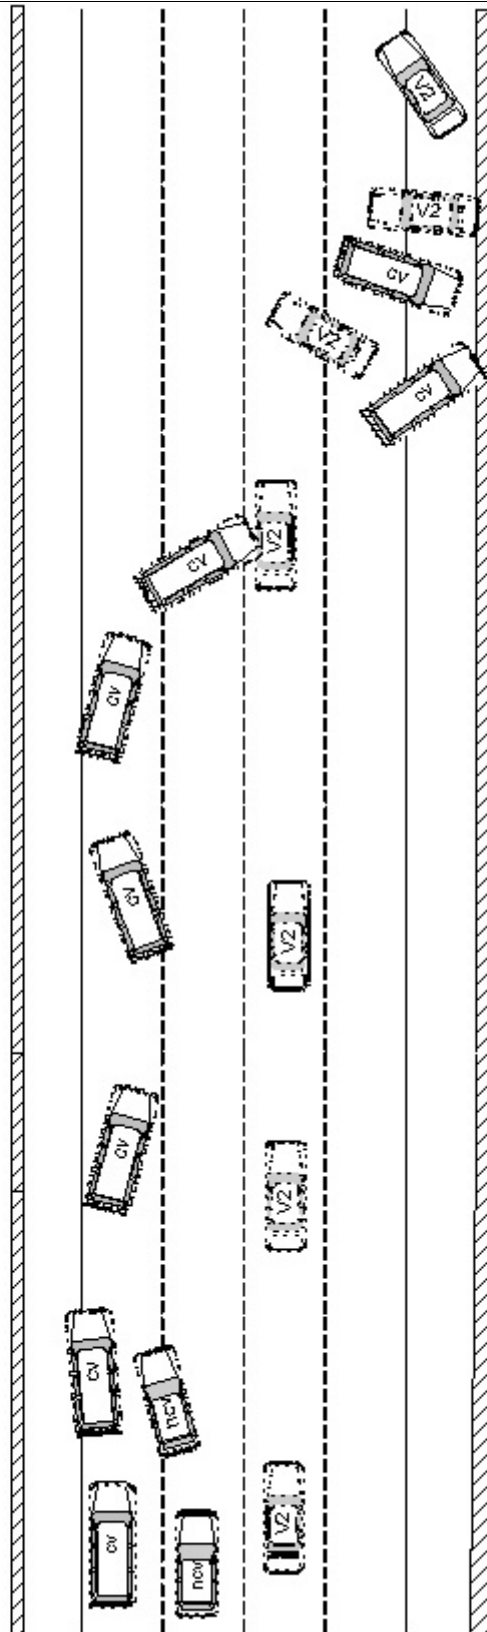
IN-03-005

Impact and final rest positions of both vehicles are estimated based on police schematic and interview with case vehicle's owner/occupant

1 cm = 2.5 m
Straight, Level (i.e., very slight slope, negative to south--downgrade)
Dark but lighted, Snowing, Snowy/slushy concrete roadway; Coefficient of friction = .40
