**CALSPAN ON-SITE ADULT AIR BAG RELATED FATALITY  
INVESTIGATION**

**CASE NO: CA03-019**

**VEHICLE: 1995 MERCURY GRAND MARQUIS**

**CRASH DATE: FEBRUARY 2000**

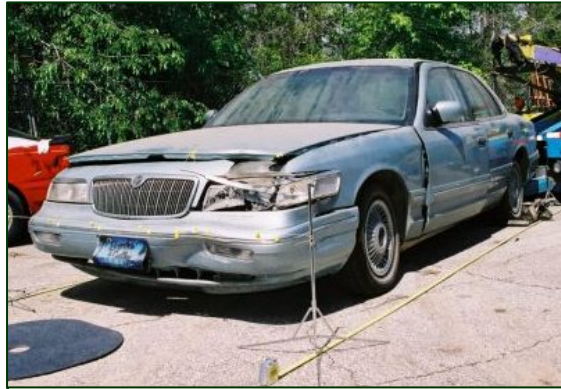
This on-site investigation focused on the source of injury that resulted in the death of a 45-year old female driver of a 1995 Mercury Grand Marquis (**Figure 1**). The Mercury was equipped with a first generation frontal air bag system for the driver and front right passenger positions that deployed as a result of a front left impact with a concrete base for a light pole in a super market parking lot. The impact resulted in minor damage to the vehicle. The driver was unrestrained and was observed slumped forward in close

**Figure 1. 1995 Mercury Grand Marquis**

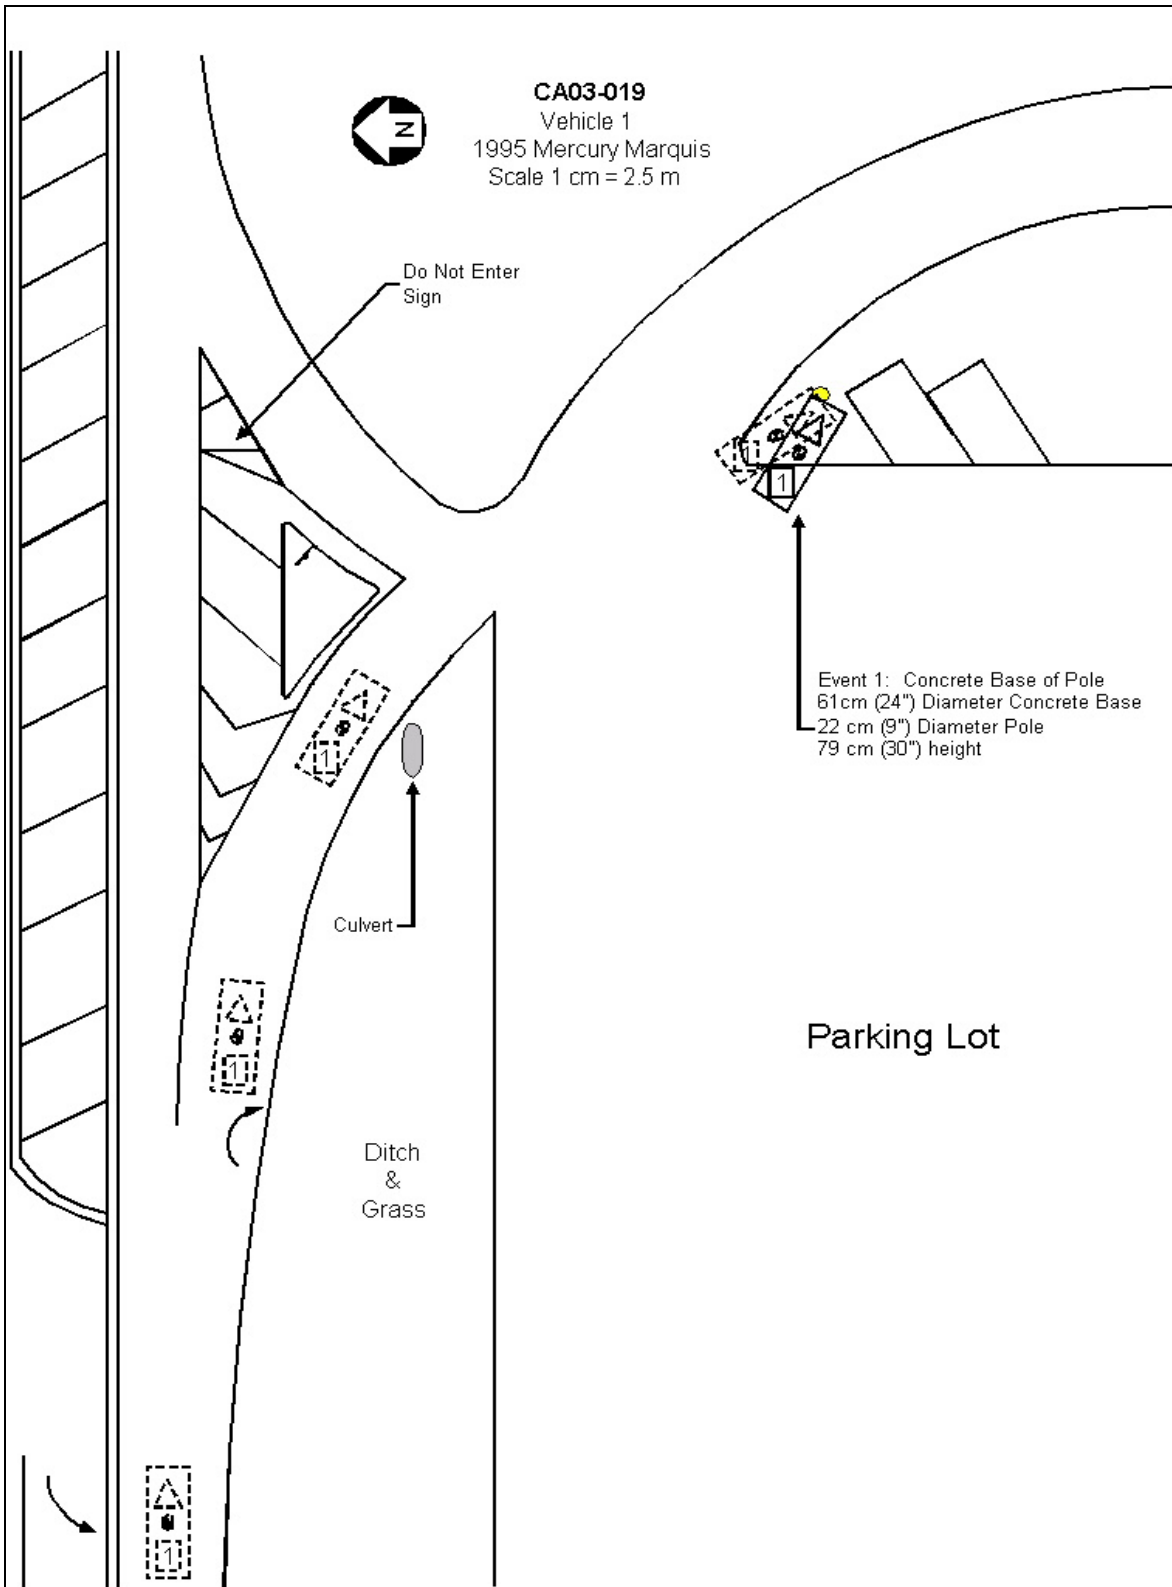
Figure 11 – Scene Schematic

The aluminum light pole was mounted on-top of a poured concrete (**Figure 3**) base that was 61 cm (24") in diameter and 79 cm (31") in height, and was located 15.6 m (51.2') east of the gore and 24.3 m (79.7') east of the east road edge of the northbound travel lane. There was no damage reported to the pole or the concrete base. The Crash Schematic is included as **Figure 11** of this narrative report.
