**VERIDIAN ON-SITE SCHOOL BUS INVESTIGATION  
SCI TECHNICAL SUMMARY REPORT**

**VERIDIAN CASE NO. CA03-020**

**VEHICLE: 1991 CARPENTER SCHOOL BUS**

**CRASH DATE: MARCH 2003**

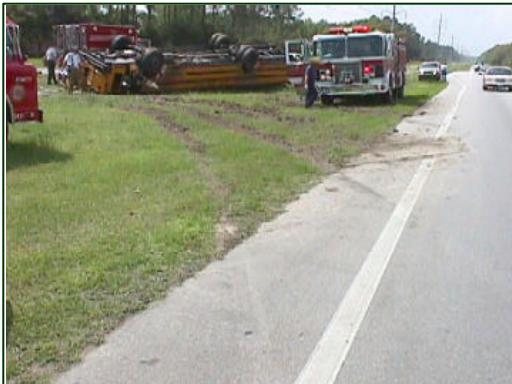
This on-site investigation focused on the performance of the roof structure of an 83-passenger Type-D 1991 Carpenter school bus. The bus was operated by a 50-year old female driver and was involved in a run-off-road rollover crash (**Figure 1**). There were no students on board the bus at the time of the crash. The roof of the school bus collapsed to the beltline (**Figure 2**) during the two-quarter turn rollover event. The school bus driver was seated in a high-back suspension seat and was restrained by the manual 3-point lap and shoulder belt system. She sustained a fracture of the left femur, multiple rib fractures, a superior scalp laceration, and multiple soft tissue contusions. The driver was transported to a local hospital where she was admitted for a period of four days for surgical repair of the femur fracture. She was transferred to a rehabilitation facility for five days prior to discharge to her residence. Following an inspection of the collapsed roof on the school bus by local transportation officials, all similar Carpenter school buses (13) were removed from service by the county operated school bus transportation district.

**Figure 1.** CCW trajectory and final rest position of school bus.

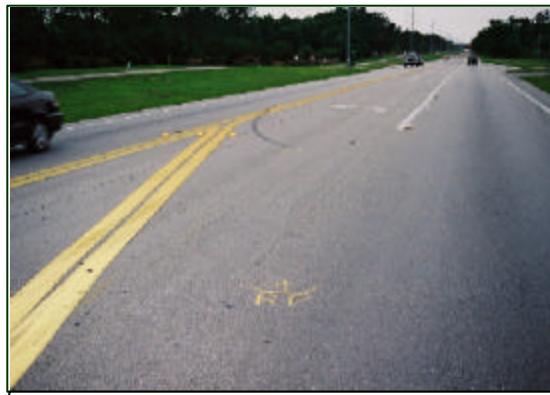
The bus yawed across the painted median and left turn lane (**Figure 3**) and departed the south (left) shoulder. As the school bus departed the south road edge line, the bus had rotated approximately 42 degrees CCW. The SCI inspection of the crash site occurred 19 days post-crash. Substantial physical evidence remained at the crash site to reconstruct the trajectory of the school bus. Both front tire yaw marks and the dual right rear tire marks remained evident on and off the asphalt road surface. The right front yaw mark was 35.9 m (117.8') in length and ended 9.75 m (24.8') into the grassy roadside. The left front tire mark began in the eastbound travel lane and extended 17.25 m (43.8') in length, ending 10.3 m (33.8') south of the south road edge line. The right rear dual tire yaw marks were 26.5 m (86.9') in length and terminated 3.9 m (12.8') south of the reference edge line. As the bus entered the wet grassy off-road surface, the tires furrowed into the earth which tripped the school bus into a lateral right side leading rollover event. At the on-set of the rollover, the school bus yawed approximately 109 degrees in a CCW direction.

**Figure 3.** CCW yaw marks of the school bus.

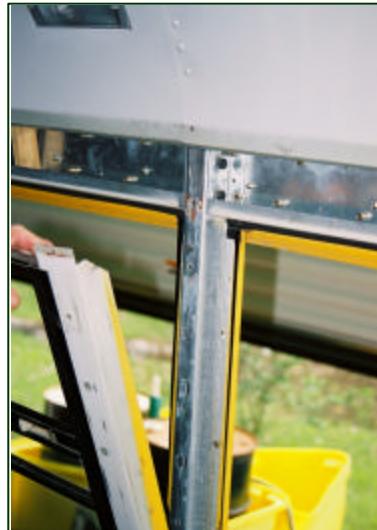
This Richmond, Indiana Carpenter body school bus was manufactured following the design change of the roof/pillar structure. This system utilized a continuous one-piece roof bow/pillar that extended from floor-to-floor of the bus (**Figure 15**). An interior roof panel, pillar covering, and window assembly were removed from this bus to facilitate the inspection and photographic documentation of this design. There were no structural/manufacturing problems identified with this bus.

**Figure 15.** Continuous roof bow/pillar in the 1998 Carpenter bus.

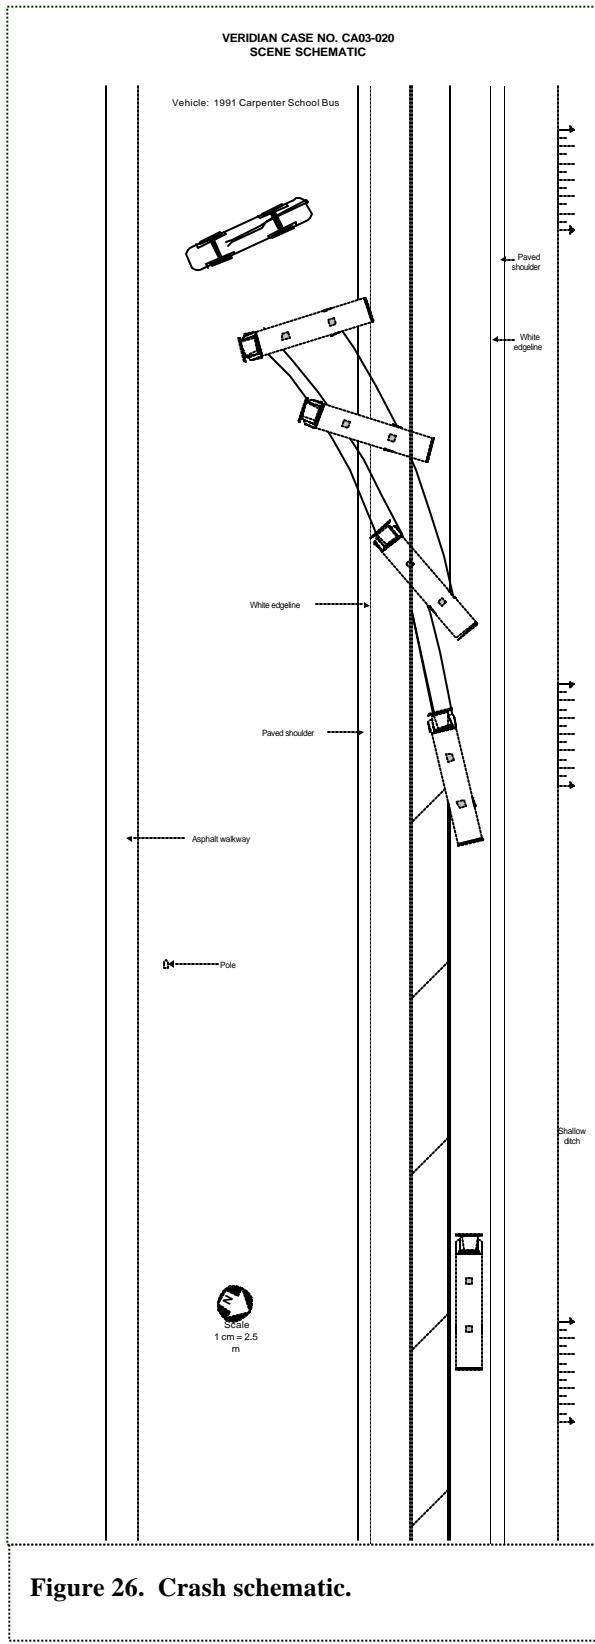
## *Crash Schematic*

The driver of the 1991 Carpenter school bus was traveling in a westerly direction on the two-lane state route at a driver estimated speed of 64-72 km/h (40-45 mph). On her approach to the impending crash site, the driver noted that a heavy rain shower had passed through the area ahead resulting in a wet asphalt road surface. As she entered the area of wet pavement, the driver stated that she looked down at the speedometer to check her travel speed. As she redirected her attention forward to the road surface, the driver stated that the bus broke traction on the wet asphalt surface and initiated a counterclockwise (CCW) yaw. Although the driver was trained to steer into a skid, she was reluctant to attempt a clockwise steering input to the bus. She backed-off the accelerator pedal and maintained her grip on the steering wheel rim as the bus continued to yaw CCW. The driver did not attempt avoidance actions. The Crash Schematic is attached as **Figure 26** on Page 21.
