ON-SITE CHILD SAFETY SEAT CRASH INVESTIGATION

VEHICLE: 2002 CHEVROLET VENTURE

CASE NO: CA03-022

CRASH DATE: FEBRUARY, 2003

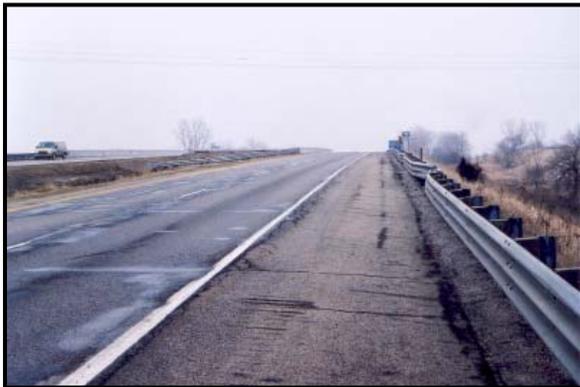
Figure 2: Eastward view along the highway.

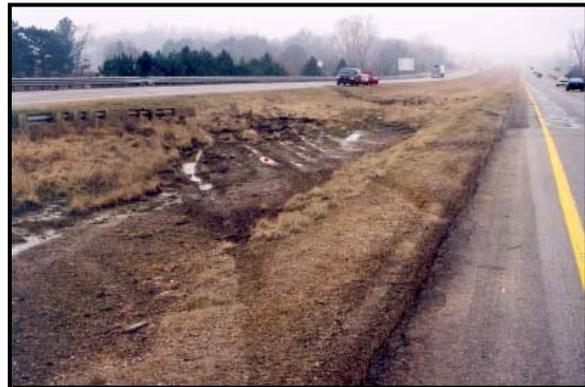
Figure 3: Westward trajectory view of the Ford into the center median.

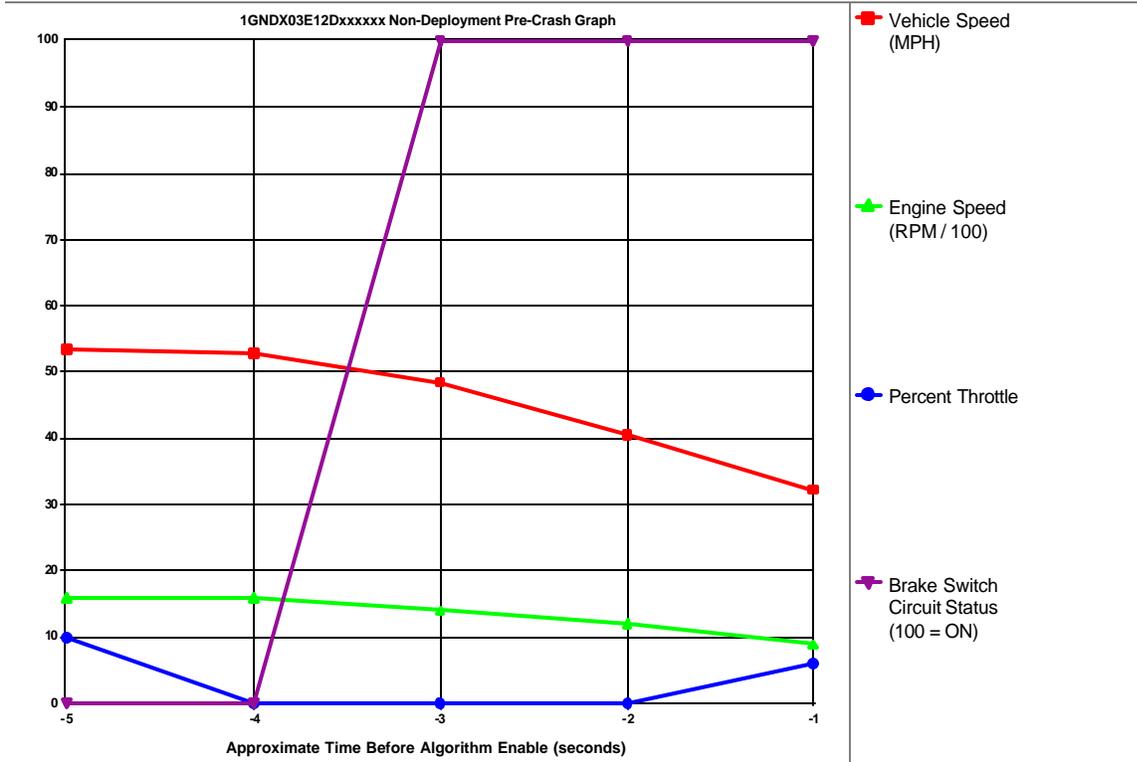
SIR Warning Lamp Status	OFF
Driver's Belt Switch Circuit Status	BUCKLED
Ignition Cycles At Non-Deployment	716
Ignition Cycles At Investigation	717
Maximum SDM Recorded Velocity Change (MPH)	-5.85

Seconds Before AE	Vehicle Speed (MPH)	Engine Speed (RPM)	Percent Throttle	Brake Switch Circuit Status
-5	53	1600	10	OFF
-4	53	1600	0	OFF
-3	48	1408	0	ON
-2	40	1152	0	ON
-1	32	896	6	ON

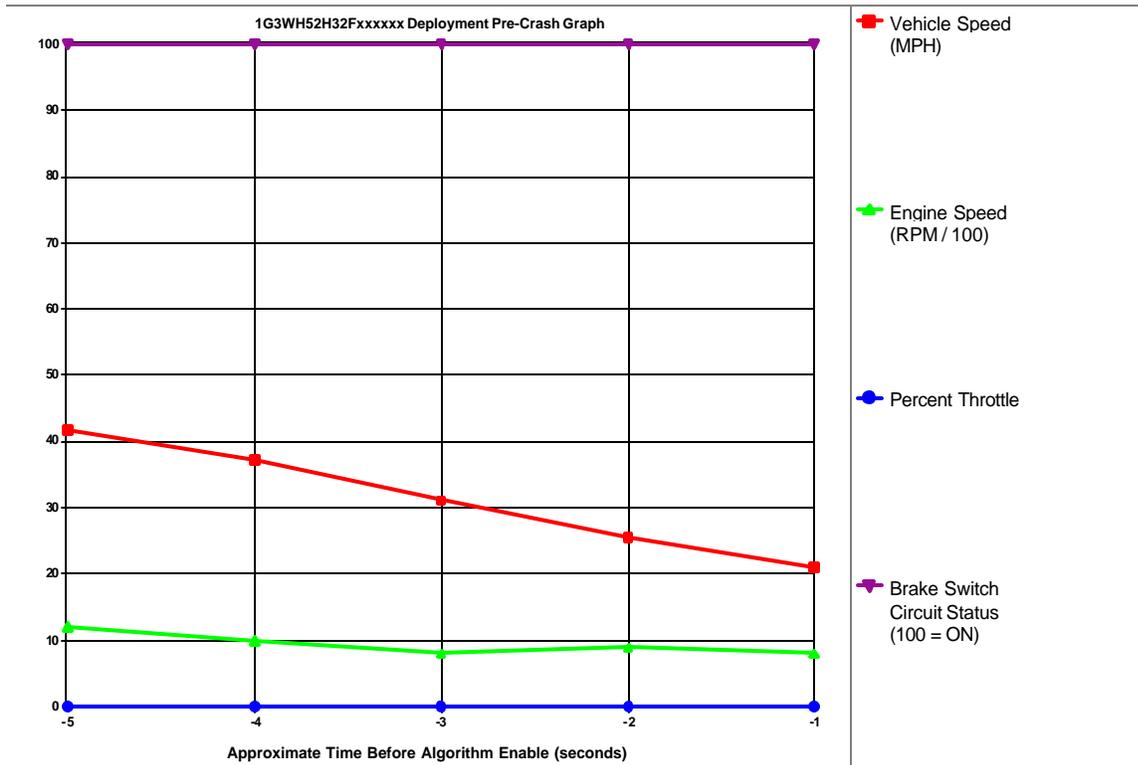
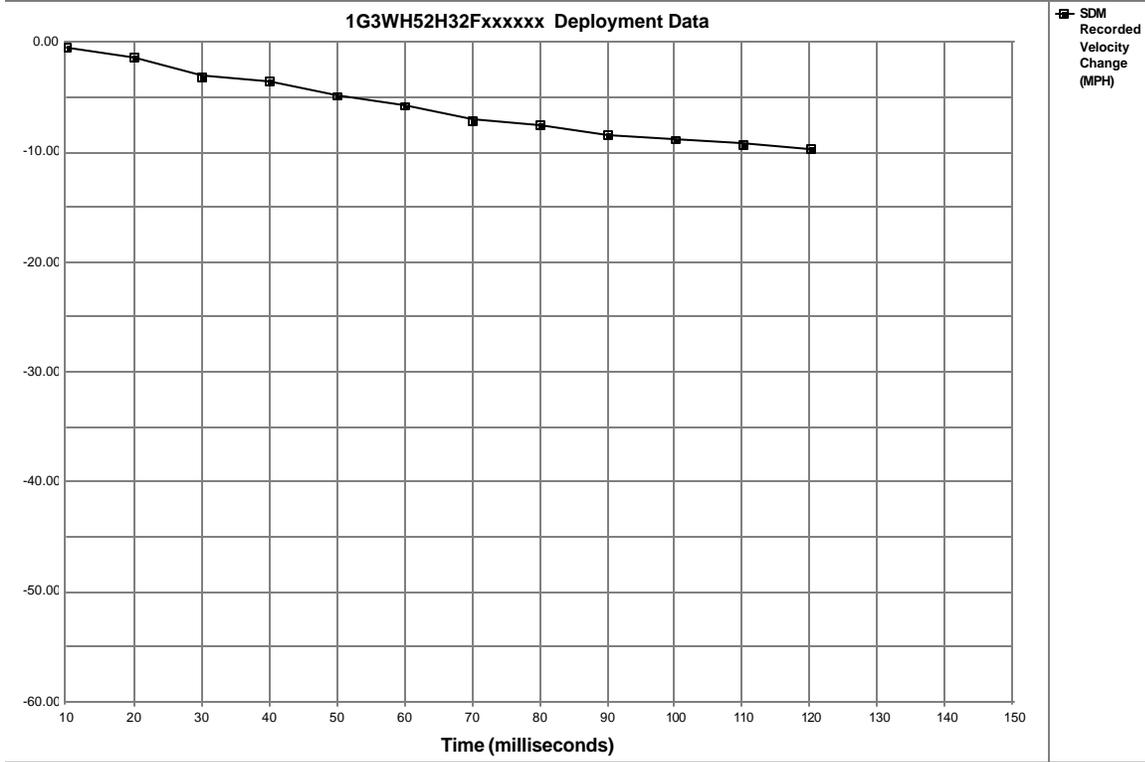
SIR Warning Lamp Status	OFF
Driver's Belt Switch Circuit Status	BUCKLED
Passenger Front Air Bag Suppression Switch Circuit Status	Air Bag Not Suppressed
Ignition Cycles At Deployment	761
Ignition Cycles At Investigation	765
Maximum SDM Recorded Velocity Change (MPH)	-10.06
Algorithm Enable to Maximum SDM Recorded Velocity Change (msec)	112.5
Time Between Non-Deployment And Deployment Events (sec)	N/A
Time From Algorithm Enable to Deployment Command Criteria Met (msec)	17.5

Seconds Before AE	Vehicle Speed (MPH)	Engine Speed (RPM)	Percent Throttle	Brake Switch Circuit Status
-5	42	1152	0	ON
-4	37	1024	0	ON
-3	31	832	0	ON
-2	25	896	0	ON
-1	21	832	0	ON

Time (milliseconds)	10	20	30	40	50	60	70	80	90	100	110	120	130	140	150
SDM Recorded Velocity Change	-0.44	-1.32	-3.07	-3.51	-4.83	-5.70	-7.02	-7.46	-8.34	-8.78	-9.21	-9.65	N/A	N/A	N/A

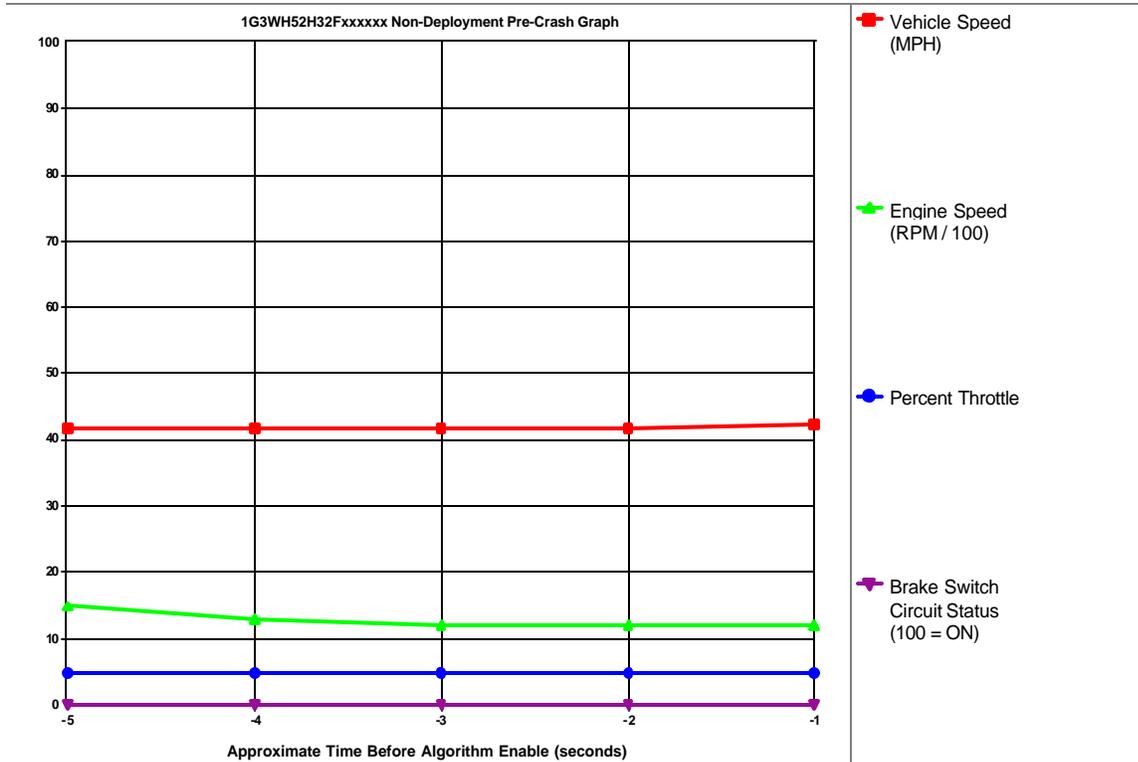
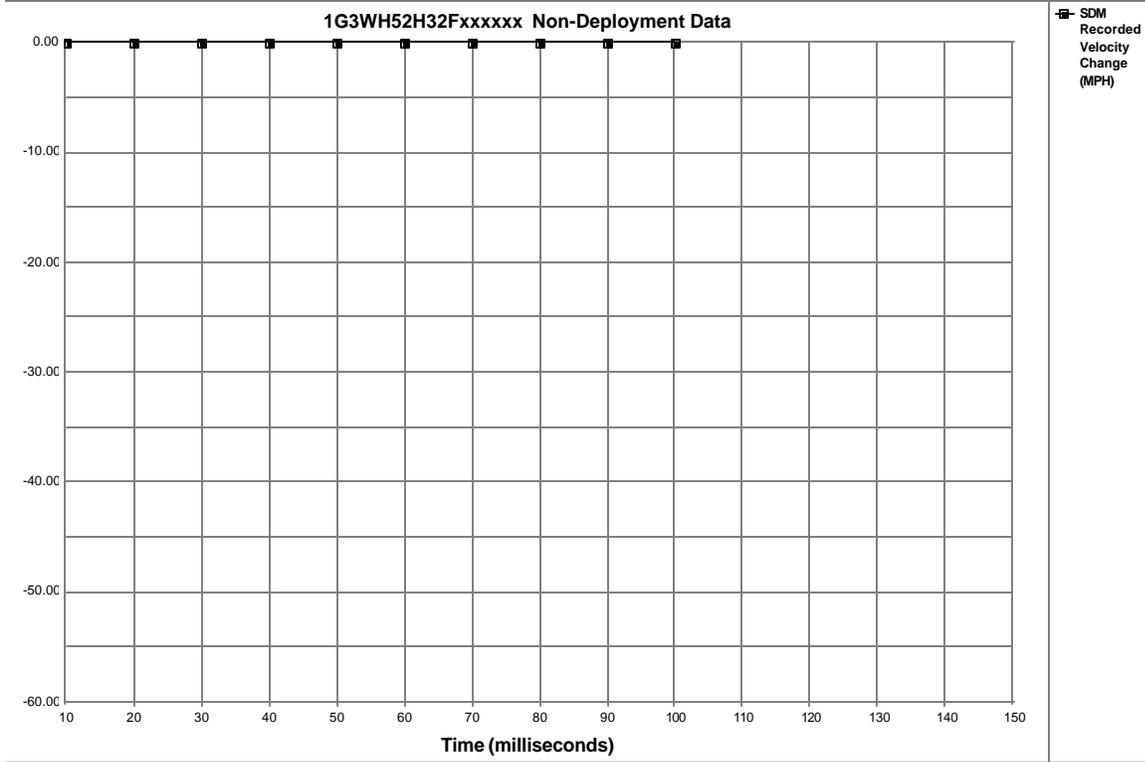
SIR Warning Lamp Status	OFF
Driver's Belt Switch Circuit Status	UNBUCKLED
Passenger Front Air Bag Suppression Switch Circuit Status	Air Bag Not Suppressed
Ignition Cycles At Non-Deployment	759
Ignition Cycles At Investigation	765
Maximum SDM Recorded Velocity Change (MPH)	-0.15
Algorithm Enable to Maximum SDM Recorded Velocity Change (msec)	105

Seconds Before AE	Vehicle Speed (MPH)	Engine Speed (RPM)	Percent Throttle	Brake Switch Circuit Status
-5	42	1472	5	OFF
-4	42	1280	5	OFF
-3	42	1216	5	OFF
-2	42	1152	5	OFF
-1	42	1216	5	OFF

Time (milliseconds)	10	20	30	40	50	60	70	80	90	100	110	120	130	140	150
SDM Recorded Velocity Change	0.00	0.00	0.00	0.00	0.00	0.00	0.00	0.00	0.00	0.00	N/A	N/A	N/A	N/A	N/A
