**CALSPAN ADULT DRIVER AIR BAG RELATED FATALITY
INVESTIGATION**

CASE NO: CA03-023

VEHICLE: 1999 FORD TAURUS SE

CRASH DATE: APRIL 2001

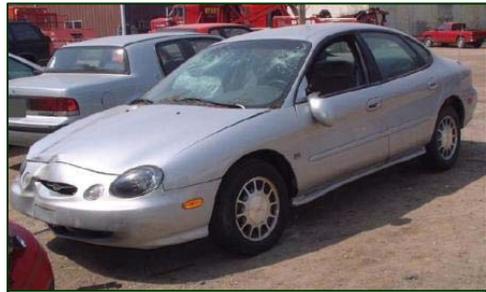
This remote investigation focused on the severity of the crash and the injury sources that caused the death of a 62-year old male driver of a 1999 Ford Taurus (**Figure 1**). The Taurus was equipped with redesigned frontal air bags for the driver and front right passenger positions that deployed as a result of a frontal crash with the trunk of a large shrub. The unrestrained driver sustained multiple internal injuries of the chest from the deploying air bag. The expanding air bag displaced the driver rearward into the left B-pillar. He sustained multiple head injuries from the B-pillar contact. The driver was removed from the Taurus by emergency medical personnel and transported by ambulance to a local hospital where he expired. The Taurus sustained minor severity frontal and right side damage from impact with the shrub and was towed from the crash site.

Figure 1. 1999 Ford Taurus.

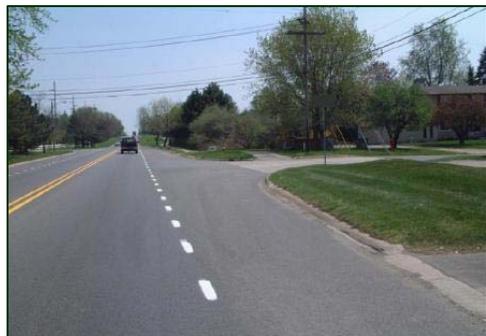
The crash occurred off-road of a three-leg T-intersection on a lawn area of a private residence (**Figure 2**). The Taurus departed the right side of an east/westbound roadway that consisted of four lanes in the area of the intersection. The asphalt road surface was straight and level with a posted speed limit of 72 km/h (45 mph). The crash occurred during daylight hours on dry environmental surfaces. The travel lanes were bordered by concrete curbs with lawn areas extending outboard of the curb lines. The intersecting roadway was surfaced with concrete.

Figure 2. Eastbound view of the crash site.

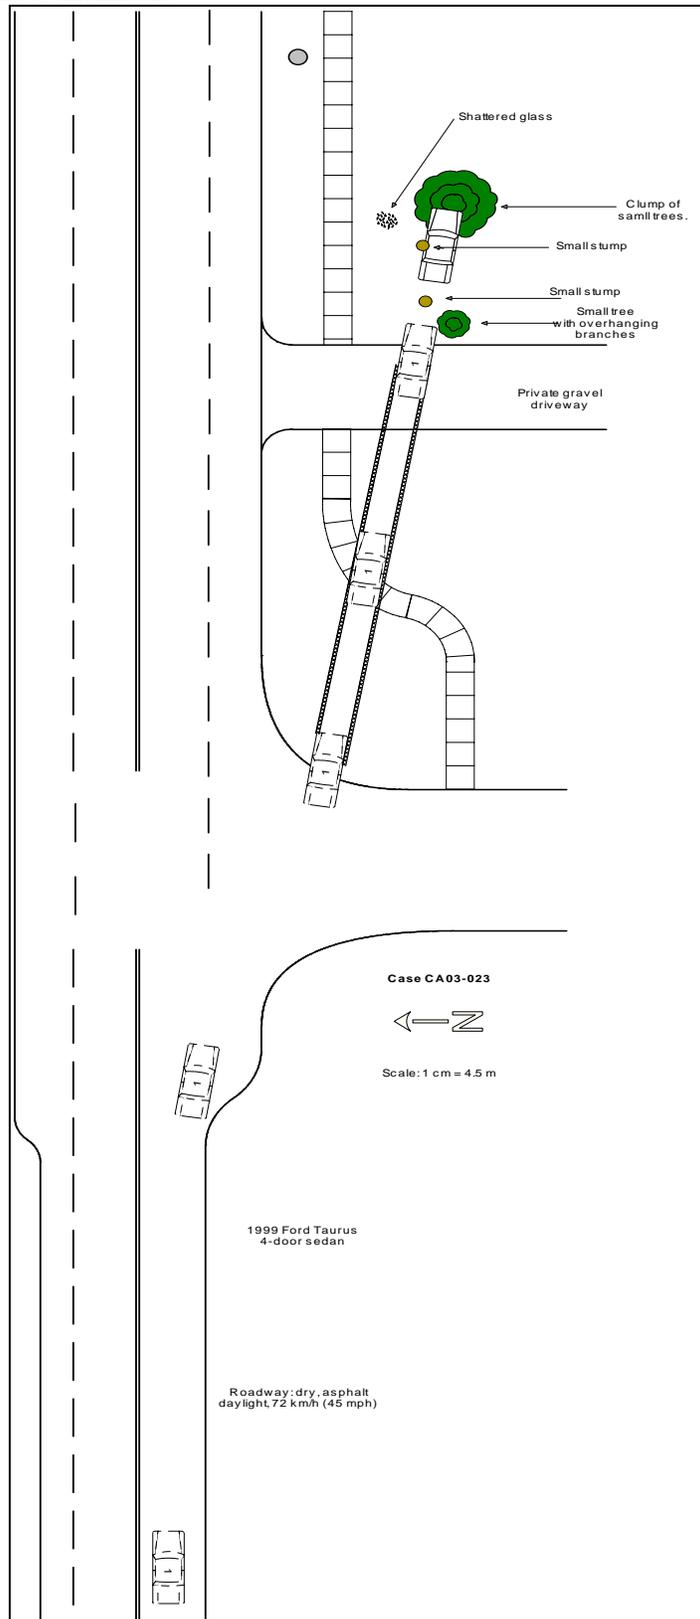
Figure 15 – Scene Schematic

The 62-year old male driver of the Ford Taurus departed his residence to pick-up a pizza. While returning to his residence, he was traveling in an easterly direction. Reportedly, he stopped the Taurus behind several vehicles for a non-contact vehicle that was initiating a left turn at an intersection located west of the crash site. As traffic started to accelerate, the driver of the Taurus accelerated in an easterly direction on the four lane segment of the roadway. For an unknown reason, the driver of the Taurus allowed the vehicle to drift to the right as it departed the roadway in a tracking mode at the three-leg T-intersection. The Taurus overrode the barrier curb at an area of a storm receiver. At this location, the concrete road surface was tapered to the receiver which exposed a higher curb face. There was no evidence of undercarriage contact to the curb or storm receiver. The Taurus mounted the curb and departed the southeast quadrant of the intersection and traversed the lawn area in a slight, but tracking counterclockwise arc. The vehicle's trajectory was evidenced by rotating tire prints across the lawn area (**Figure 3**). The Taurus traversed a sidewalk and the stone driveway on a departure angle that was approximately 10 degrees from the south road edge. There was no scene evidence to support avoidance maneuvers. The Scene Schematic is included as **Figure 15** at the end of this narrative report.
