VERIDIAN ON-SITE REAR IMPACT CRASH/FIRE INVESTIGATION

VERIDIAN CASE NO. CA03-025

VEHICLE: 2000 FORD CROWN VICTORIA POLICE INTERCEPTOR

CRASH DATE: MAY 2003

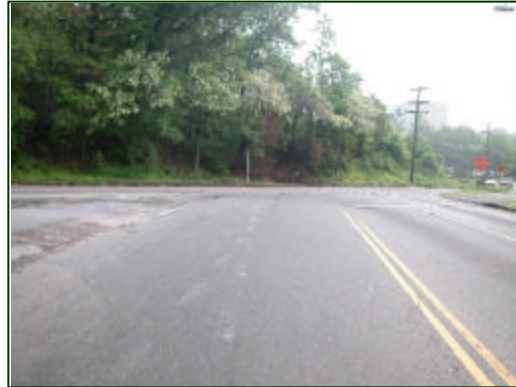
This crash occurred during the daytime hours of May 2003, in the District of Columbia. At the time of the crash, the weather was clear and the asphalt roadway surface was dry. The crash occurred at a three-leg, Y-intersection of two urban roadways (**Figure 2**). The north/south roadway was configured with two travel lanes in each direction, separated by a double-yellow centerline, and bordered by asphalt curbs. This roadway had a negative two percent northbound grade on the approach to the intersection. The north/south roadway terminated at the intersection. The

Figure 2. Overall view of the crash site.

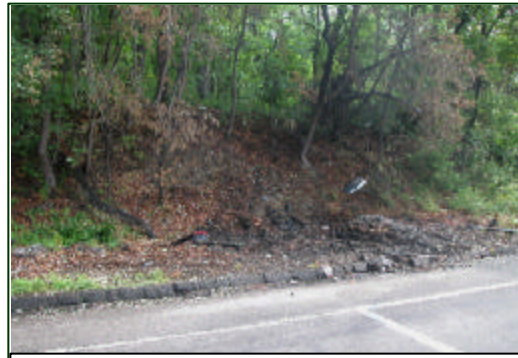
aspect of the lower radiator support panel and air conditioning condenser impacted an object on the embankment. The embankment was littered with numerous firewood-size logs and several small diameter tree trunks. The specific environmental object could not be identified due to the fire and the subsequent removal of the vehicle from the scene. The grass and tree branches surrounding the final rest position of the vehicle were charred and scorched by the fire and heat. **Figure 3** is impact and final rest areas of the Crown Victoria.

Figure 3. Impact and final rest area of the Ford Crown Victoria.

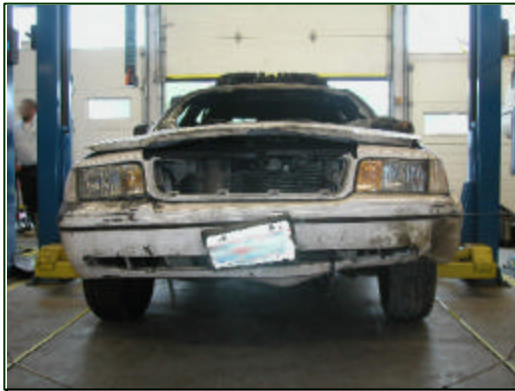
The Crown Victoria struck two police officers as it was deflected forward by the rear impact sequence with the Taurus. There was no discernable vehicle damage associated with these impacts. Based on the nature and location of the first officer's injuries, it was presumed that the front bumper (**Figure 7**) of the Crown Victoria struck the police officer. The CDC for the frontal impact to the first police officer was 12-F999 with an unknown extent zone. The impact location for the second officer was unknown.

Figure 7. Frontal view of the Crown Victoria.

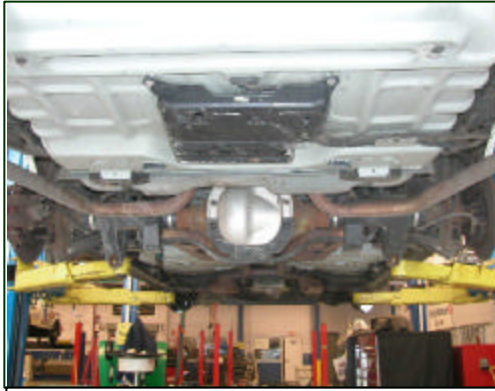
A Field Service Campaign (02B02) was announced by Ford in September 2002, to install a retrofit shield kit to the rear axle and fuel tank straps. The kit included two fiberglass reinforced shields that cover the shock and sway-bar mounting brackets, a rubberized shield that protects the differential cover, rubber boot-type shields that protect the bottom attachment point of the fuel tank straps, and the installation of three rivets to the leading edge of the rear mounted vapor recovery system mounting bracket. **Figure 13** is a view of an exemplar vehicle with the retrofit kit installed. An authorized Ford technician demonstrated and supervised the installation of these kits to the police maintenance technicians. The kits were subsequently installed by the police maintenance technicians on all vehicles within this police fleet. The kit was installed on the crash-involved Crown Victoria on March 15, 2003. Following the crash and fire, the kit remained intact, with moderate fire-related damage (**Figure 14**), and appeared to have been installed properly to Ford's specifications.

Figure 13. Shield kit installed on an exemplar Crown Victoria.

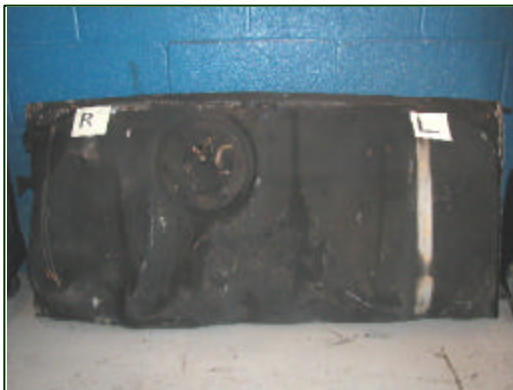
Attempts to remove the tank from between the frame rails were unsuccessful. At this point, two alternatives were addressed for the removal of the fuel tank without inflicting damage to the tank. The first method was to cut the left frame rail from the vehicle. The second method was to position a hydraulic ram between the frame rails in an attempt to spread the rails sufficiently to remove the tank. Since the latter method was less invasive to the vehicle, a local body shop was called to supply the hydraulic tool. The rear body mounts were disconnected and the ram was positioned between the frame rails. After several attempts, the frame rails were spread sufficiently and the tank was removed from the vehicle. **Figures 17 and 18** are views of the removed fuel tank.

Figure 17. Forward aspect of the removed fuel tank.

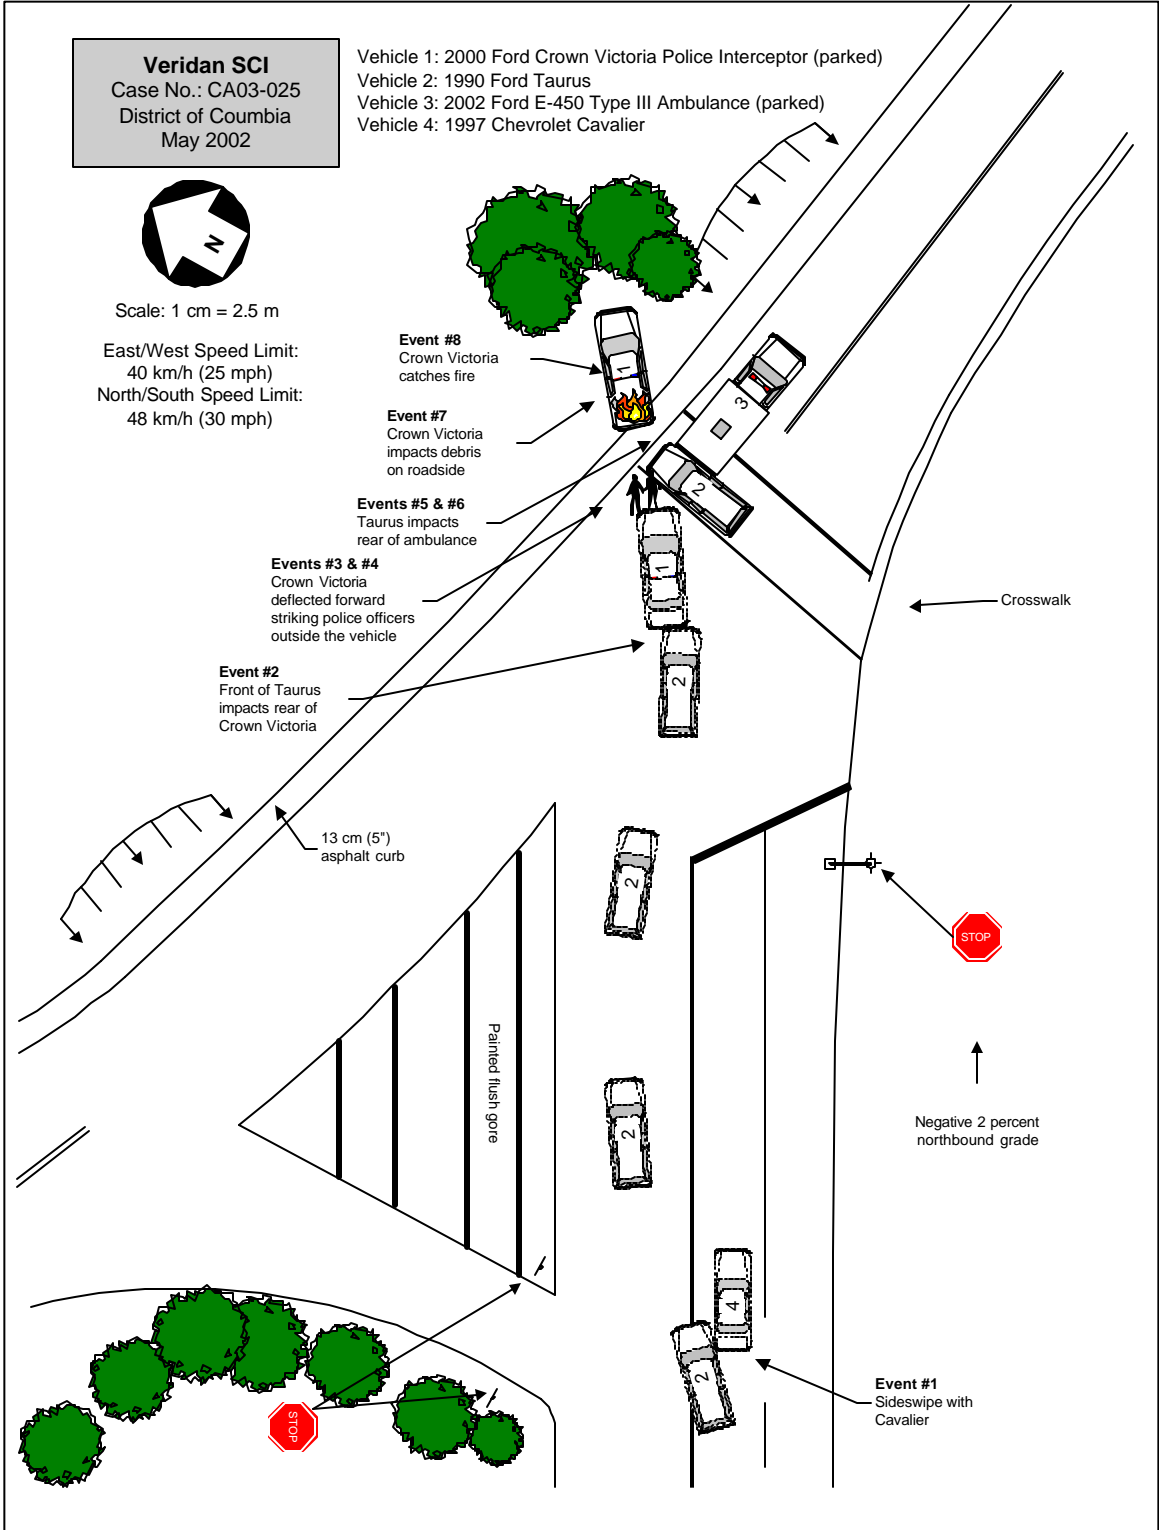
Figure 28. Scene schematic

The east/west roadway was configured with one travel lane in each direction, separated by a double-yellow centerline and bordered by asphalt shoulders and 13 cm (5") asphalt curbs. The north/south roadway intersected the east/west roadway at a 57 degree angle. The travel lanes curved to the right in a westbound direction as the roadway continued past the intersection. A painted-flush gore at the southwest quadrant of the intersection directed eastbound traffic through the intersection or onto a designated right turn lane onto the southbound roadway. Northbound traffic flow entering the intersection was controlled by a stop sign. A marked crosswalk was present on the east leg of the intersection. The general roadside environment consisted of residential and wooded areas. The north roadside consisted of a hillside with numerous trees. Debris (firewood-sized logs) from previously cut trees was present on the roadside in addition to fragments of the fractured asphalt curb. It was not known if the curb was damaged during this crash. The posted speed limit for the north/south roadway was 48 km/h (30 mph) and the posted speed limit for the east/west roadway was 40 km/h (25 mph). The scene schematic is included as **Figure 28**, Page 20 of this narrative report.
