***ON-SITE AIR BAG RELATED CHILD PASSENGER SERIOUS INJURY  
INVESTIGATION***

**GENERAL DYNAMICS CASE NO: CA03-026**

***VEHICLE: 1996 DOGE CARAVAN***

**CRASH DATE: MAY, 2003**

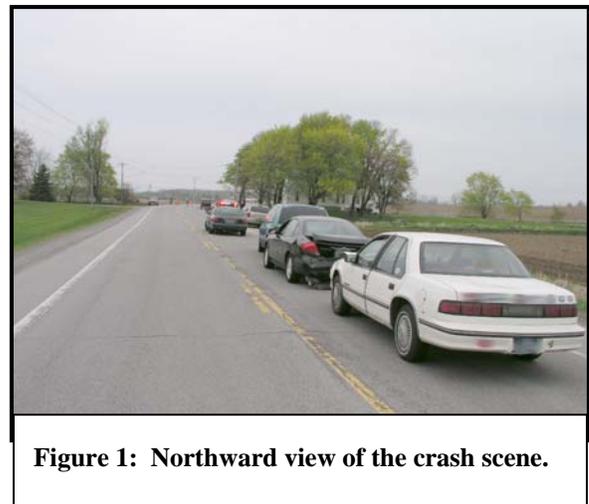
This four-vehicle, front-to-rear, chain reaction crash occurred in the afternoon hours of May, 2003. At the time of the crash, it was daylight and there were no adverse weather conditions. The road surface was dry. The crash occurred on a two-lane north/south state route in a rural setting. At the scene, a large agri-business was located on the west side of the road. Reportedly, there was a back-up in traffic due to slow moving agricultural equipment that contributed to the cause of the crash. The speed limit in the area of the crash was 89 km/h (55 mph). **Figure 1** is a northward view of the crash scene taken by the police investigator.

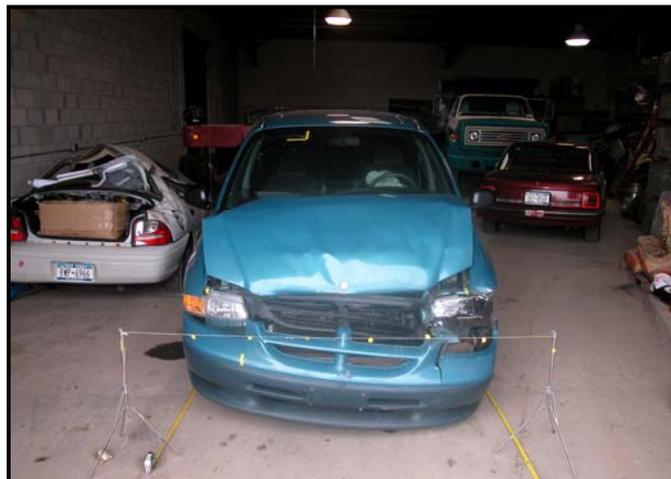
**Figure 2: 1996 Dodge Grand Caravan front view.**

The front plane of the Caravan sustained 132.6 cm (52.2 in) of direct contact damage as a result of the impact with the 2002 Caravan. The direct contact began 54.4 cm (21.4 in) right of center and extended to the left corner. The combined with of the direct and induced damage extended across the entire 156.4 cm (61.6 in) end width of the vehicle. The nature and profile of the impact damage was indicative of an underride. **Figure 3** is a left lateral view of the damage. There was no measurable residual crush at the elevation of the front bumper. Minor abrasions were observed on the vertical face of the bumper fascia that wrapped onto the fascia's horizontal face. This contact pattern then transitioned into direct impact damage to the center grille area. All the residual impact damage was above the elevation of the front bumper with the greatest crush located along the upper radiator support and leading edge of the hood. The severity of the impact was determined by an averaged residual crush profile as an input to the Damage Algorithm of the WINSMASH model. This averaged profile was: C1 = 0, C2 = 11 cm (4.3 in), C3 = 12 cm (4.7 in), C4 = 11 cm (4.3 in), C5 = 0, C6 = 0. There was no reduction in the vehicle's wheelbase measurements and all the doors remained operational. The calculated total delta V was 16.1 km/h (10.0 mph). The longitudinal and lateral components of the delta V were -16.1 km/h (10.0 mph) and 0 km/h, respectively. The Collision Deformation Classification (CDC) for the impact was 12-FDMW-1.

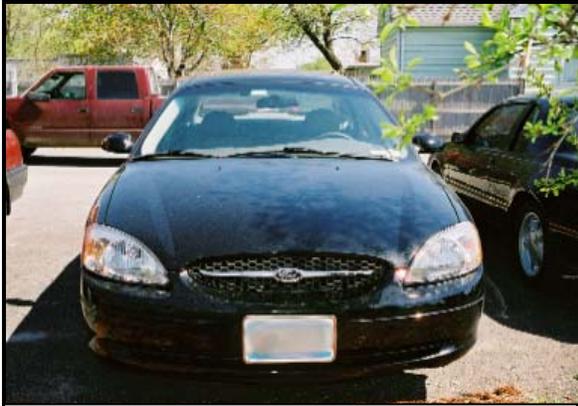
**Figure 7: Front view of the Ford.**

The northbound momentum of the Chevrolet displaced the Ford forward into a secondary front-to-rear impact with the 1996 Caravan. **Figures 9 and 10** are front views of the Taurus. There was no residual damage to the front bumper system of the Taurus. During the minor impact, the center aspect of the front bumper elastically deformed rearward approximately 2.0 cm (0.8 in) along the vehicle's centerline and then rebounded to its original position. The movement of the center section was evidenced by longitudinal abrasions on the horizontal surface of the fascia,

Figure 9. The abrasions resulted from frictional contact between the fascia and the lower surface of the center grille. The minor nature of the frontal impact did not warrant deployment of the Taurus's safety systems given that both front occupants were restrained by the 3-point manual lap and shoulder belt.

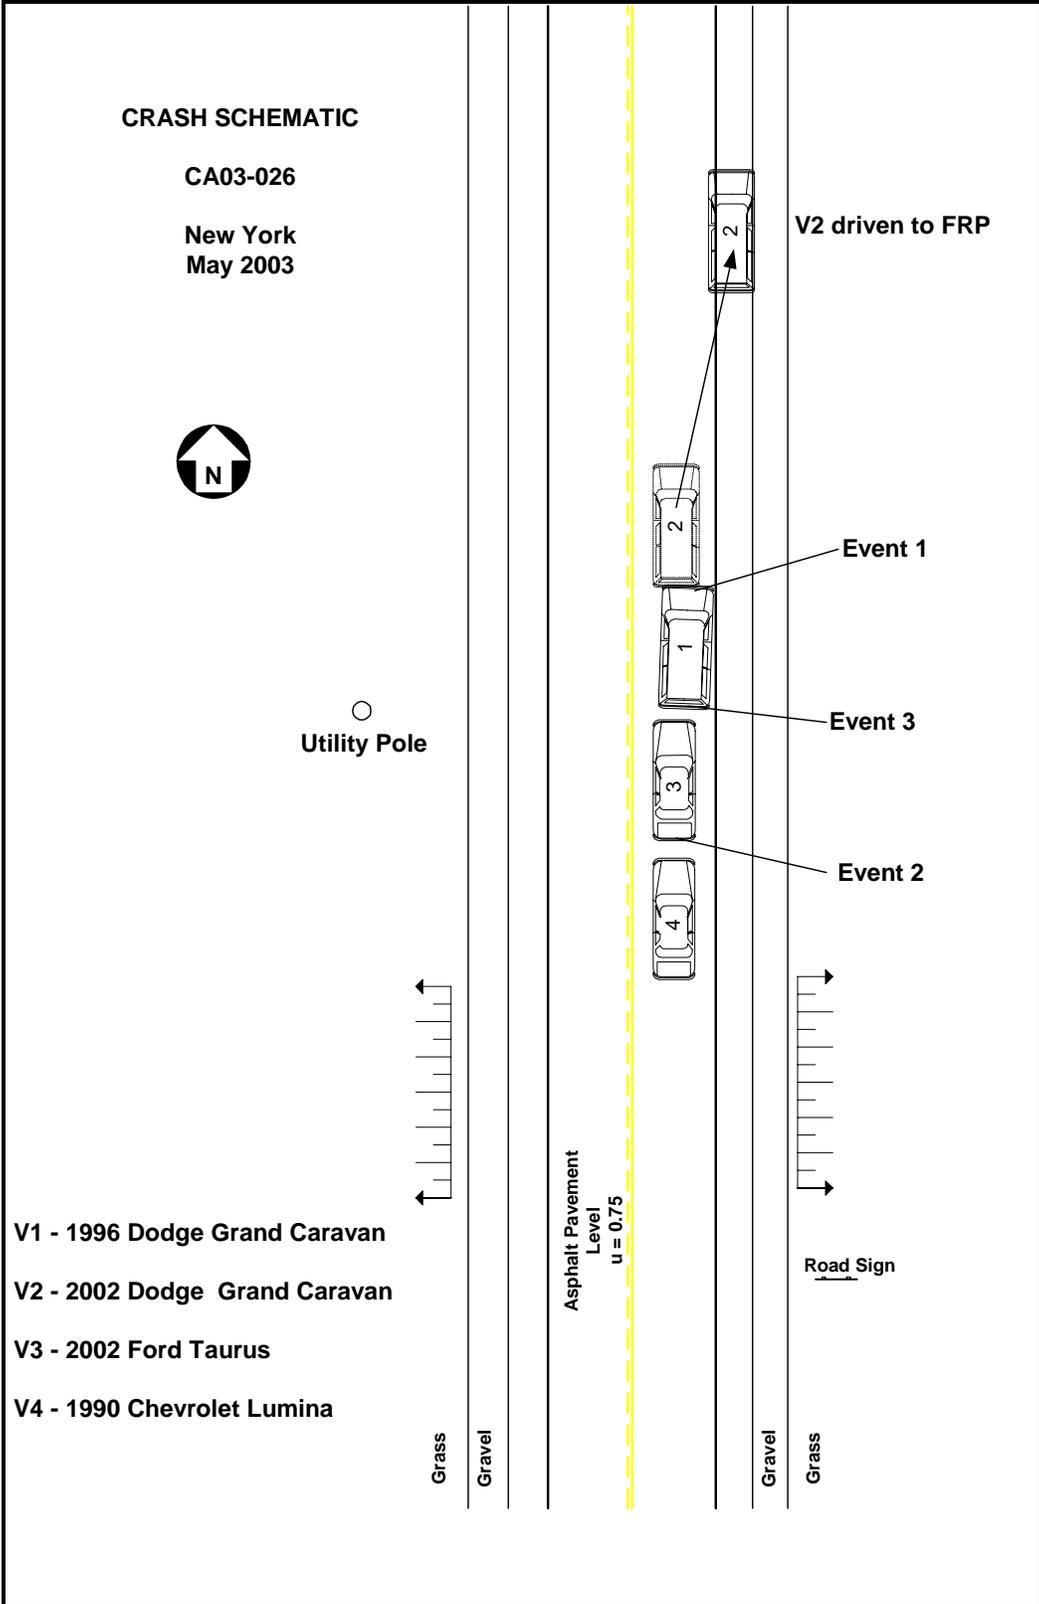
**Figure 19: Crash schematic.**

The subject crash occurred when the front bumper system of the 1996 Dodge Caravan impacted and underrode the back plane of the 2002 Dodge Caravan. The force of the impact caused the frontal air bag system in the 1996 Dodge to deploy. At the time of the deployment, the child was out-of-position in close proximity to the passenger air bag module. The deploying front right passenger air bag contacted the head and neck of the child resulting in the reported head trauma. **Figure 19**, page 15, is a schematic of the crash.
