**TRANSPORTATION SCIENCES
CRASH DATA RESEARCH CENTER**

**GENERAL DYNAMICS ON-SITE REAR IMPACT CRASH/FIRE
INVESTIGATION
SCI 1 CASE NO: CA03-028
VEHICLE: 2003 FORD CROWN VICTORIA POLICE INTERCEPTOR
LOCATION: MISSOURI
CRASH DATE: MAY 2003**

Contract No. DTNH22-01-C-17002

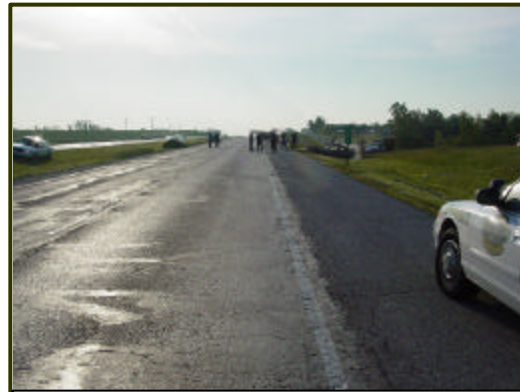
The crash occurred on a four lane divided interstate roadway during daylight hours. The east/westbound travel lanes were separated by a depressed grass median. The crash occurred on the outboard shoulder of the eastbound travel lanes. The eastbound lanes consisted of two lanes that were 3.6 m (12.0') in width and delineated by a broken white centerline. The outboard edge line was a solid white line and the inboard edge was marked with a solid yellow edge line. The lanes were bordered by asphalt shoulders. The inboard shoulder width was 1.4 m (4.5') while the outboard shoulder width was 2.9 m (9.5'). Adjacent to the outboard shoulder was an earth and grass surface that sloped downward from the shoulder. The weather was police reported as clear and dry. In the vicinity of the crash site, the roadway was straight with a positive 1.1 percent grade to the east with an approximate 1.6 km (1.0 mile) line of sight afforded to eastbound traffic. The posted speed limit was 113 km/h (70 mph). The police measured a coefficient of friction for the outboard shoulder of the eastbound lane at 0.67. **Figure 2** is an overall eastbound view of the crash site.

Figure 2. Overall eastbound view of the crash site on approach to impact.

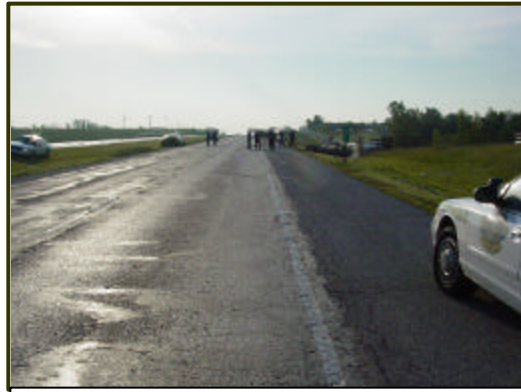
Figure 3. Eastbound view of the approach to the crash site.

As the driver of the Ford F-350 continued his eastbound trajectory, he reported that the glare from the morning sun was bothering his eyes. He reportedly reached to his right across the instrument panel to retrieve his sunglasses. This reaching movement resulted in an inadvertent right steering maneuver that redirected the pickup truck onto the outboard shoulder of the road. The MSHP investigation documented two pre-crash counterclockwise arcing tire marks attributed to the right front and right rear tires of the truck. The marks measured approximately 14.6 m (48.0 ft) in length. The characteristics of the marks indicated the driver of the truck was steering to the left and braking prior to the impact. These inputs followed his detection of the parked CVPI and the impending crash. **Figure 3** is an eastbound view of the approach to the crash site.

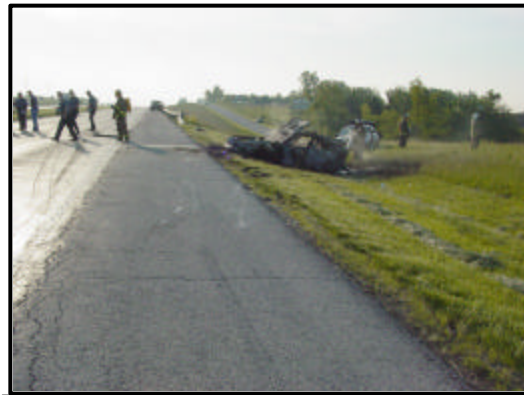
The front right aspect of the F-350 impacted the back left aspect of the CVPI in an offset 12/6 o'clock impact configuration. An estimate of the Ford F-350's impact speed was approximately 105 km/h (65 mph) based on the Conservation of Momentum. **Figure 4** is an eastbound trajectory view of the point of impact. The position of the CVPI was evidenced by a scuffmark attributed to the left rear tire. The total Delta V for the CVPI was calculated by the Damage Algorithm of the WinSMASH model at 41.0 km/h (25.4 mph). The longitudinal and lateral components were +41.0 km/h (+25.4 mph) and 0 km/h, respectively. This analysis underestimated the crash severity due to the offset crash configuration, the use of the overlapping damage pattern of the striking F-350 truck, and the model's limitation of the 4,536 kg (10,000 lb) vehicle weight limit. The Ford F-350 exceeded this weight at the time of the crash. A WinSMASH analysis using the Missing Vehicle Algorithm estimated the CVPI's delta V to be 45 km/h (28.0 mph). The Missing Vehicle analysis was more consistent with the vehicle's damage.

Figure 4: Eastbound trajectory view at the POI.

The eastbound momentum of the Ford accelerated both vehicles to the southeast as it drove-through the impact. The CVPI and Lincoln initiated counterclockwise (CCW) rotations. The F-350's right front axle fractured during its engagement with the CVPI. The tire, wheel rim, and brake rotor separated from the F-350. This tire/wheel separation redirected the F-350 in a CW direction as the truck continued in a general eastbound trajectory. The front right area of the F-350 impacted the W-beam guardrail that was located on the south road edge several times. The F-350 eventually came to rest against the guardrail approximately 134 m (440') east of the point of impact. Its trajectory was evidenced by left tire marks, gouge marks from the right front suspension, and impacts to the guardrail. The final rest of the F-350 is depicted in the background of **Figure 4**.

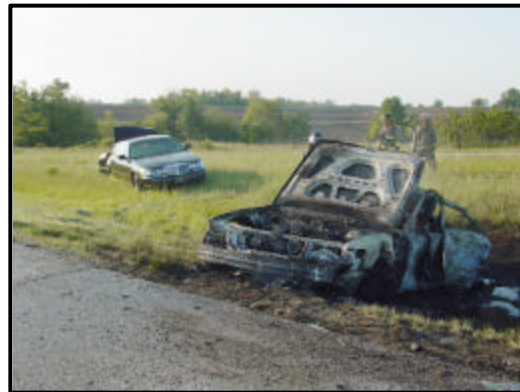
The CVPI disengaged from the Lincoln and rotated approximately 100 degrees counterclockwise during its spinout to final rest. The CVPI came to rest off the south edge of the pavement facing northward, approximately 15 m (50 ft) southeast of the initial point of impact. The vehicle was engulfed in flames at this time. Witnesses reported the fire started nearly instantaneously upon impact with the F-350. In summary, the fire ignited when the fuel tank filler tube that was located in the left rear quarter panel area of the CVPI was severed, allowing gasoline to escape under hydraulic pressure as the tank was crushed during the rear impact.

Figure 5. Final rest positions of the CVPI and the Lincoln Town Car.

It should be noted that at the time of the crash, the fuel tank on the CVPI was nearly full. Details regarding the cause and origin of the fire are detailed in various sections of this report that follow. **Figure 5** is a southeasterly view of the final rest positions of the CVPI and the Lincoln.

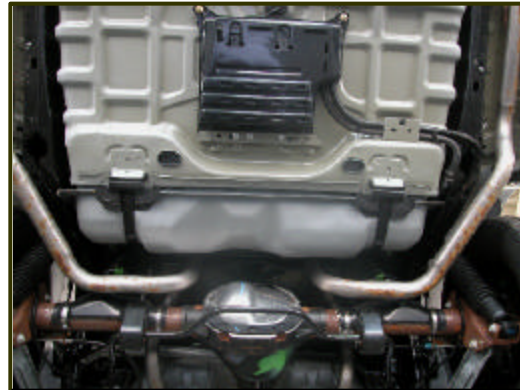
Design changes incorporated into the 2003 model year vehicle included rack and pinion steering, an alloy radiator support panel, an enhanced performance-oriented front suspension redesign, and a redesigned frame for improved crash rigidity and performance. The rear aspect of the frame was widened to accommodate the redesigned rear suspension that positioned the rear shock absorber mounting brackets away from the fuel tank, outboard of the frame rails. The 2003 model was also equipped with the OEM shields covering the sway bar brackets and the tank straps, a molded rubber grommet that recessed the bolt heads on the lower aspect of the rear differential cover, and a redesigned vapor canister mounted to the lower surface of the trunk (**Figure 12**).

The fuel system of the 2003 Ford Crown Victoria consisted of a 72 liter (19 gallon) steel fuel tank that was mounted vertically to the undercarriage, aft of the rear axle and forward of the trunk. The tank was fastened to the vehicle by two steel tank straps that were hinged at the lower aspect of the tank and bolted to the top surface of the undercarriage. An internal electric fuel pump was mounted to the sending unit that was positioned on the upper forward surface of the tank. This sending unit was fastened to the tank with six bolts and sealed with a gasket. A single steel braided fuel supply line was attached to the sending unit output. This fuel line extended the length of the right frame rail to the engine compartment. **Figure 12** is an undercarriage view of an exemplar 2003 Ford CVPI.

Figure 12. Undercarriage view of an exemplar 2003 CVPI depicting the fuel system and shield kit.

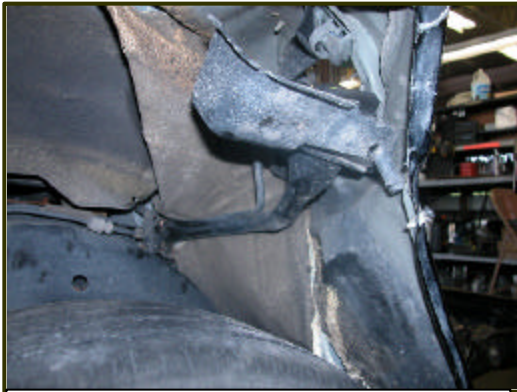
During the inspection process of the Lincoln, it was observed that the fuel tank filler tube was contacted and partially crushed by the forward displacement of the vertical seam edge of the inner fender. The aft aspect of the tube was crushed outboard of the positioning bracket. The inner fender edge was deformed in a concave configuration from the engagement against the filler tube. At this point, the crush to the Lincoln ceased as maximum engagement occurred. Slight restitution of the inner fender was noted aft of the filler tube. There was no fuel leakage associated with this engagement. **Figures 21 and 22** are views of the deformation from engagement of the Lincoln’s inner fender edge against the filler tube.

Figure 21. Filler tube location on the 1999 Lincoln Town Car.

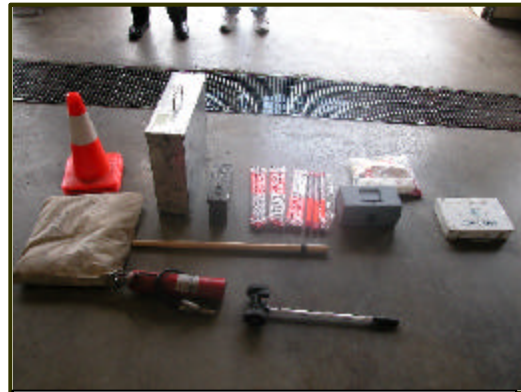
The MSHP had a required set of equipment/contents that were stored in the trunk of the CVPI’s (**Figure 23**). This required list was the basic equipment for Troopers assigned to road patrol. Most Troopers transported additional equipment for their personal needs; and in some cases, transported additional job-related gear for the Hazardous-Material, SWAT, and the crash reconstruction team members. The required equipment typically stored in the trunk of the MSHP CVPI’s included the following:

Figure 23. Typical trunk contents of the MSHP CVPI’s.

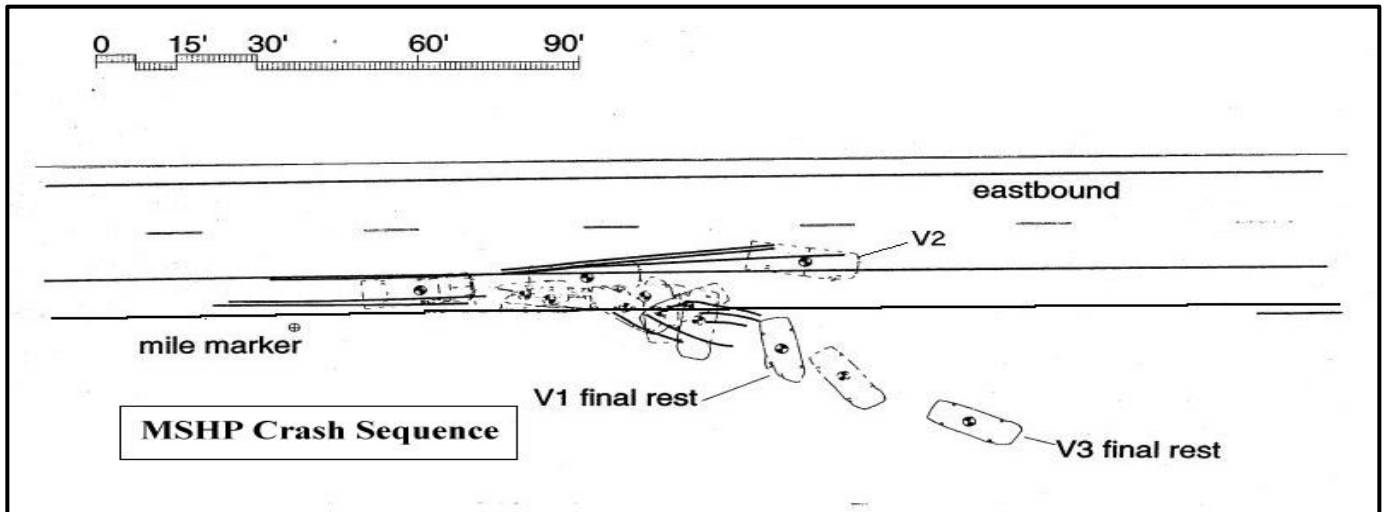
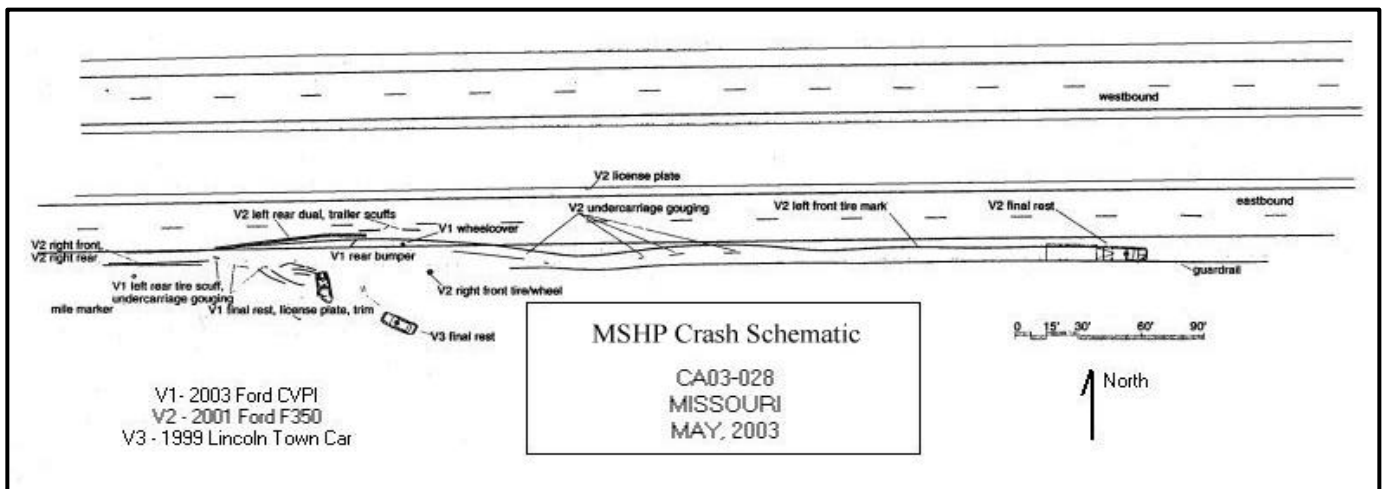
The unoccupied Lincoln came to rest off the south edge of the pavement approximately 20 m (67 ft) southeast of the impact. The vehicle rotated approximately 152 degrees CCW, facing in a northwesterly direction. Schematics of the crash developed by the MSHP using a total station (electronic survey) are attached as **Figures 24 and 25**.

Figures 24 and 25. MSHP schematic of the crash sequence.
