REMOTE AIR BAG DEPLOYMENT REPORT

CASE NUMBER - IN-03-028

VEHICLE - 1996 Mercury Cougar XR7

CRASH DATE - March 2001

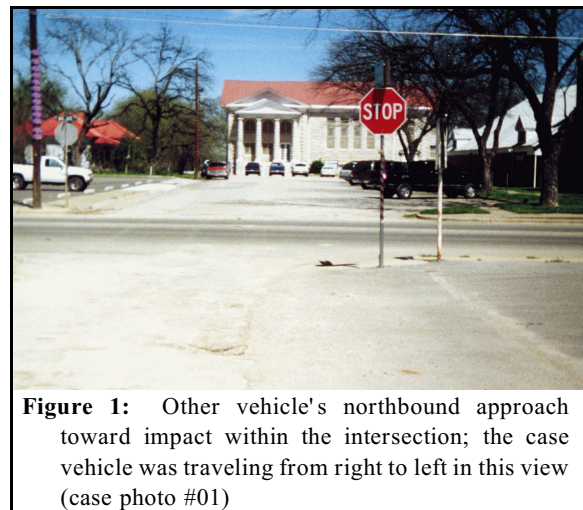
Figure 1: Other vehicle's northbound approach toward impact within the intersection; the case vehicle was traveling from right to left in this view (case photo #01)

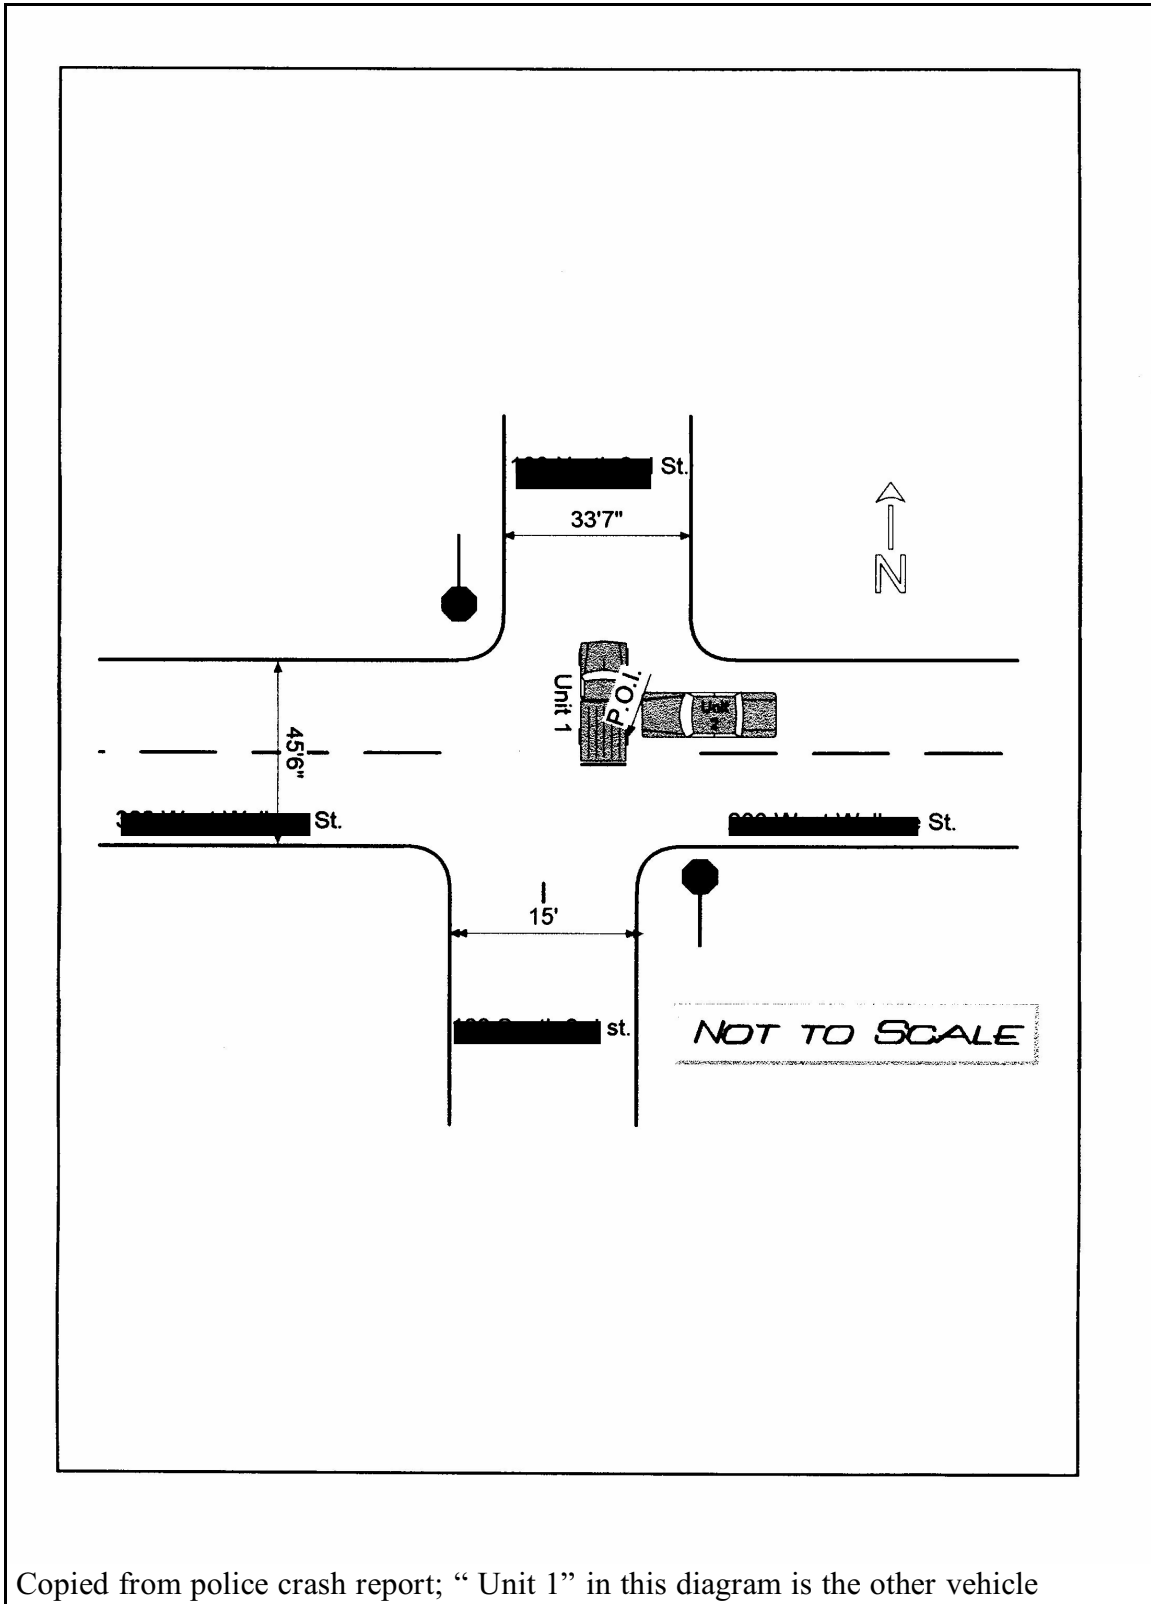
Copied from police crash report; "Unit 1" in this diagram is the other vehicle
