Inflatable Side Air Curtain Investigation / Vehicle to Object
Dynamic Science, Inc. / Case Number: DS03030
2003 Mini Cooper S three-door hatchback
Colorado
August, 2003

1. Report No. DS03030		2. Government Accession No.		3. Recipient Catalog No.	
4. Title and Subtitle Inflatable Side Air Curtain Investigation				5. Report Date August 5, 2004

**Dynamic Science, Inc.
Accident Investigation
Case Number: DS03030**

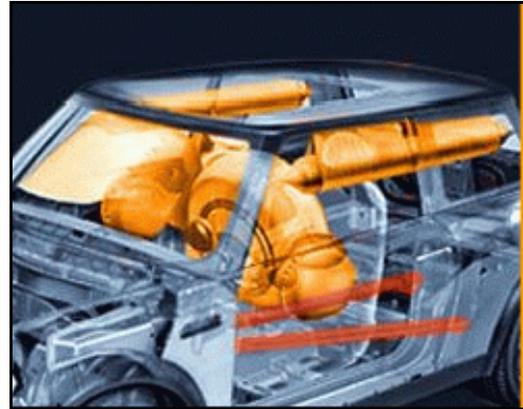
Figure 10. Overview of air bag locations

The case vehicle was equipped with a dual stage driver's air bag, a dual stage front right passenger's air bag, driver and front right passenger seat back mounted side air bags, left and right side air curtains¹, and latch mounted seat belt pretensioners with force limiters for the front seats. The front right passenger air bag has a cutoff sensor that is activated by seat belt engagement and passenger weight. In this crash, the driver's air bag, the front right passenger's air bag, the right passenger side air bag, and right side air curtain all deployed. Both front seat pretensioners actuated.

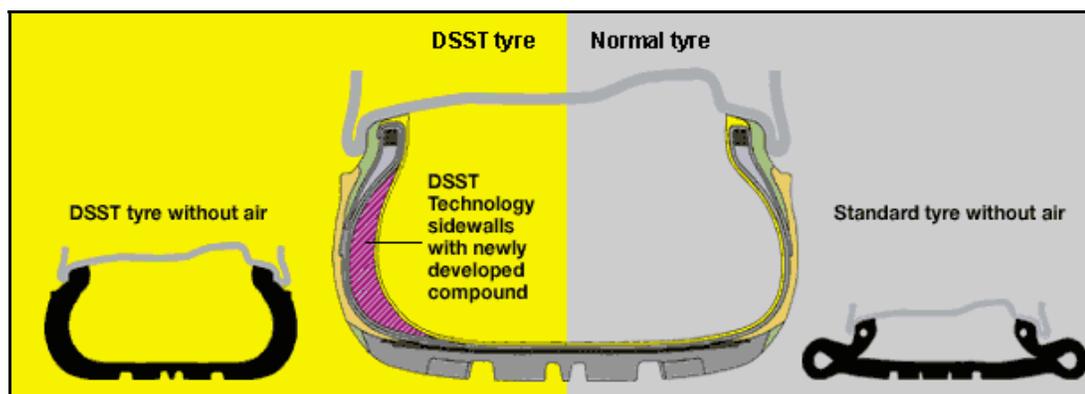
Figure 18. DSST overview

The case vehicle was equipped with Dunlop P205/45R17 tires that use Dunlop's Self-Supporting Technology (DSST). This is a tire technology that allows driving to continue under certain conditions, even after a loss of tire pressure. DSST tires incorporate special reinforcements into the tire, which allows the tire to support the weight of the vehicle for up to 80 kilometers (50 miles) at speeds up to 89 km/h (55 mph).

Because of these capabilities, if a DSST tire loses its inflation pressure, the driver may not be aware of such a loss and may continue driving for extended distances at high speeds. The vehicle is equipped with sensors that will warn the driver if inflation has been lost. In this case the front right tire sustained a complete air out due to the impact, but appears to have retained some measure of vehicle support.
