GENERAL DYNAMICS ON-SITE CHILD SAFETY SEAT INVESTIGATION

GENERAL DYNAMICS CASE NO: CA03-035

VEHICLE: 1997 MERCURY SABLE

CRASH DATE: JUNE 2003

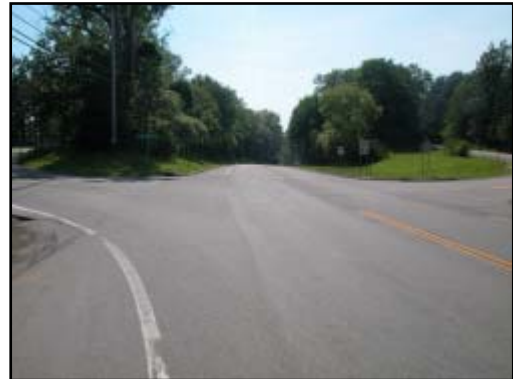
Figure 2. Northwest view of intersection.

This two-vehicle crash occurred during the evening hours of June 2003. At the time of the crash, the weather was clear with no adverse conditions. The crash occurred at a four-leg intersection of two roadways. **Figure 2** is a northwest view of the intersection. The east/west roadway was configured with one travel lane in each direction separated by a double-yellow centerline. The roadway curved left with an uphill grade for the eastbound direction. The north/south roadway was configured with one travel lane in each direction separated by a double-yellow centerline. Asphalt shoulders bordered both roadways. East/west traffic flow through the intersection was not controlled. The posted speed limit for eastbound traffic was 72 km/h (45 mph) and 64 km/h (40 mph) for the westbound traffic. The scene schematic is included as **Figure 15** of this report.

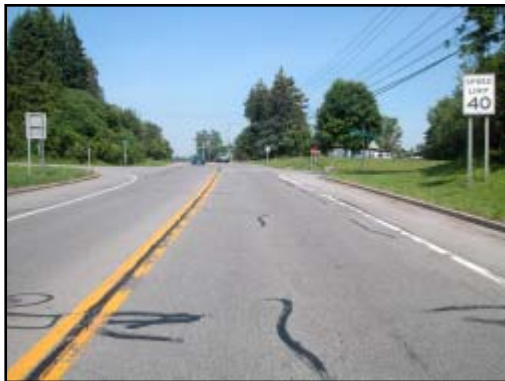
Figure 3. Eastbound approach for the Sable.

The 36-year-old female driver of the Mercury Sable was operating the vehicle eastbound on the two-lane roadway approaching the four-leg intersection (**Figure 3**). The 18-year-old male driver of the Passat was traveling westbound while talking on a hand-held cellular telephone (**Figure 4**). He passed a police officer that was on the east roadside conducting police business. The police officer then made a U-turn with the intent to stop the Passat as hand-held cellular telephone use by a driver of a vehicle is illegal in New York State. The driver of the Passat disregarded eastbound traffic and proceeded to turn left at the intersection across the path of the Sable. The lack of pre-impact evidence indicated that no avoidance maneuvers were attempted by either driver.

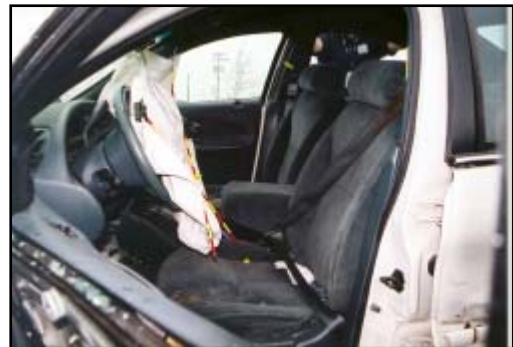
Figure 12 - Driver's safety belt in Sable.

The 1997 Mercury Sable was equipped with 3-point manual lap and shoulder safety belts for the four outboard seating positions and a lap belt for the front center position. The driver's safety belt (**Figure 12**) was configured with a sliding latch plate and an Emergency Locking Retractor (ELR). Adjustable D-rings were present on the B-pillars for the front left and right safety belts. The front left D-ring height adjustment was 3.8 cm (1.5") above the lowest position and the front right was in the full-down position at the time of the inspection. Inspection of the front left latch plate showed evidence of historical use. The driver's safety belt showed evidence of usage in the crash. In the extended position, the torso section of the webbing had blood spatter that would not be present if the safety belt was not used. The front center safety belt was configured with a locking latch plate. The front right and rear outboard safety belts were configured with sliding latch plates and switchable ELR/Automatic Locking Retractors (ALR). The center rear safety belt was a lap and shoulder belt with detachable shoulder belt and was configured with an ELR retractor and a locking/cinching latch plate.
