**GENERAL DYNAMICS ON-SITE CERTIFIED ADVANCED 208-COMPLIANT
VEHICLE CRASH INVESTIGATION
SCI TECHNICAL SUMMARY REPORT**

CASE NO. CA03-041

VEHICLE – 2003 ACURA MDX

CRASH DATE – JULY 2003

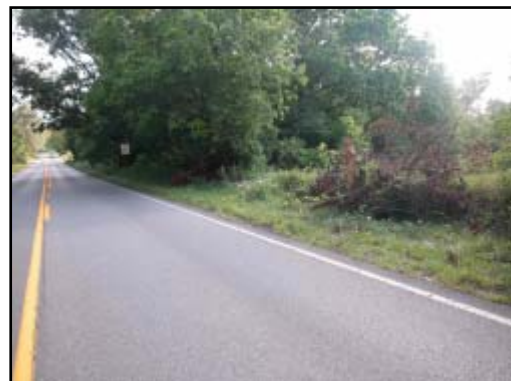
Figure 2. Overall view of crash scene

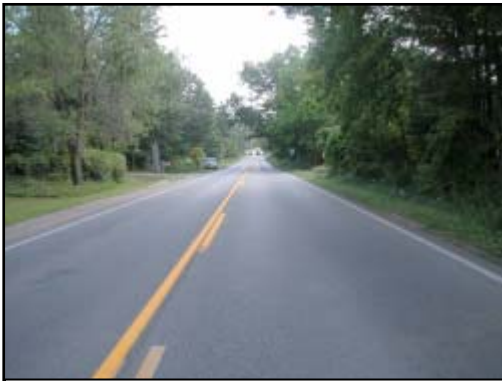
The 34-year-old male was operating the Acura MDX in a southbound direction on the two-lane roadway (**Figure 3**). The driver stated that the vehicle was traveling approximately 81 km/h (50 mph) prior to the impact. As the vehicle approached the crash site, he observed a large tree limb fracture and fall onto the roadway. The driver applied the brakes as the MDX approached the tree limb in the roadway. The tree trunk that measured 45.7 cm (18.0”) in diameter fractured 134.6 cm (53.0”) above the base (**Figure 4**) and began to fall at this point in time.

Figure 3. Southbound approach for the MDX
