TRANSPORTATION RESEARCH CENTER

REMOTE CERTIFIED ADVANCED 208-COMPLIANT VEHICLE INVESTIGATION

CASE NUMBER - IN-03-043
LOCATION - Texas
VEHICLE - 2003 Honda Odyssey
CRASH DATE - September 2003

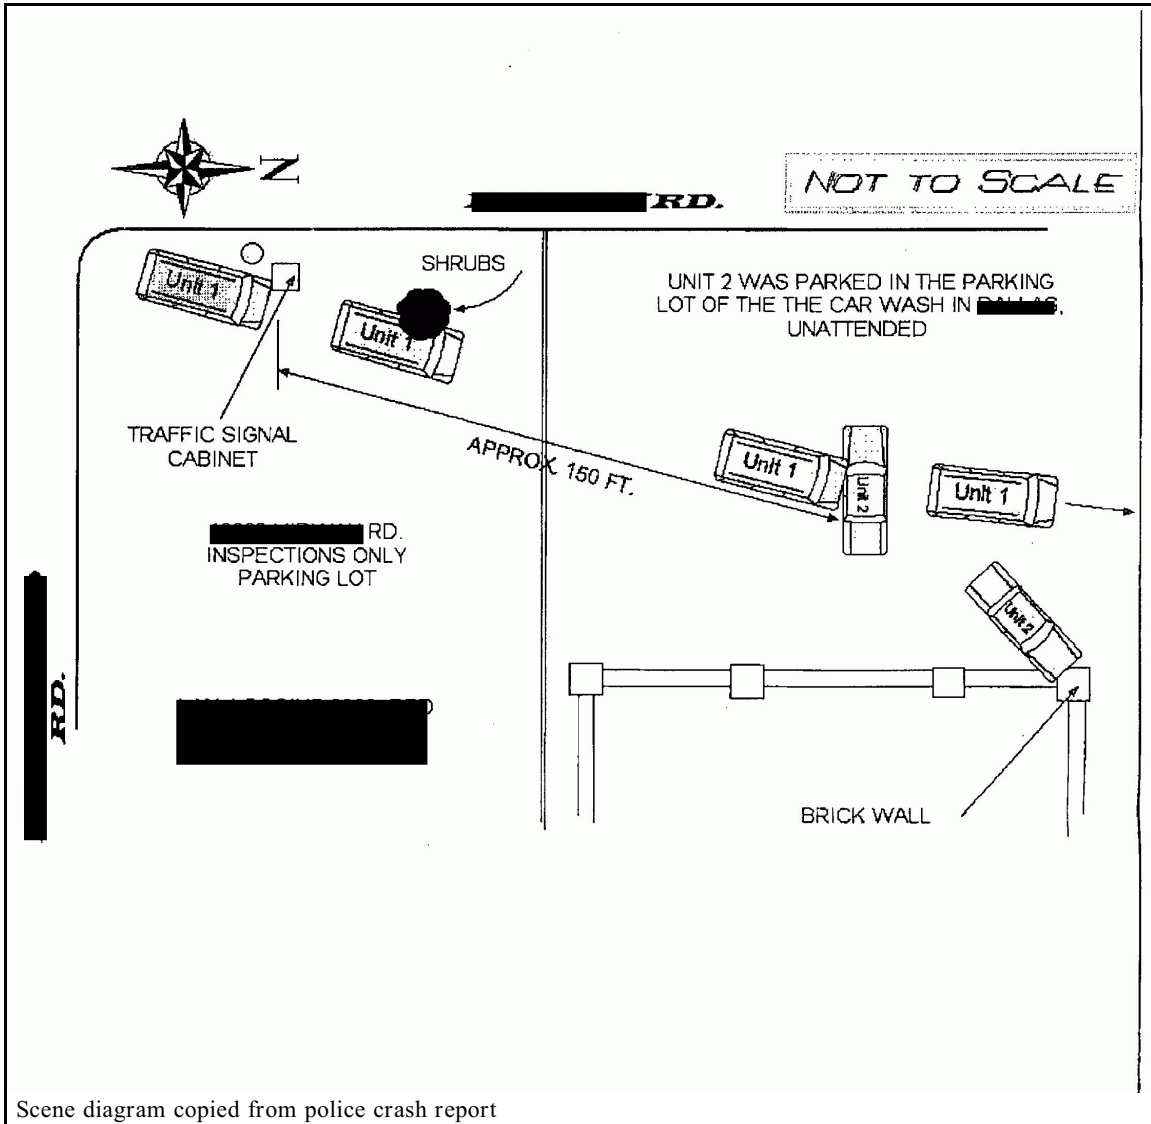
Scene diagram copied from police crash report

The case vehicle had been traveling northward in the outside northbound lane of a multi-lane roadway that was part of a divided trafficway and was approaching a four-leg intersection, intending to turn right to travel eastward in the eastbound lanes of the intersecting divided trafficway. The intersection was controlled by automatic signals. It was daylight, there were no adverse atmospheric conditions and the concrete road surface was dry. The speed limit on both roadways was 56 km.p.h. [35 m.p.h.] and both roadways were straight and level. The Toyota was legally parked and unoccupied in the parking lot of a car wash at the northeast corner of the intersection, heading west, near the car wash structure. As the case vehicle driver was beginning the intended right turn, he suffered a syncopic episode (i.e., lost consciousness). The front right passenger attempted to steer by grabbing the steering wheel, but the vehicle failed to negotiate the turn and ran off the road at northeast corner of the intersection. Other than the passenger's effort to steer, there were no avoidance actions attempted. The crash occurred on the roadside at the northeast corner of the intersection.

The case vehicle's front left corner area impacted a traffic signal control box on the northeast corner of the intersection. The case vehicle continued forward over some shrubs and into the car wash parking lot. The case vehicle's front impacted the left side of the parked Toyota, approximately 46 meters [150 feet] northeast of the first impact, causing the case vehicle's driver and front right passenger air bags to deploy. The impact caused the Toyota to rotate approximately 150 degrees clockwise and its front impacted a brick wall. The case vehicle continued across the parking lot in a northeasterly direction approximately an additional 91 meters [300 feet] and came to rest. There are no photographs of the scene.
