**GENERAL DYNAMICS ON-SITE ADAPTIVE CONTROL VEHICLE**

**DEFECT INVESTIGATION**

**SCI 1 CASE NO: CA03-063**

**VEHICLE: 2000 DODGE GRAND CARAVAN SPORT**

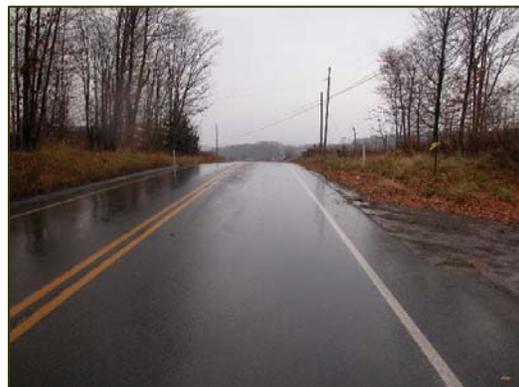
On approach to the farm field where the crash occurred, the state route consisted of a positive grade for eastbound traffic that extended for a measured length of 1.0 km (0.6 miles). This positive grade terminated at a hillcrest (**Figure 2**). The ascending grade immediately prior to the hillcrest averaged 6-7 percent.

**Figure 2.** Vehicle's ascent to hillcrest prior to road departure.

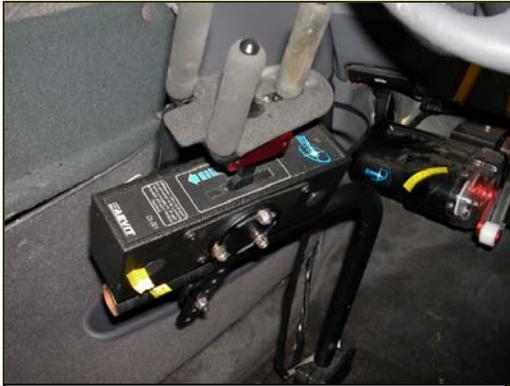
The remote throttle and brake controller was an AEVIT DL-001, Serial No. 1199 (**Figure 3**). The unit was mounted on a stalk to the left of the driver's position and consisted of a rectangular control unit that measured 24.1 cm (9.5") in length x 6.4 cm (2.5") in width by 9.5 cm (3.75") in height. A tri-pin hand device was mounted on the stalk of the unit. Fore and aft motion was programmed into the unit to control the throttle and brake functions. In this installation, the forward position controlled the throttle while the aft motion applied the vehicle's service brakes. It was stated during the investigation that the parking brake was activated when the controller was placed in the rear position with the ignition turned to the off-position. In addition to the throttle and brake functions, up to eight vehicle functions could be programmed into this unit. These functions included headlamp activation with highbeam, turn signals, four-way flashers, wiper/washer, etc. To activate these functions, a lateral input was required by the driver through the tri-pin device. A DigiTone audible signal confirmed the function selection.

**Figure 3.** Adaptive hand control for the throttle and brake functions.

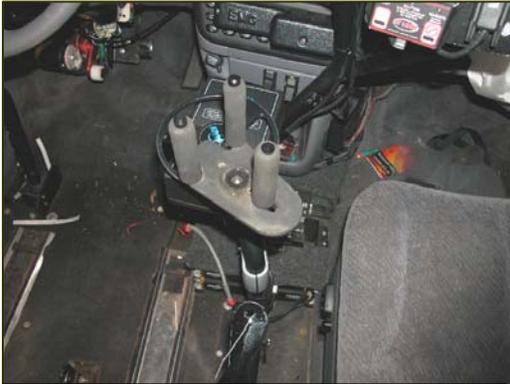
The vehicle steering system was configured with a low-effort remote system that was mounted on a stalk position at the right aspect of the driver's position, near the centerline of the vehicle. The unit was an EMC AEVIT DW-001, Serial No. 1154. The remote steering module consisted of a rectangular control unit with a 15.2 cm (6.0") diameter wheel positioned in a horizontal position. A tri-pin device was affixed to the 15.2 cm (6.0") diameter wheel for driver control/grip (**Figure 5**). The steering module was hard-wired to a servo motor that was mounted to the aft aspect of the OEM steering column.

**Figure 5.** Remote steering assembly with tri-pin device.

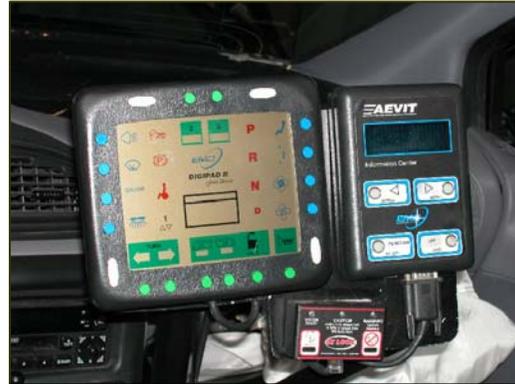
**Figure 6.** DigiPad II control display with the AEVIT information system.

An electronic touch screen control panel was positioned on a stalk forward of the remote steering system. This unit was an EMC DigiPad II, Gold Edition that provided controls for the vehicle functions (ignition, lights, signals, cruise control, and horn), HVAC, and vehicle shifting. The overall dimensions of this unit were 16.5x19.1 cm (6.5x7.5”) with a screen size of 11.4x14.0 cm (4.5x5.5”). On the perimeter of the unit were a series of buttons. The elongated bottoms were used to scroll through the selection guide while the small diameter buttons activated the selected feature. The AEVIT information system was mounted adjacent to the DigiPad II control panel. **Figure 6** is a view of the function touch pad controls.

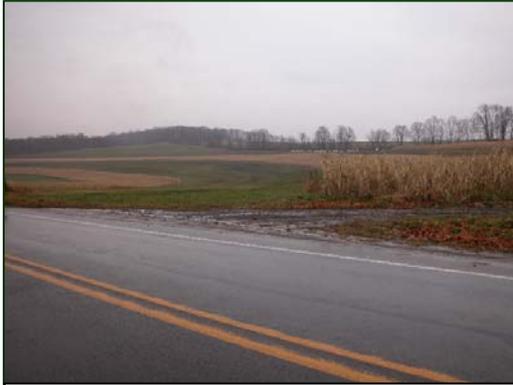
observed a stack of large diameter hay bales. He intentionally steered the Caravan into the bales in an attempt to stop, or slow the vehicle.

**Figure 4.** Intentional road turn-off trajectory of the Dodge Caravan into the cut alfalfa field.

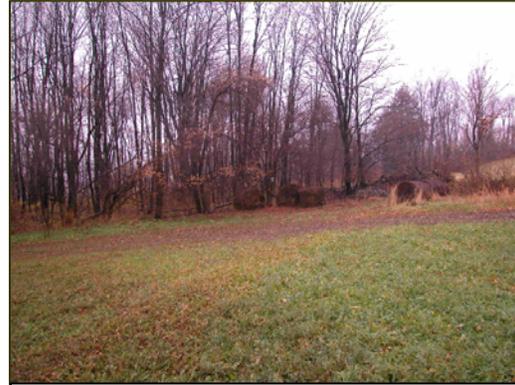
**Figure 5.** Trajectory of the Caravan to impact with the hay bales and tree.

The full frontal area of the Caravan impacted the large round hay bales. The impact resulted in superficial damage to the hood face of the vehicle and displaced several of the bales. The bales redirected the van laterally left as it continued forward. The front left area of the Caravan impacted a tree cluster that was located at the edge of a tree line at the edge of the field. The struck tree was located 763.4 m (2,504.6') from the point of road departure. **Figure 9** is a view of the Caravan's trajectory to impact with the hay bales and tree cluster.
