CALSPAN ON-SITE CHILD SAFETY SEAT INVESTIGATION

CASE NO.: CA03-068

VEHICLE: 1999 DODGE GRAND CARAVAN

CRASH DATE: DECEMBER 2003

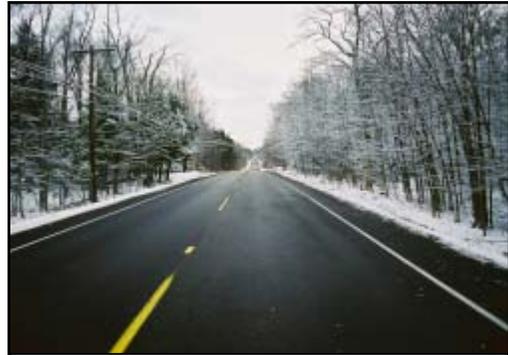
The 32-year-old female driver was operating the vehicle in a southbound direction on the two-lane roadway during snow conditions (**Figure 2**). The roadway surface was slippery due to snow accumulation and had not been plowed or treated by road maintenance crews. The driver stated that she was attempting to maintain control of the vehicle by driving in existing tire tracks that were present in the lane from a previous vehicle. As she ascended the slight positive grade, she noted a dump truck approaching in the opposite lane. She attempted to steer slightly to the right to provide additional distance for the truck to pass. As the Grand Caravan traveled out of the tire tracks and into the deeper snow, the driver lost control of the vehicle. The Grand Caravan initiated a CW yaw, departed the right roadside, and entered the roadside ditch.

Figure 2. Southbound approach for the Grand Caravan

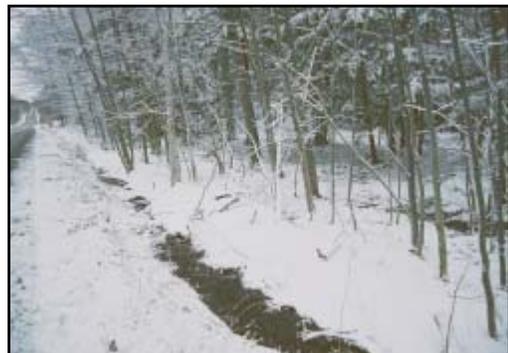
The front right bumper corner impacted the west outboard ditch bank. The initial impact was minor due to the snow accumulation on the roadside, and was not sufficient to deploy the frontal air bag system. The impact caused the Grand Caravan to rotate approximately 90 degrees in a rapid CW direction about the front right bumper corner, and the angle of the ditch bank caused the Grand Caravan to tip laterally, with the left side leading. The left front door area impacted a tree that measured 20 cm (8") in diameter. Due to the non-horizontal attitude of the vehicle, the direct contact and pocketing extended onto the roof. The impact resulted in severe left side/left roof damage and significant vertical passenger compartment intrusion. The left front fender struck a small tree that measured 8 cm (3") in diameter and additional multiple small trees were contacted which did not produce measurable vehicle damage. The Grand Caravan came to rest in a non-horizontal attitude with its left side engaged against the tree.

Figure 3. View of ditch and struck tree cluster

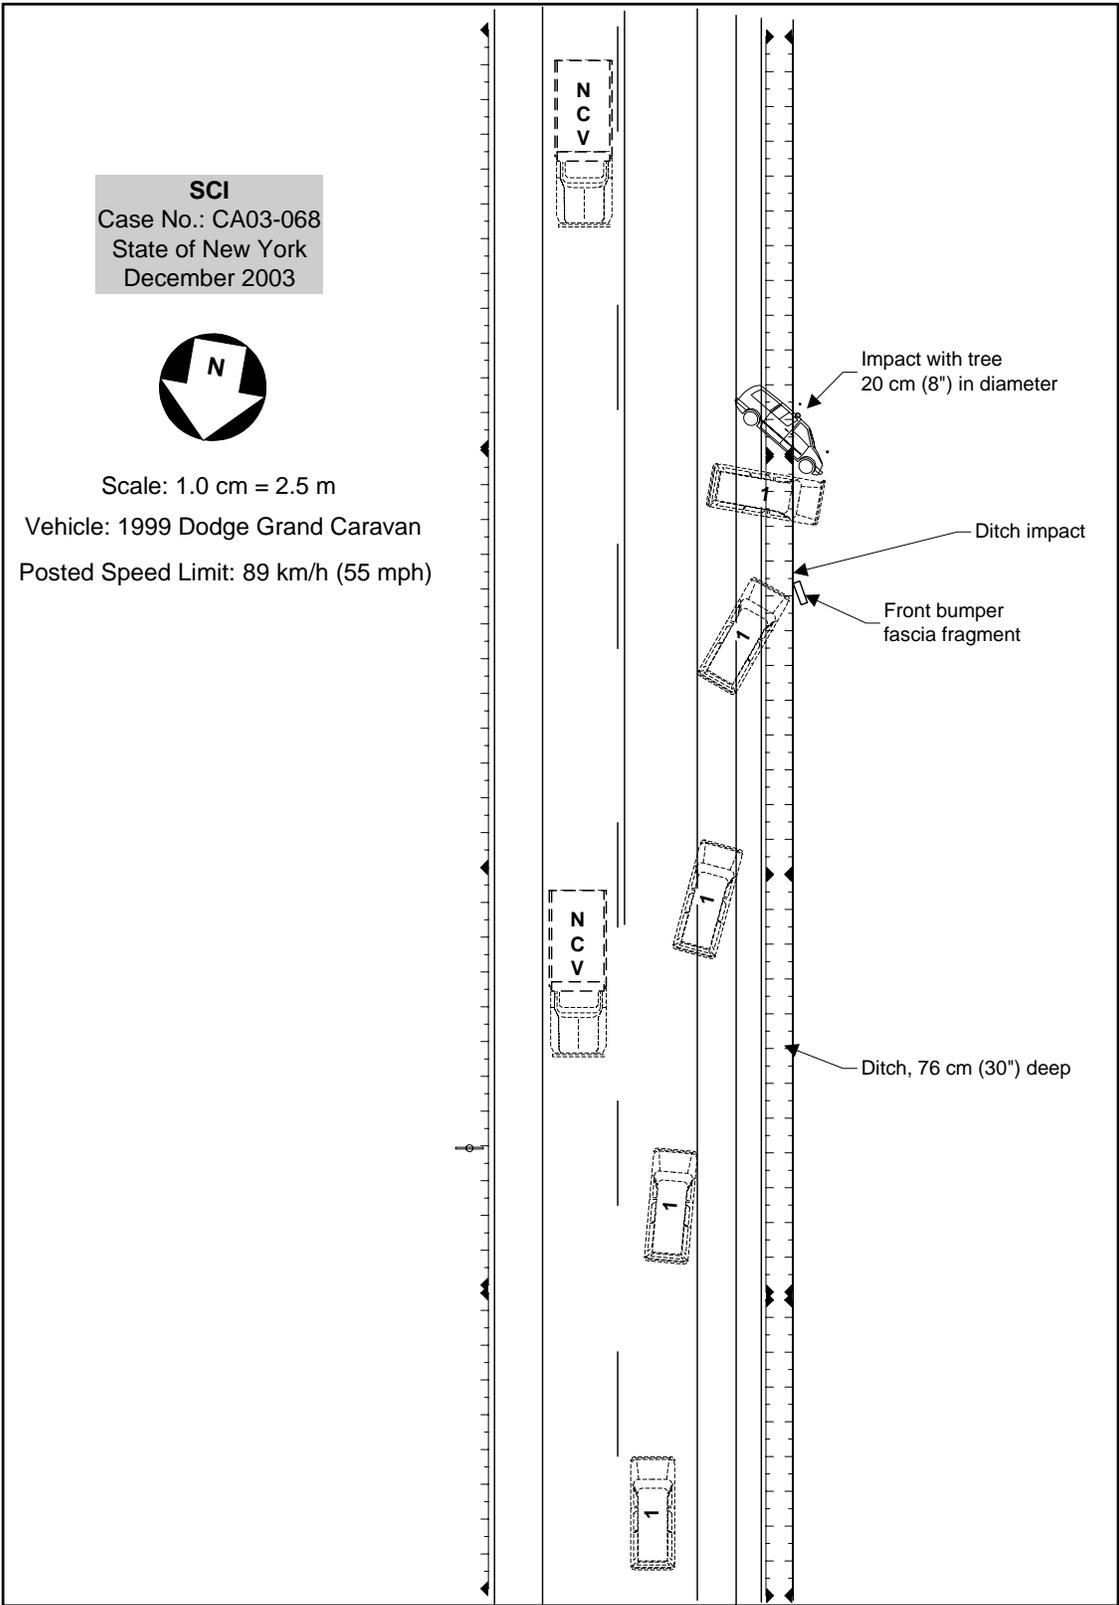
Figure 10. Scene schematic

This single-vehicle crash occurred during the daylight hours of December 2003, in the state of New York. At the time of the crash, snow was falling and the asphalt roadway was snow-covered. The north/south two-lane roadway was configured with a broken yellow centerline for northbound traffic and a solid yellow centerline for southbound traffic. A single broken yellow centerline was present north of the crash site. The roadway exhibited a slight positive southbound grade. Asphalt shoulders bordered the roadway with earth drainage ditches paralleling the shoulders. The west roadside ditch was located 1.1 m (3.6') from the west road edge, and measured 1.5 m (4.9') in width and 76 cm (30") in depth. Wooded areas were located on each roadside and the west tree line began at the west aspect of the roadside ditch. The crash site was located at a cluster of small trees that measured 8 - 10 cm (3 - 4") in diameter. A tree that measured 20 cm (8") in diameter was also located at the crash site. The posted speed limit was 89 km/h (55 mph). The scene schematic is included as **Figure 10** of this narrative report.
