**CALSPAN REMOTE CERTIFIED ADVANCED 208-COMPLIANT  
VEHICLE CRASH INVESTIGATION**

**CASE NO: 2004-02-041A**

**VEHICLE: 2004 GMC YUKON XL**

**CRASH DATE: MARCH 2004**

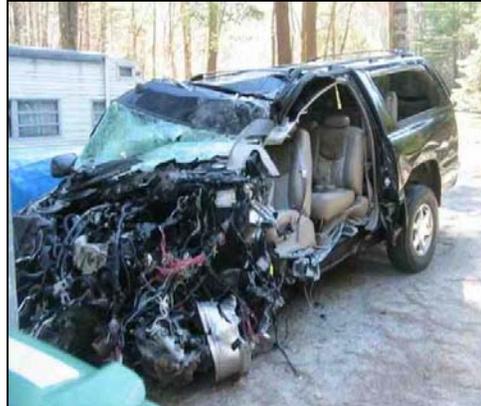
**Figure 1 - Subject vehicle 2004 GMC Yukon XL.**

This remote investigation focused on the performance of the Certified Advanced 208-Compliant (CAC) safety system in a 2004 GMC Yukon XL (**Figure 1**). The manufacturer of this vehicle has certified that this 2004 GMC Yukon XL meets the advanced air bag requirements of the Federal Motor Vehicle Safety Standard (FMVSS) No. 208. The vehicle was equipped with an Event Data Recorder (EDR) that was downloaded during the NASS-CDS vehicle inspection. The EDR printout is included as

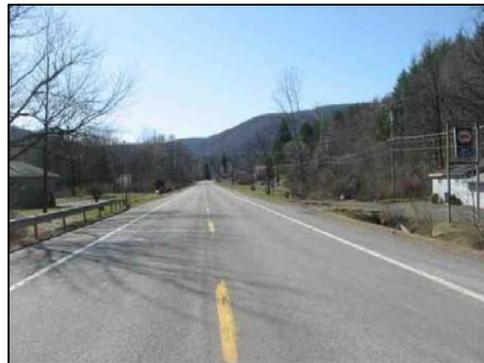
**Figure 2 - Overall view of the east/west roadway.**

The crash occurred on a two-lane, east/west roadway (**Figure 2**) in a sparsely populated residential area during daylight hours. The roadway was surfaced with asphalt and was delineated with a broken yellow centerline and white edge lines. The travel lanes were 3.5 m (11.5') in width and were bordered by paved shoulders of which the north shoulder was 2.0 m (6.6') in width and south shoulder was 2.4 m (7.9'). The environment alongside the roadway consisted of natural growth and sporadic dwellings protected by one guardrail on the south roadside approximately 1 m (3.3') outboard the roadway. At the time of the crash, the road

surface was dry and there were no adverse atmospheric conditions present. The Yukon was traveling in a westerly direction on a straight and level roadway and the straight truck was traveling eastbound on the same roadway. An uninvolved vehicle was traveling westbound in front of the Yukon prior to the crash. The speed limit was posted at 89 km/h (55 mph). The Crash Site Schematic is included as **Figure 14** at the end of this narrative report.

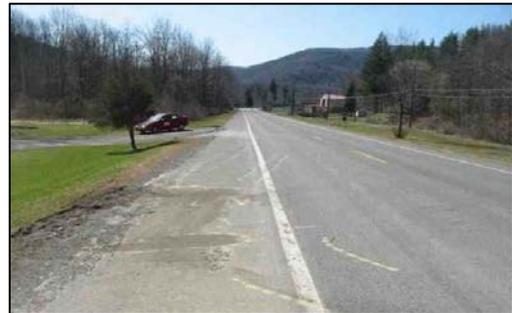
**Figure 4 - Yukon's westbound trajectory.**

The 42-year old driver of the GMC Yukon was traveling in a westerly direction on the two-lane roadway (**Figure 4**) behind another unrelated vehicle. The 4700 Series truck was traveling in an easterly direction on the same roadway. The Yukon was equipped with an Event Data Recorder (EDR) that was downloaded during the NASS-CDS investigation. The EDR recorded five seconds of pre-crash data. Based on the output, the vehicle's speed was recorded at 95 km/h (58 mph) at the five-second interval prior to the crash with five percent throttle application and no braking. The vehicle maintained a 5 percent throttle application as he was passing the unrelated vehicle and then steered left onto the southbound shoulder to avoid the oncoming truck. The scene inspection revealed no physical evidence of pre-crash braking by either vehicle.

The Yukon attempted to pass the unrelated vehicle, and upon realization that the straight truck occupied the oncoming eastbound lane, the driver steered left onto the southbound shoulder in an attempt to avoid the impact. In an attempt to avoid striking the Yukon, the driver of the truck steered right onto the southbound shoulder. The EDR recorded a decrease in the Yukon's speed from the 95 km/h (58 mph) speed at the five-second interval to 86 km/h (55 mph) at the one-second pre-crash interval. The driver did not apply the brakes and the vehicle maintained a five percent throttle throughout the five-second interval prior to the crash.

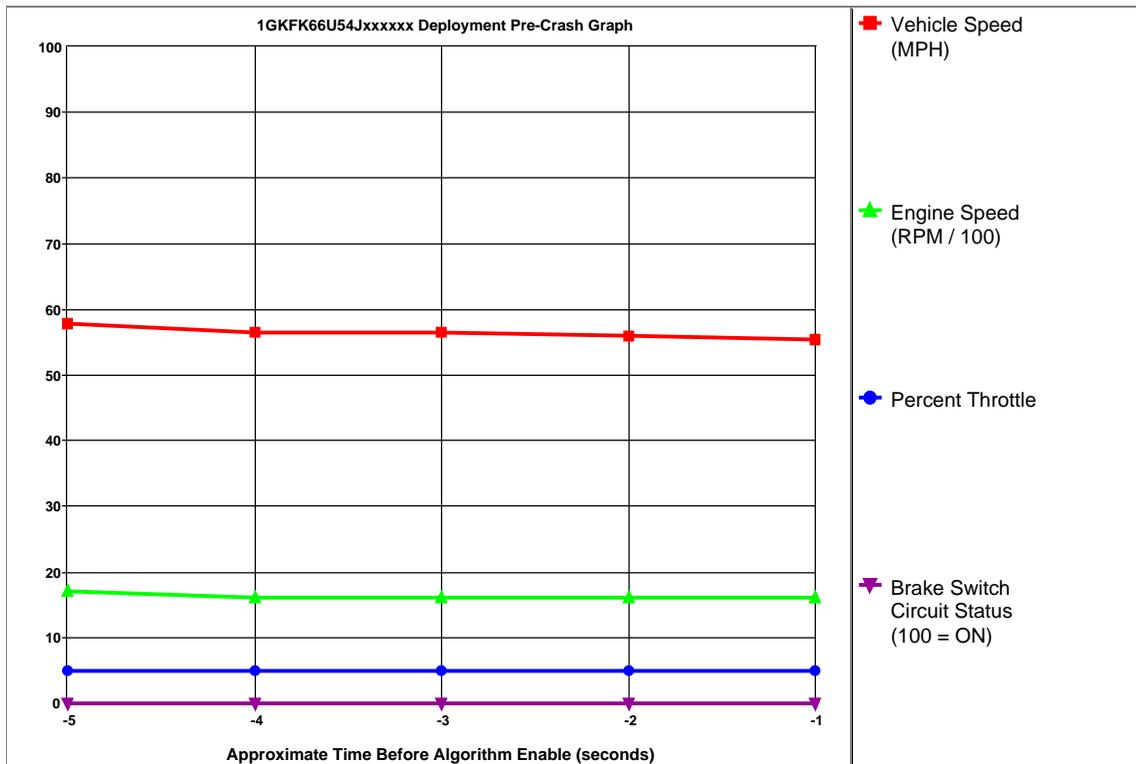
Seconds Before AE	Vehicle Speed (MPH)	Engine Speed (RPM)	Percent Throttle	Brake Switch Circuit Status
-5	58	1664	5	OFF
-4	57	1600	5	OFF
-3	57	1600	5	OFF
-2	56	1600	5	OFF
-1	55	1600	5	OFF

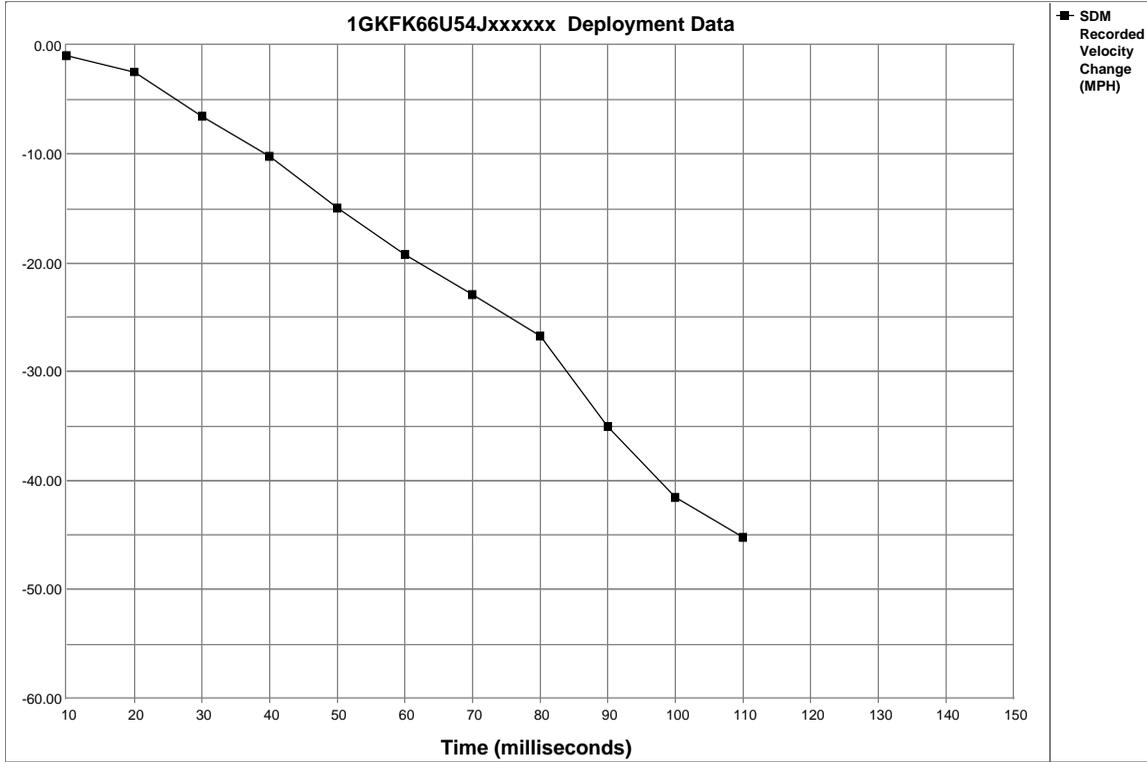
Time (milliseconds)	10	20	30	40	50	60	70	80	90	100	110	120	130	140	150
Recorded Velocity Change (MPH)	-0.93	-2.48	-6.51	-10.23	-14.88	-19.22	-22.94	-26.66	-35.03	-41.54	-45.26	N/A	N/A	N/A	N/A

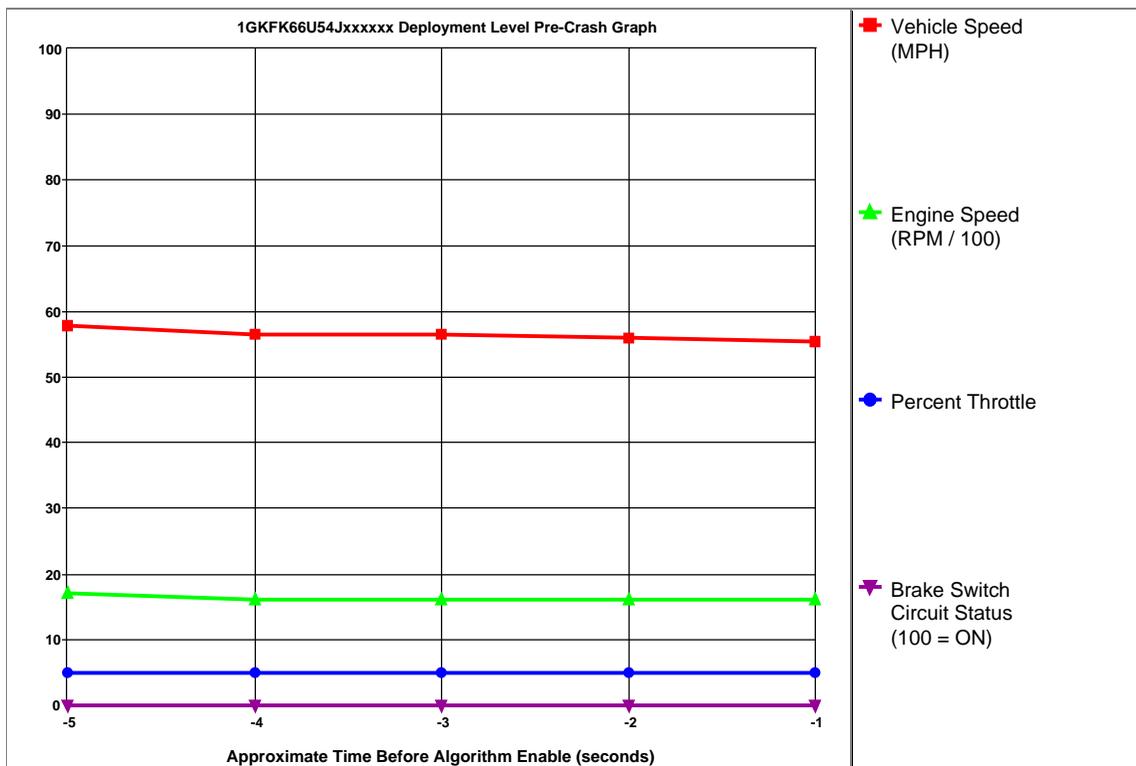
Seconds Before AE	Vehicle Speed (MPH)	Engine Speed (RPM)	Percent Throttle	Brake Switch Circuit Status
-5	58	1664	5	OFF
-4	57	1600	5	OFF
-3	57	1600	5	OFF
-2	56	1600	5	OFF
-1	55	1600	5	OFF

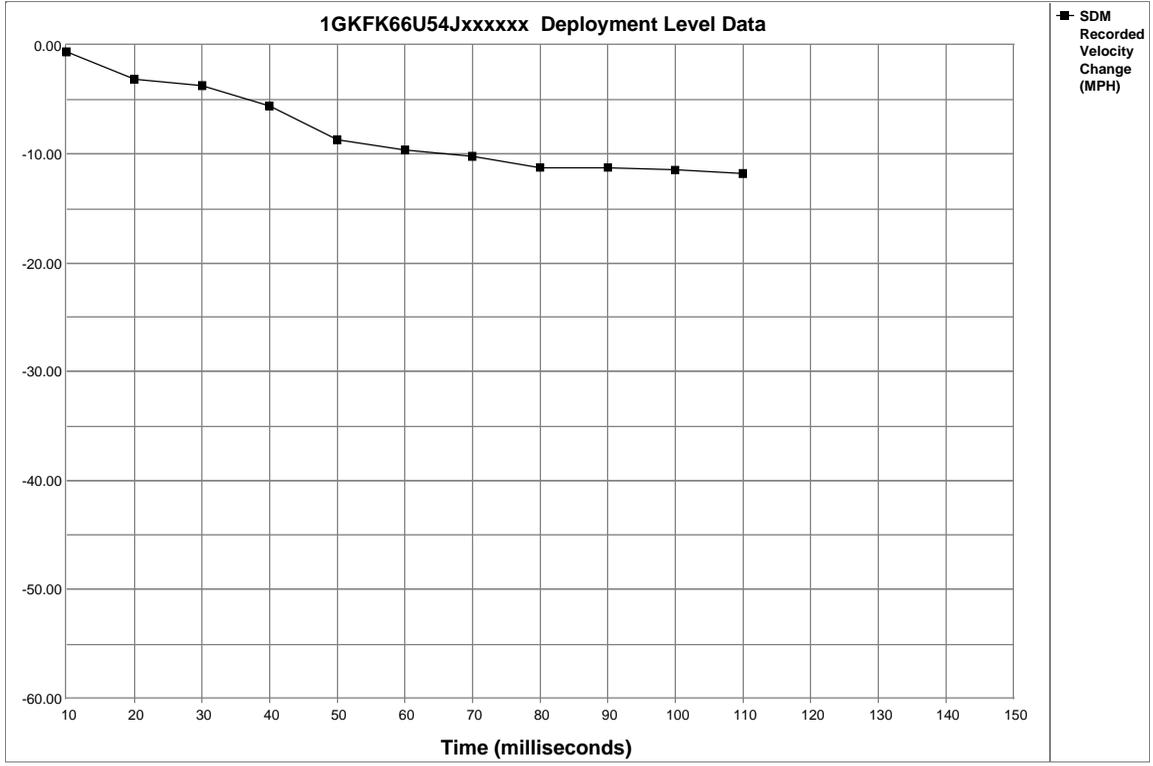
Time (milliseconds)	10	20	30	40	50	60	70	80	90	100	110	120	130	140	150
Recorded Velocity Change (MPH)	-0.62	-3.10	-3.72	-5.58	-8.68	-9.61	-10.23	-11.16	-11.16	-11.47	-11.78	N/A	N/A	N/A	N/A
