Certified Advanced 208-Compliant (CAC) Vehicle Investigation / Vehicle to Object  
Dynamic Science, Inc. / Case Number: 2004-50-129G  
2004 Chevrolet 1500  
Texas  
October, 2004

1. Report No. 2004-50-129G	2. Government Accession No.		3. Recipient Catalog No.	
4. Title and Subtitle Certified Advanced 208-Compliant (CAC) Vehicle Investigation		5. Report Date February 12, 2005

**Dynamic Science, Inc.**  
**Crash Investigation**  
**Case Number: 2004-50-129G**

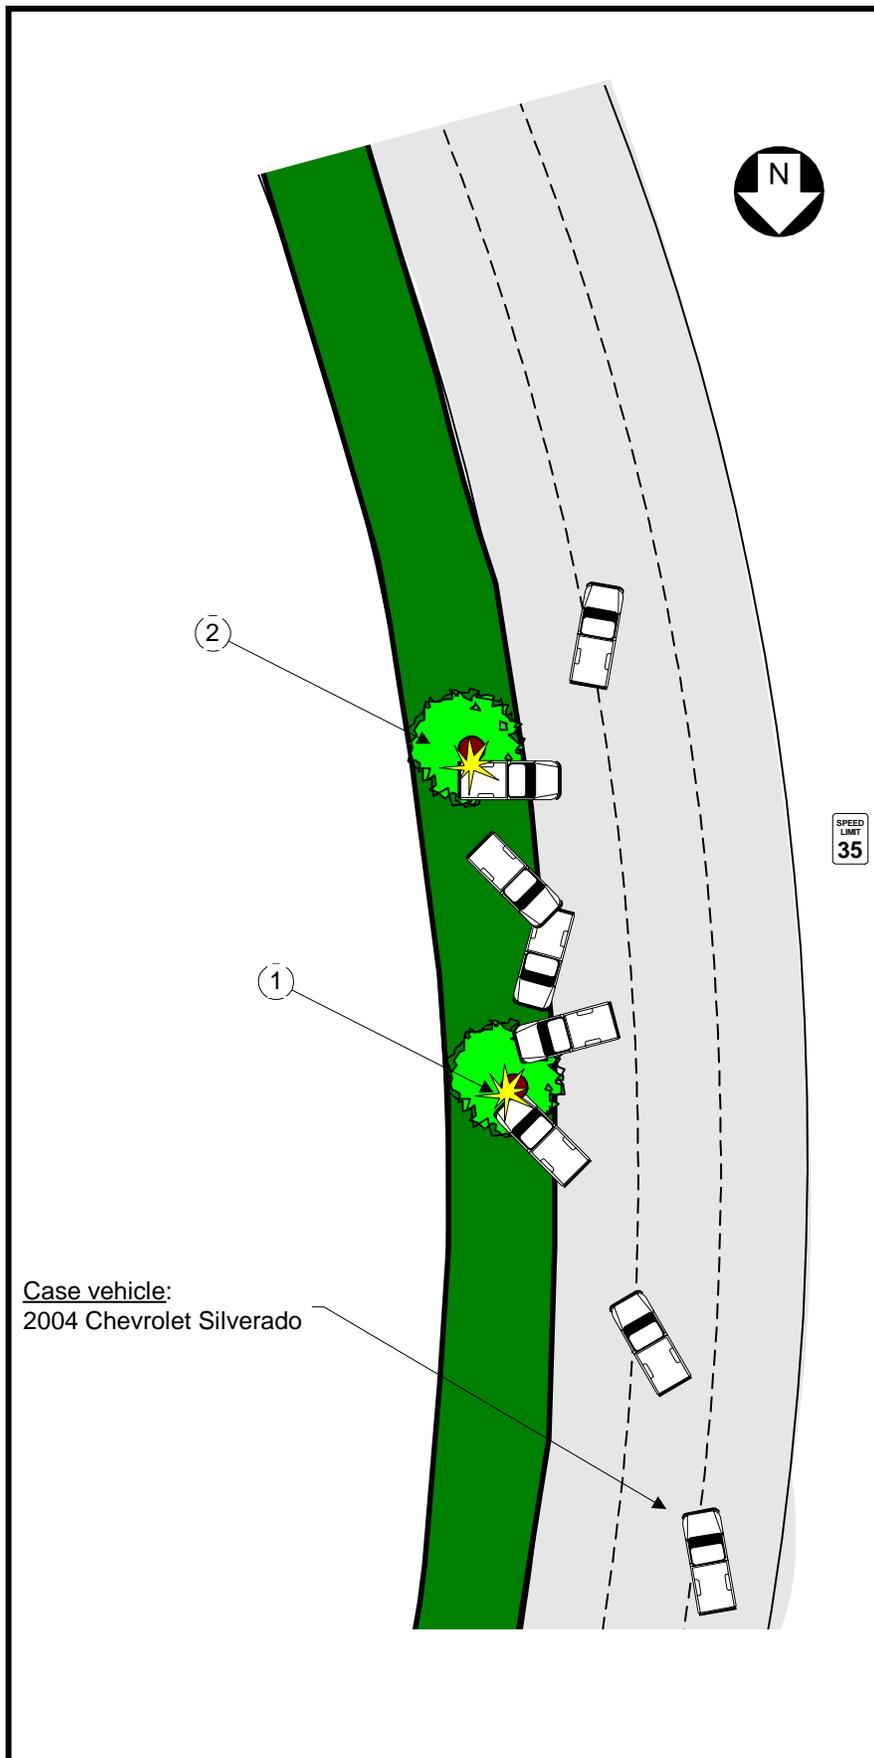
Attachment 1. Scene Diagram

The Chevrolet entered the median and struck a tree that was roughly in the center of the median with its front end (81FDEW2). The total velocity change calculated by the damage only algorithm of the WinSmash collision model was 30.0 km/h (18.6 mph). The longitudinal and lateral components were -26.0 km/h (-16.2 mph) and -15.0 km/h (-9.3 mph), respectively. The barrier equivalent speed was calculated as 30.0 km/h (18.6 mph). The System Diagnostic Module (SDM) recorded a velocity change of -26.60 km/h (-16.53 mph). The driver's air bag deployed at this point. The Chevrolet rotated about the tree in a counterclockwise fashion while continuing to travel south in the median. After the vehicle had rotated approximately 270 degrees, the Chevrolet then struck a second tree with its left side (07LBEE2). The Chevrolet spun out from this impact and back onto the roadway where it came to rest in the center lane facing west.

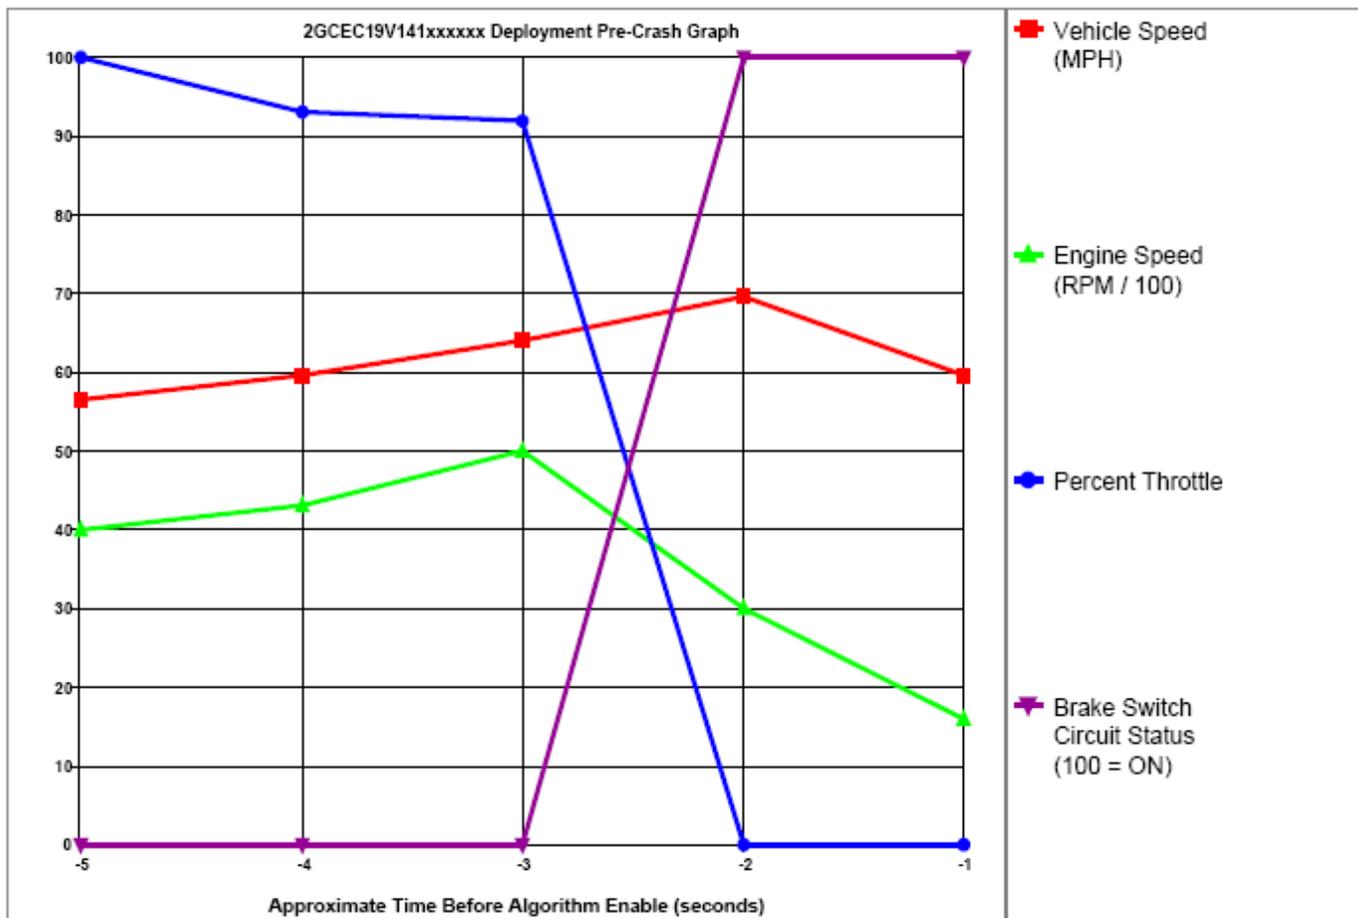
SIR Warning Lamp Status	OFF
Driver's Belt Switch Circuit Status	UNBUCKLED
Ignition Cycles At Deployment	2546
Ignition Cycles At Investigation	2547
Maximum SDM Recorded Velocity Change (MPH)	-16.53
Algorithm Enable to Maximum SDM Recorded Velocity Change (msec)	150
Driver First Stage Time Algorithm Enabled to Deployment Command Criteria Met (msec)	5
Driver Second Stage Time Algorithm Enabled to Deployment Command Criteria Met (msec)	N/A
Passenger First Stage Time Algorithm Enabled to Deployment Command Criteria Met (msec)	Suppressed
Passenger Second Stage Time Algorithm Enabled to Deployment Command Criteria Met (msec)	N/A
Time Between Non-Deployment And Deployment Events (sec)	N/A
Frontal Deployment Level Event Counter	1
Event Recording Complete	Yes
Multiple Events Associated With This Record	No
One Or More Associated Events Not Recorded	No

<b>Seconds Before AE</b>	<b>Vehicle Speed (MPH)</b>	<b>Engine Speed (RPM)</b>	<b>Percent Throttle</b>	<b>Brake Switch Circuit Status</b>
-5	57	3968	100	OFF
-4	60	4288	93	OFF
-3	64	4992	92	OFF
-2	70	3008	0	ON
-1	60	1600	0	ON

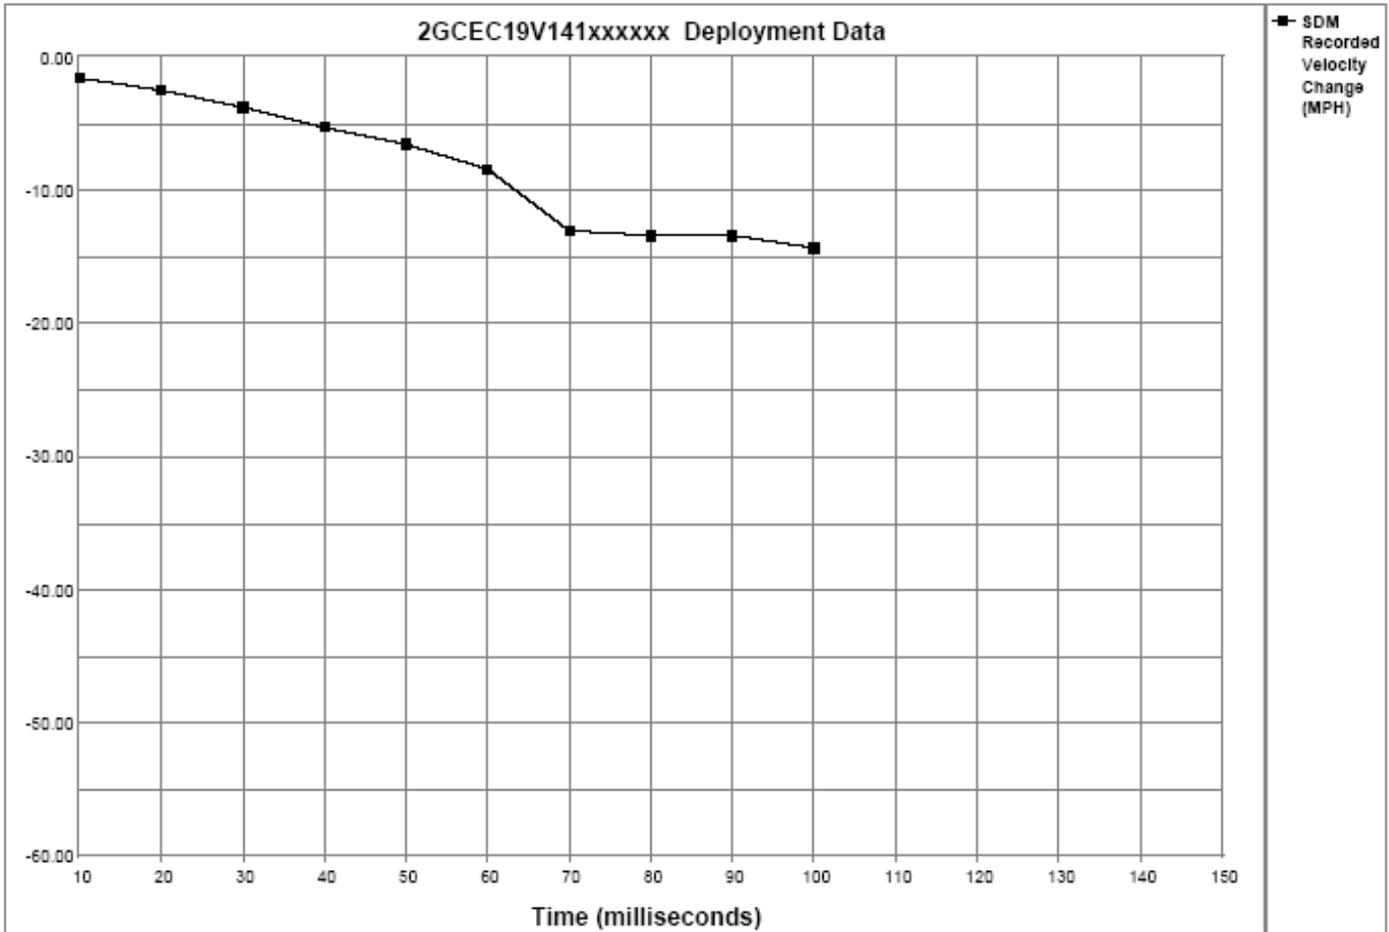
Time (milliseconds)	10	20	30	40	50	60	70	80	90	100	110	120	130	140	150
Recorded Velocity Change (MPH)	-1.55	-2.48	-3.72	-5.27	-6.51	-8.37	-13.02	-13.33	-13.33	-14.26	N/A	N/A	N/A	N/A	N/A
