ON-SITE CERTIFIED ADVANCED 208- COMPLIANT VEHICLE INVESTIGATION

CASE NUMBER - IN-04-005

VEHICLE - 2003 CHEVROLET SILVERADO

CRASH DATE - December 2003

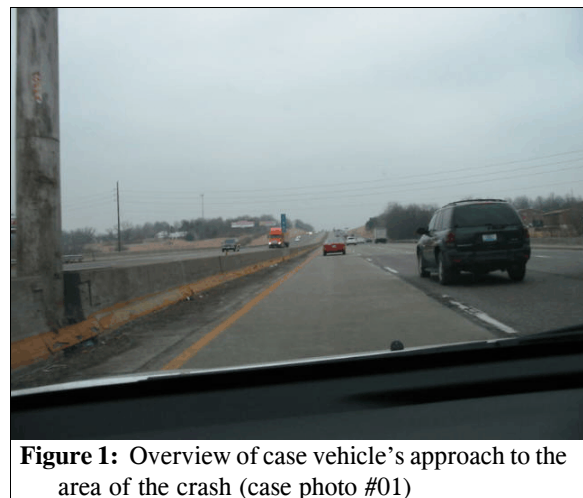
Crash Environment: The trafficway on which the case vehicle was traveling was an eight-lane, divided, Interstate highway, traversing in a northeasterly and southwesterly direction. The trafficway was divided by a concrete median barrier, and the case vehicle's roadway contained four travel lanes (**Figure 1**). The case vehicle's approach to the crash location was uncontrolled and the speed limit was 97 km.p.h. (60 m.p.h.). There was no regulatory speed limit sign posted near the crash site. The interstate highway was straight and level, and the pavement was snow covered, travel polished bituminous and concrete with areas of ice on the roadway. Each travel lane was nominally 3.7 meters wide (12 feet). The shoulders were bituminous and the shoulder widths are unknown. The roadway pavement markings consisted of single broken white lane lines, a white outside edge line and a yellow inside median line. The estimated coefficient of friction of the snow and ice covered roadway surface was 0.25. At the time of the crash the light condition was dark, but illuminated by overhead street

Figure 1: Overview of case vehicle's approach to the area of the crash (case photo #01)

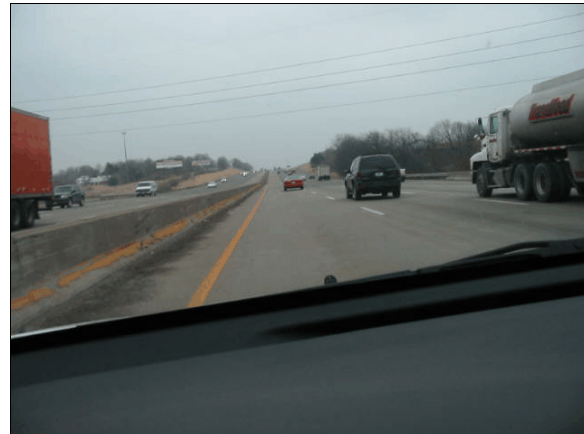
Pre-Crash: The case vehicle was traveling northeast (**Figure 2**) in the inside through lane at an EDR indicated speed of 122 km.p.h. (76 m.p.h.), and the driver was intending to continue straight ahead. The case vehicle's driver reported that she contacted a patch of ice on the roadway and lost control of the case vehicle. The driver braked briefly prior to the crash. The crash occurred off the roadway to the left.

Figure 2: Approach of case vehicle northeastbound to impact with the concrete longitudinal median barrier (case photo #02)
