ON-SITE CHILD AIR BAG-RELATED FATALITY INVESTIGATION

CASE NUMBER - IN-04-006
LOCATION - Louisiana
VEHICLE - 1999 HYUNDAI ELANTRA
CRASH DATE - February 2004

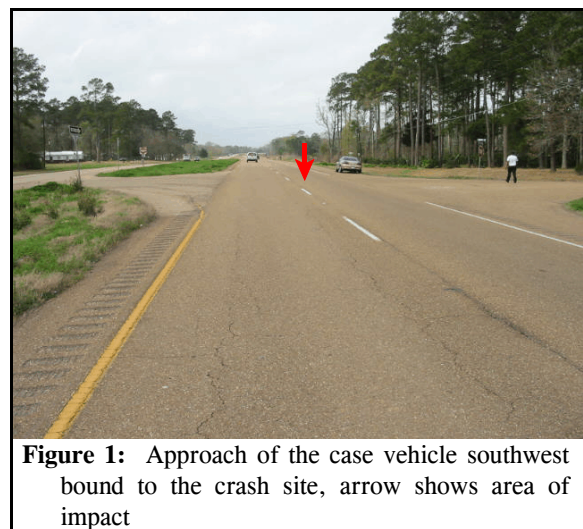
Pre-Crash: The case vehicle was traveling southwest in the inside lane (**Figure 1**), and the driver was intending to continue straight ahead. The Ford was traveling south southeast in the south southeast bound lane (**Figure 2** below), and the driver was intending to cross the intersection, travel through the median cut and make a left turn onto the U.S. highway. The case vehicle's driver steered to the right and braked attempting to avoid the crash. The crash occurred within the “T” intersection in the outside, southwest bound lane of the U.S. highway.
