Child safety seat fatality Investigation / Vehicle to Vehicle
Dynamic Science, Inc. / Case Number: DS04007
1994 Oldsmobile Cutlass
Colorado
April, 2004

| 4. Title and Subtitle Child safety seat fatality Investigation | | | 5. Report Date September 10, 2004 | |
| 7. Author(s) Dynamic Science, Inc. | | | 8. Performing Organization Report No. | |

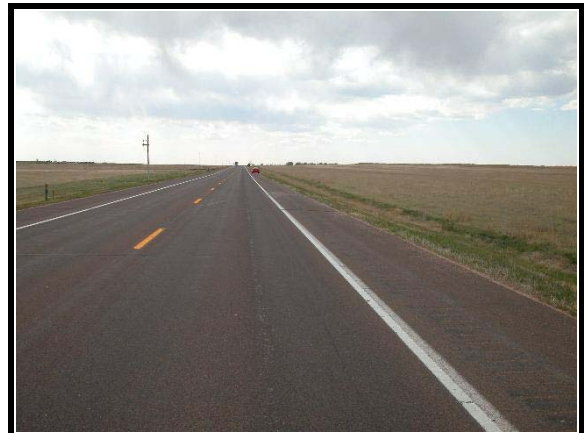
Figure 1. Approach to area of impact (east)

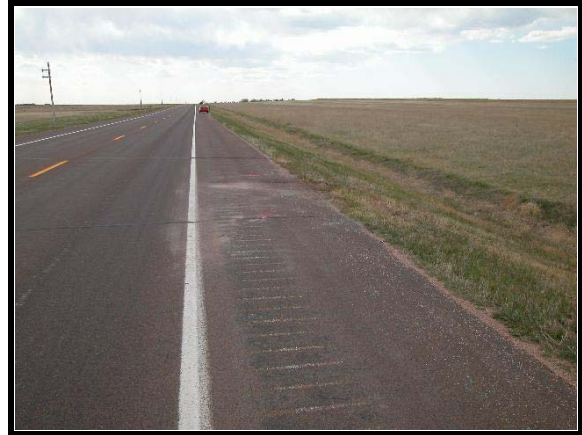
Figure 2. Area of impact and final rest (west)

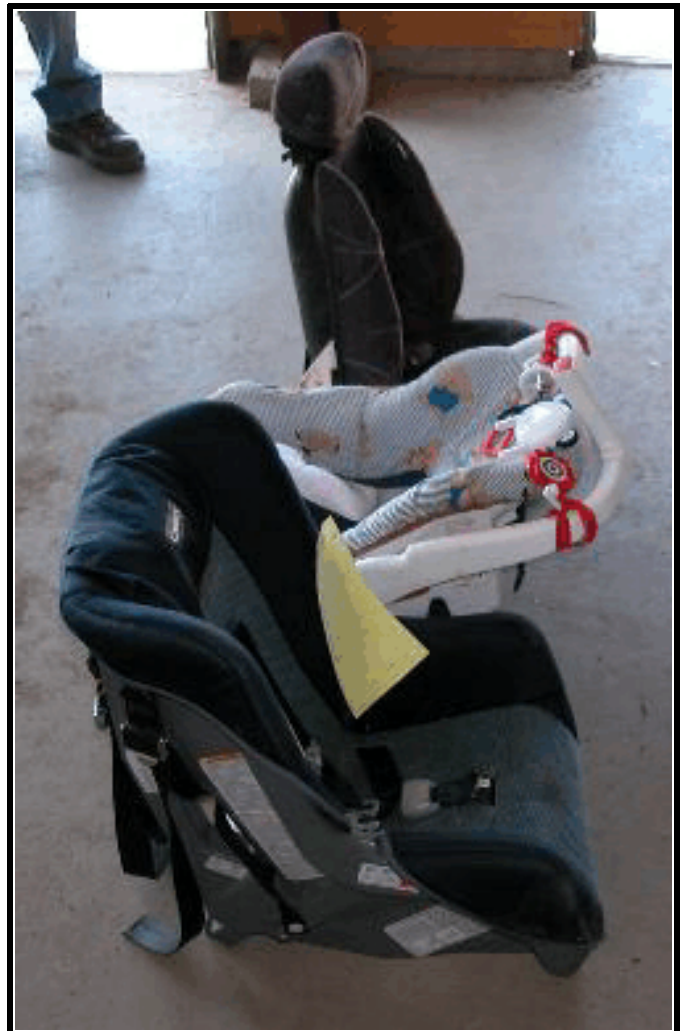
Figure 3. Child seat configuration in rear seat. Front of vehicle to the right. From top to bottom, Century Breverra Premier booster seat, Evenflo Discovery infant safety seat, Century 1000 STE convertible safety seat.

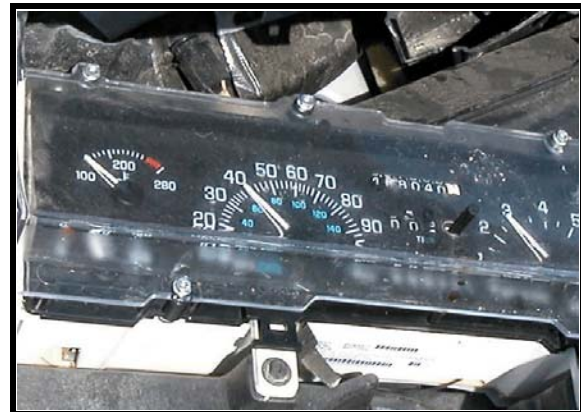
The driver of the Buick lost control of her vehicle, possibly due to a steering over correction. The Buick began a counterclockwise rotation and entered the eastbound travel lane. It was struck in the right side (03RDAW6) by the front (12FDEW2) of the Oldsmobile. The total velocity change for the Oldsmobile calculated by the damage algorithm of WinSmash was 63.2 km/h (39.3 mph). The longitudinal and lateral components were -62.2 km/h (-38.7 mph) and 11.0 km/h (6.8 mph), respectively. The driver's air bag deployed at this time. The rear seat back failed at impact. The total velocity change for the Buick was 59.3 km/h (36.9 mph). The longitudinal and lateral components were 10.3 km/h (6.4 mph) and -58.4 km/h (-36.3 mph), respectively. According to Buick's speedometer, the Buick was traveling at approximately 63 km/h (39.0 mph) at impact.

Figure 6. Speedometer, Buick

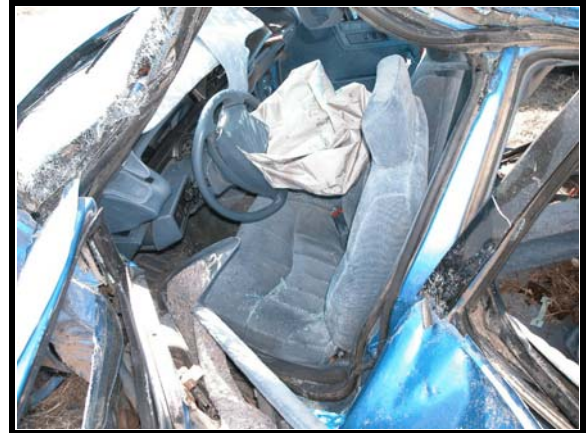
Interior damage to the Oldsmobile Cutlass was significant and was attributed to occupant contact and passenger compartment intrusion. The windshield was fractured damage from impact forces. All side glass on the left side was disintegrated. Both left side doors had been jammed shut but were pried open by rescue personnel. There was intrusion into the front seating area from the instrument panel and toe pan. There was intrusion into the rear seating area as the result of a rear seat back failure. There were blood patterns found on the right C pillar, the left and right sides of the rear seat, and the driver's air bag. The front seat backs were deformed forward. The steering wheel was deformed 9.0 cm (3.5 in) forward.

Figure 8. Driver's seated position

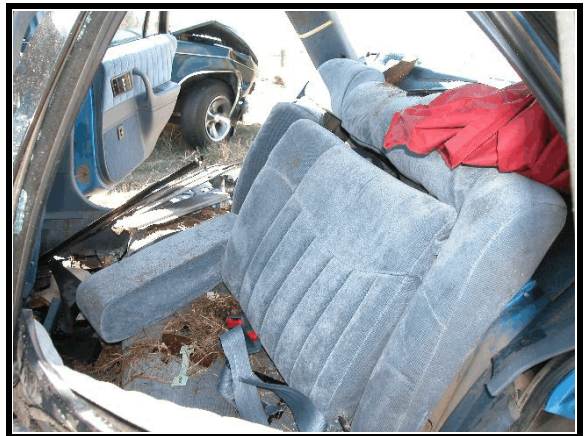
Figure 9. Lateral view of rear seat

Both halves of the rear bench seat back and the rear center fold-down arm failed due to loading from the trunk area. The bottoms of the two seat backs are held in place by metal pins that are inserted into holes at the center and at both outboard ends—forming a hinge. In normal operation, the seat rotates about the left and right hinges as this seat is folded down to allow access to the trunk area. At impact, the seat backs were loaded from materials in the trunk and forced forward. This forced the pins out of the respective holes at the left, middle left, and middle right positions (as seen facing toward the front of the vehicle). The right pin remained in place. The trunk lid was jammed shut but the materials in the trunk as viewed from the inside of the vehicle rearward consisted of two soft luggage bags and a bag containing travel materials (i.e., hair dryer, cosmetics, etc.). None of the bags appear to weigh more than 23 kg (50 lbs) as they were moved about by this investigator.

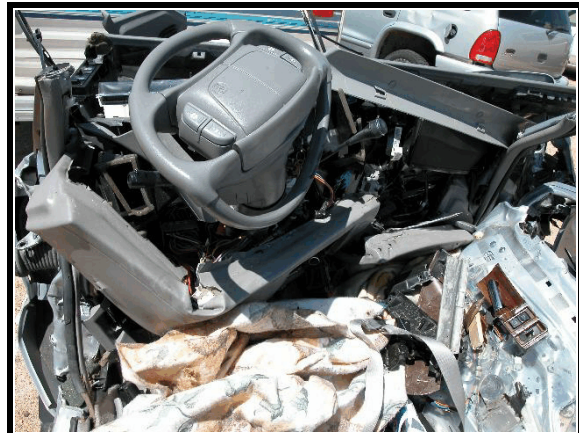
Figure 21. Overview of front seat area (1997 Buick LeSabre)

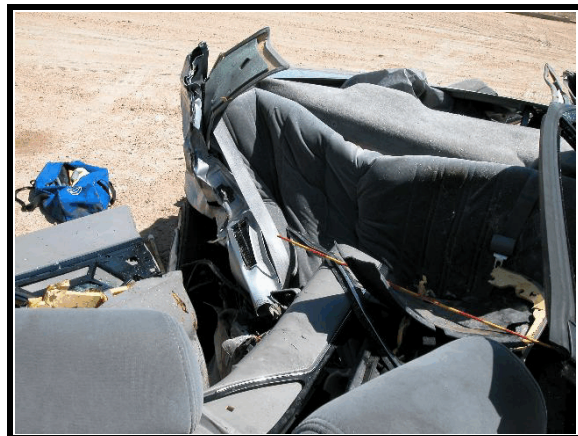
Figure 22. Overview of rear seat area (1997 Buick LeSabre)

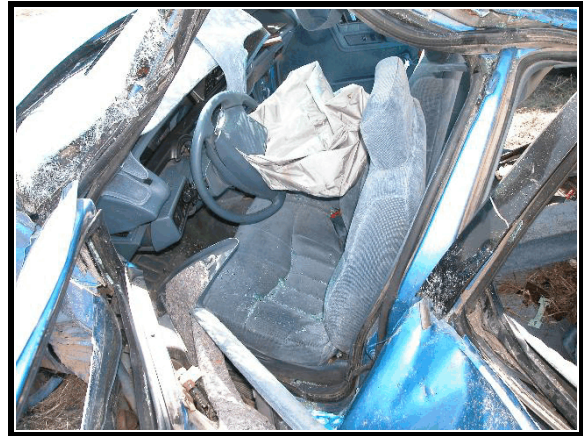
The 26-year-old female driver of the Oldsmobile was seated in a normal, upright fashion on the fabric covered 60/40 split bench seat. She was wearing the automatic three point lap and shoulder belt system. Prior to impact, the driver was braking with her right foot. Her left foot was on the floor board. Both hands were likely on the steering wheel. This occupant pitched forward and likely began to load the shoulder harness as she braked. The Oldsmobile struck the right side of the Buick. The impact was sufficient to deploy the driver's air bag. The driver's head and torso engaged the deployed air bag. The steering wheel rim was deformed by occupant loading. The driver pitched forward sharply at impact loading the shoulder belt and causing the upper chest abrasions. The driver's head pitched forward over the shoulder belt causing a hangman's fracture at C2. The driver sustained fractures to both ankles; the right while in contact with the brake pedal, the left while in contact with the floor pan.

Figure 23. Driver's seated position

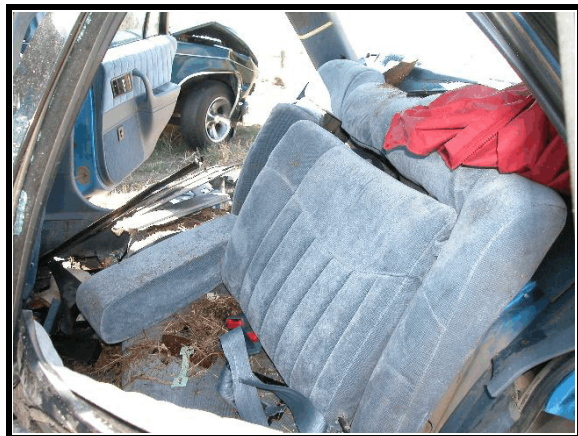
Figure 24. Overview of rear seating area

The rear left seat was occupied by a 3-year-old female who was seated in a Century Breverra Premier booster seat (see Attachment 3). It is not known if the child met the height and requirements, though she would likely be nearer to the upper end of the usage range given her age. The harness was threaded through the lower harness slots. At some point in the past the harness had been removed and then re-threaded incorrectly. The hip harness slots were bypassed, essentially converting the seat from a 5-point restraint to a 3-point restraint. The crotch strap is connected to the seat structure using a metal bar that is attached to the base of the seat. At impact, the rear left seat occupant loaded the crotch strap and it failed at the webbing. This occupant sustained abrasions to the chest, abdomen, and vulva as the child seat harness was initially loaded. As the harness failed, this occupant pitched out of the child seat and struck the rear of the driver's seat causing the multiple head and brain injuries which were ultimately fatal.

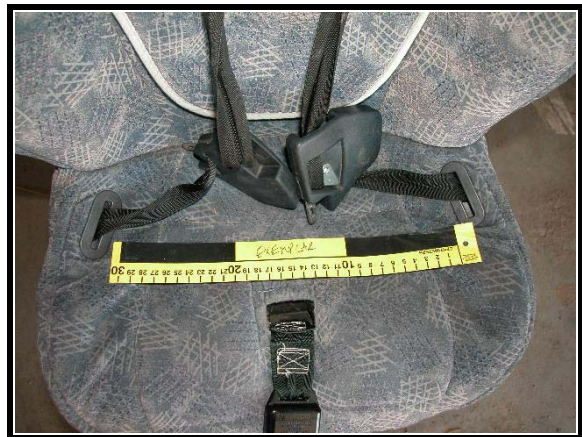
Figure 28. Exemplar seat with upper thigh harness in place
