**CALSPAN ON-SITE ADVANCED OCCUPANT PROTECTION SYSTEM  
CRASH INVESTIGATION**

**CASE NO: CA04-007**

**VEHICLE: 2004 LEXUS LS430**

**CRASH DATE: FEBRUARY 2004**

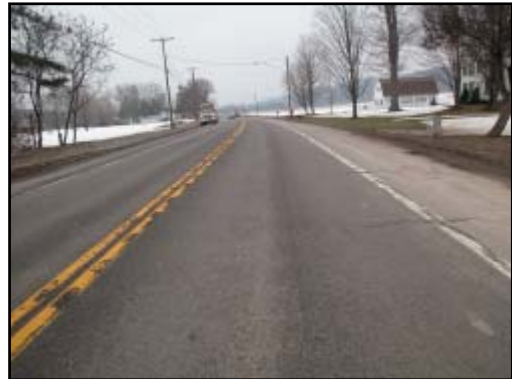
**Figure 3. Northbound approach for the 2004 Lexus LS430**

The 34-year-old driver of the Lexus LS430 was operating the vehicle in a northbound direction on the state roadway. The driver stated in a brief interview that he mistakenly ingested a sleeping pill earlier in the day and was feeling fatigued prior to the crash. The front right passenger and rear right passengers were both sleeping prior to the crash. The driver fell asleep and relinquished control of the vehicle prior to the left curve. As the Lexus reached the left curve in the roadway, the vehicle continued its straight trajectory and departed the northbound travel lane. The Lexus continued onto the right asphalt shoulder and subsequently onto the right roadside in a tracking mode. It was not known if the Pre-Collision System activated as the Lexus approached the utility pole.

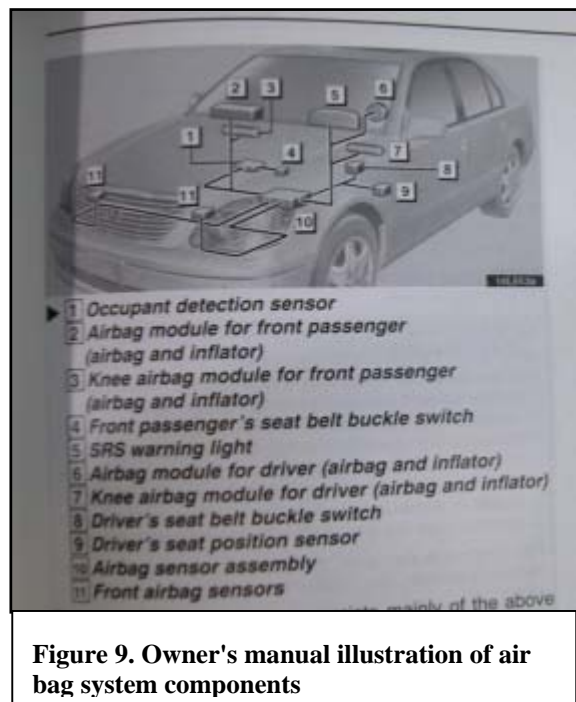
**Figure 9. Owner's manual illustration of air bag system components**

The dual-stage frontal air bag system deployed as a result of the utility pole impact. During the vehicle inspection, the ignition switch was activated and the air bag light on the instrument panel was constantly illuminated. **Figure 9**, from the vehicle's owner's manual, illustrates the air bag system components. Two air bag sensors were located on the outboard aspects of the upper radiator support area. Additional system components included a driver's seat track position sensor, a front right occupant detection sensor, driver's and front right passenger's buckle switches, and the safety belt pretensioner assemblies.

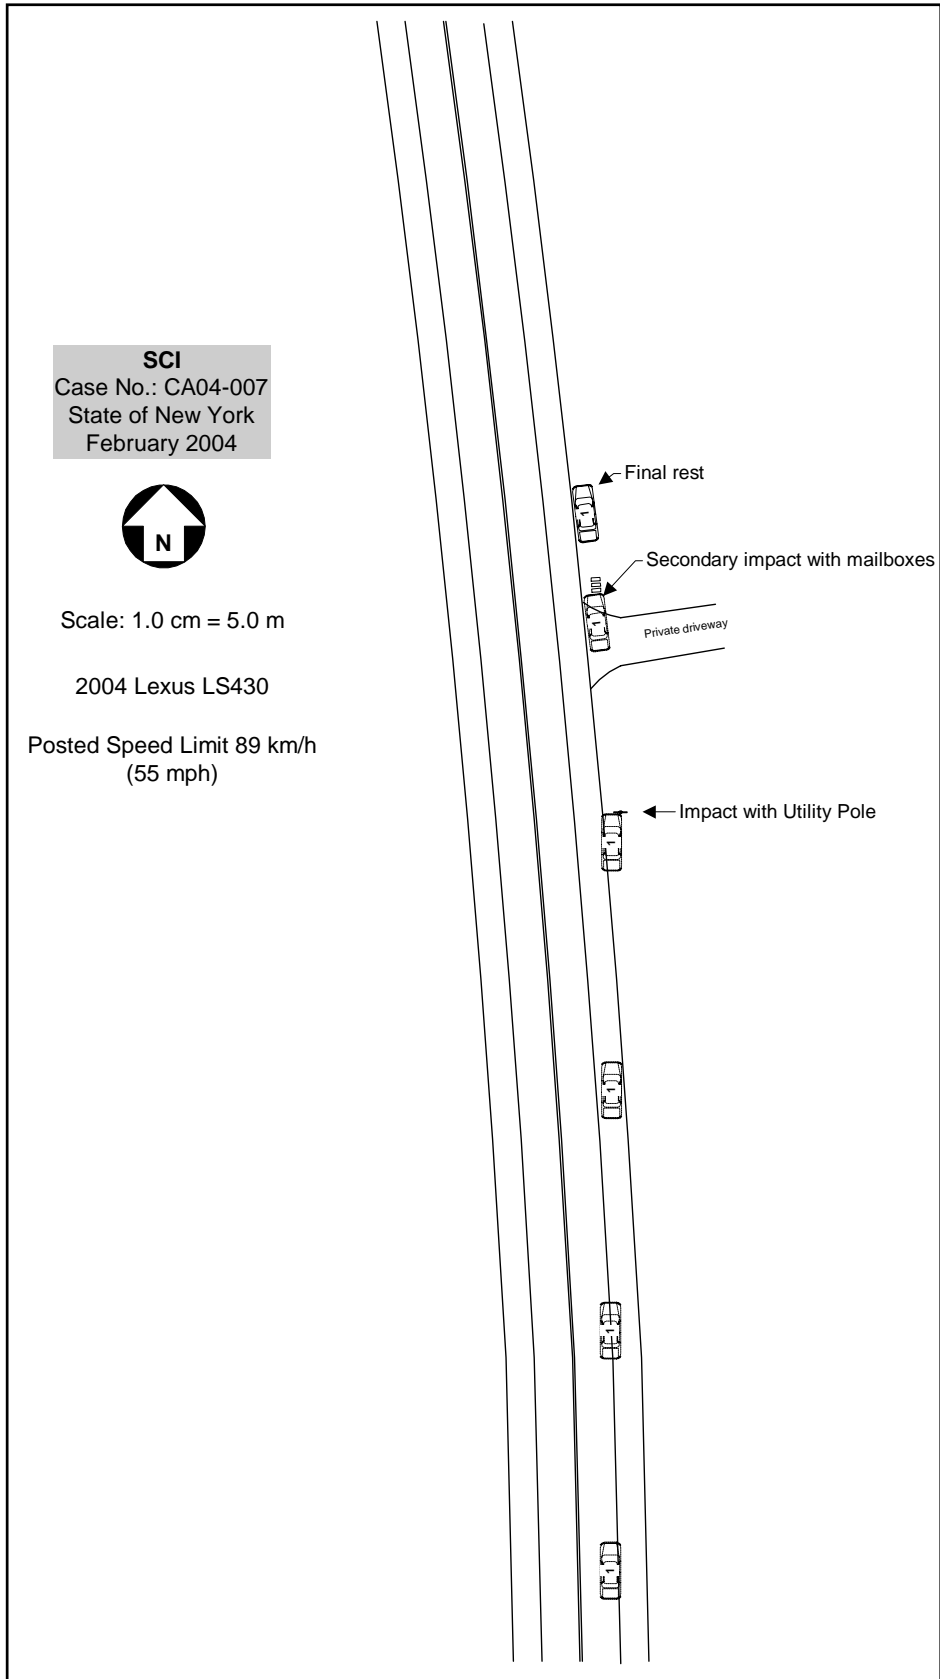
Figure 14. Scene schematic.

This single-vehicle crash occurred during the daylight hours of February 2004 in the state of New York. At the time of the crash, there were no adverse weather conditions and the asphalt roadway surface was dry. The crash occurred on a curved section of a two-lane, north/south state roadway. The roadway was configured with one travel lane in each direction, separated by a double-yellow centerline and bordered by asphalt shoulders that measured 2.6 m (8.5') in width. The roadway was level and exhibited a northbound left curve with a radius of curvature of 2.02 degrees. The rural roadway environment consisted of fields and houses. Utility poles were present on both sides of the roadway. A private asphalt driveway was present on the east side of the roadway 13.4 m (44.0') north of the struck utility pole (**Figure 2**). Private mailboxes were present on the north aspect of the driveway at the road edge. The posted speed limit for the roadway was 89 km/h (55 mph). The scene schematic is included as **Figure 14** of this narrative report.
