Hybrid Vehicle Investigation / Vehicle to Object  
Dynamic Science, Inc. / Case Number: DS04013  
2004 Honda Civic Hybrid  
California  
April, 2004

1. Report No. DS04013	2. Government Accession No.	3. Recipient Catalog No.	
4. Title and Subtitle  On Site Hybrid Vehicle Investigation		5. Report Date August 12, 2005

**Dynamic Science, Inc.**  
**Crash Investigation**  
**Case Number: DS04013**

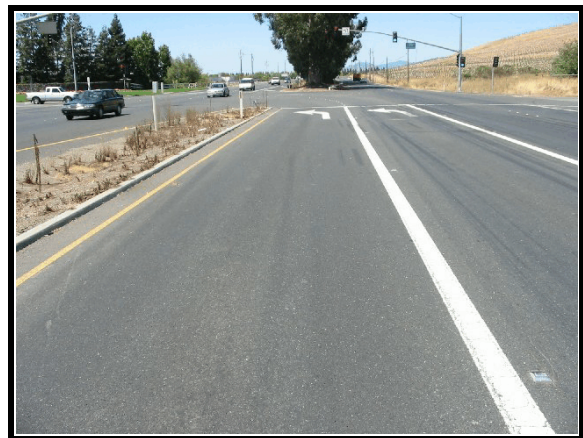
**Figure 2.** Approach to area of impact (north)

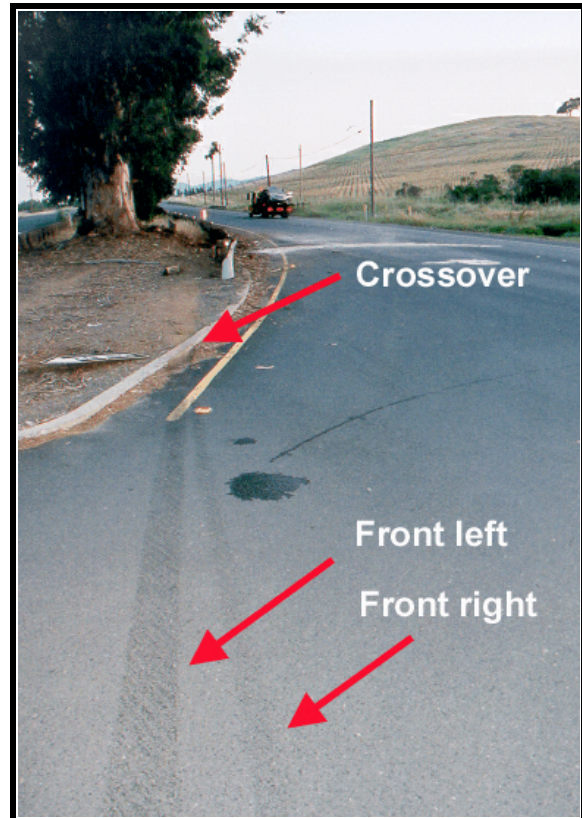
**Figure 3.** Approach to impact area. Vehicle in clockwise rotation, front tires cross and vehicle is at a 90 degree angle.

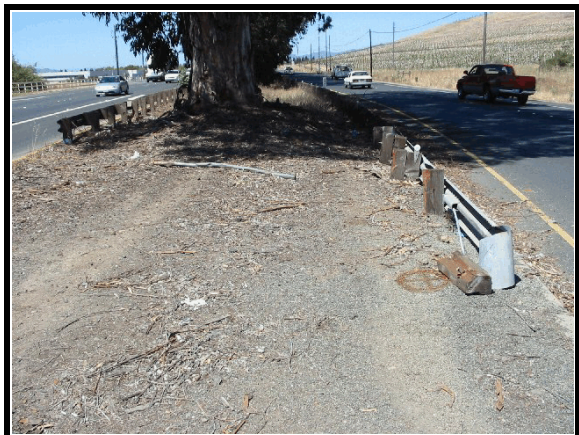
**Figure 4.** Area of guardrail and tree impact (north)

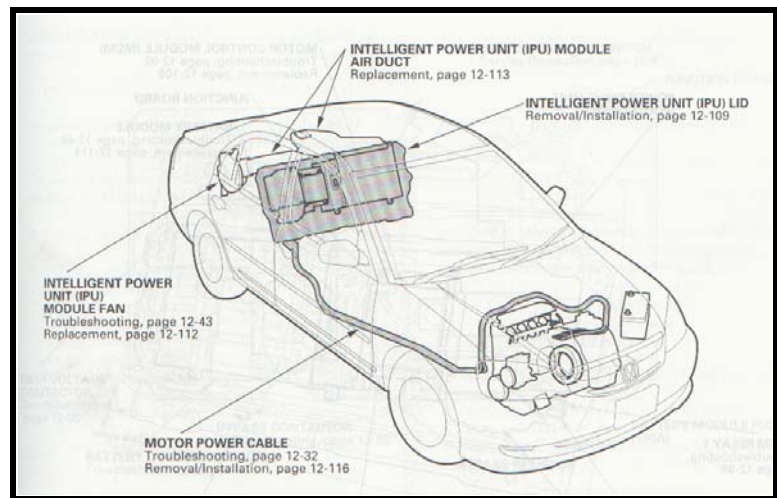
**Figure 15.** Overview, IMA system

This area of the vehicle could not be accessed and the test was not completed. There were no indications of any damage to the high voltage cables.
