**GENERAL DYNAMICS ON-SITE CERTIFIED ADVANCED-208 COMPLIANT  
VEHICLE CRASH INVESTIGATION**

**SCI CASE NO. – CA04-013**

**SUBJECT VEHICLE – 2003 CHEVROLET AVALANCHE**

**CRASH DATE – FEBRUARY 2004**

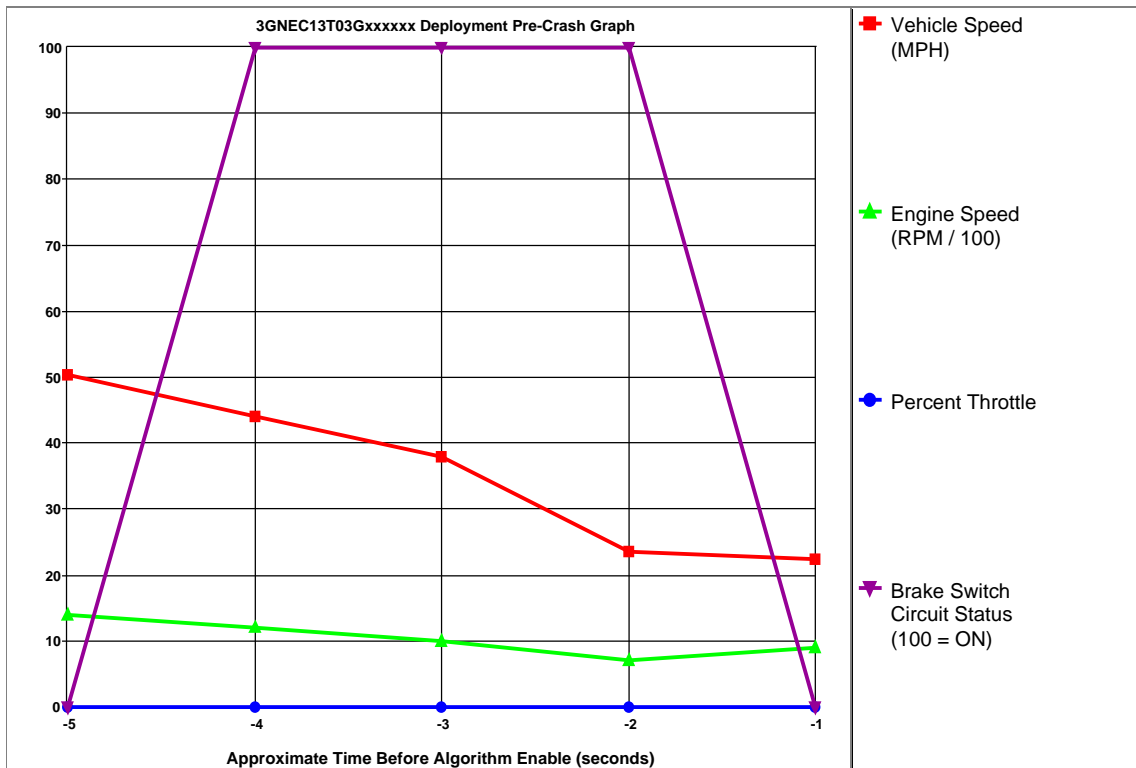
SIR Warning Lamp Status	OFF
Driver's Belt Switch Circuit Status	UNBUCKLED
Ignition Cycles At Deployment	2335
Ignition Cycles At Investigation	2350
Maximum SDM Recorded Velocity Change (MPH)	-16.30
Algorithm Enable to Maximum SDM Recorded Velocity Change (msec)	167.5
Driver First Stage Time Algorithm Enabled to Deployment Command Criteria Met (msec)	25
Driver Second Stage Time Algorithm Enabled to Deployment Command Criteria Met (msec)	N/A
Passenger First Stage Time Algorithm Enabled to Deployment Command Criteria Met (msec)	25
Passenger Second Stage Time Algorithm Enabled to Deployment Command Criteria Met (msec)	N/A
Time Between Non-Deployment And Deployment Events (sec)	1.8
Frontal Deployment Level Event Counter	1
Event Recording Complete	Yes
Multiple Events Associated With This Record	Yes
One Or More Associated Events Not Recorded	No

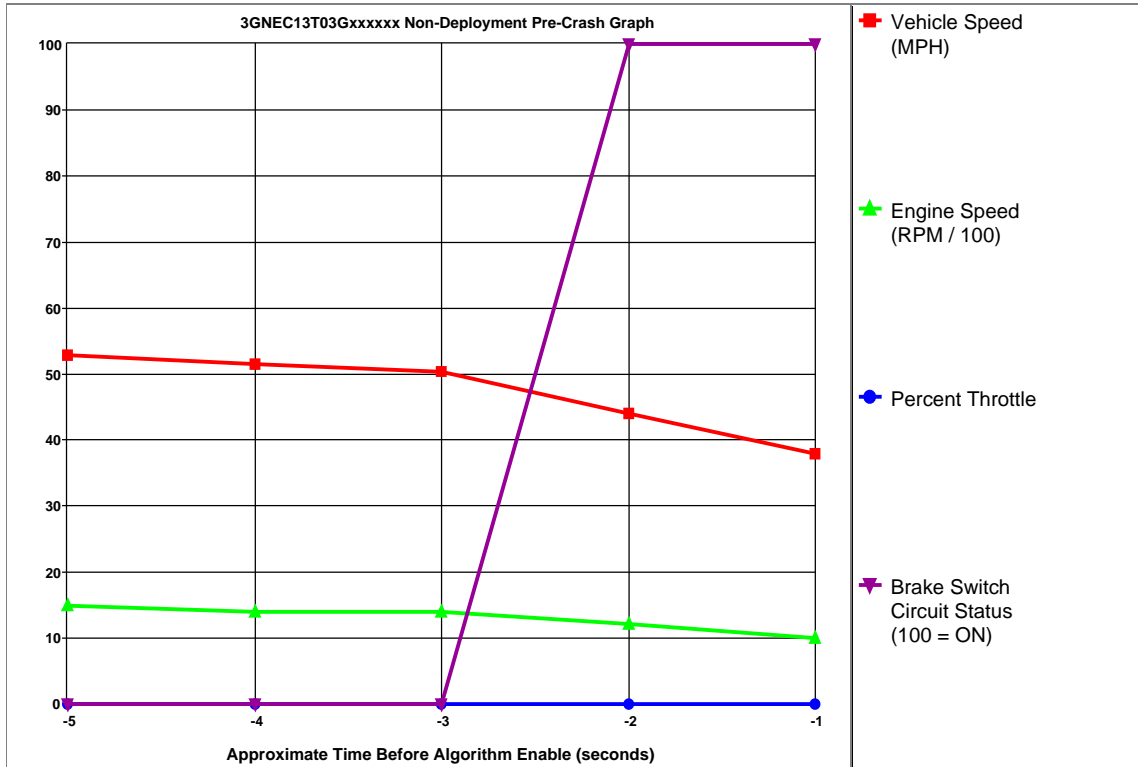
SIR Warning Lamp Status	OFF
Driver's Belt Switch Circuit Status	UNBUCKLED
Ignition Cycles At Non-Deployment	2335
Ignition Cycles At Investigation	2350
Maximum SDM Recorded Velocity Change (MPH)	-2.56
Algorithm Enable to Maximum SDM Recorded Velocity Change (msec)	140
Event Recording Complete	Yes
Multiple Events Associated With This Record	No
One Or More Associated Events Not Recorded	No
