Side Air Curtain Investigation/ Vehicle to Vehicle
Dynamic Science, Inc. / Case Number: DS04022
2004 Saturn Vue Sport Utility Vehicle
Colorado
November, 2004

1. Report No. DS04022	2. Government Accession No.		3. Recipient Catalog No.	
4. Title and Subtitle Side Air Curtain Investigation			5. Report Date April 10, 2006

Dynamic Science, Inc.
Crash Investigation
Case Number: DS04022

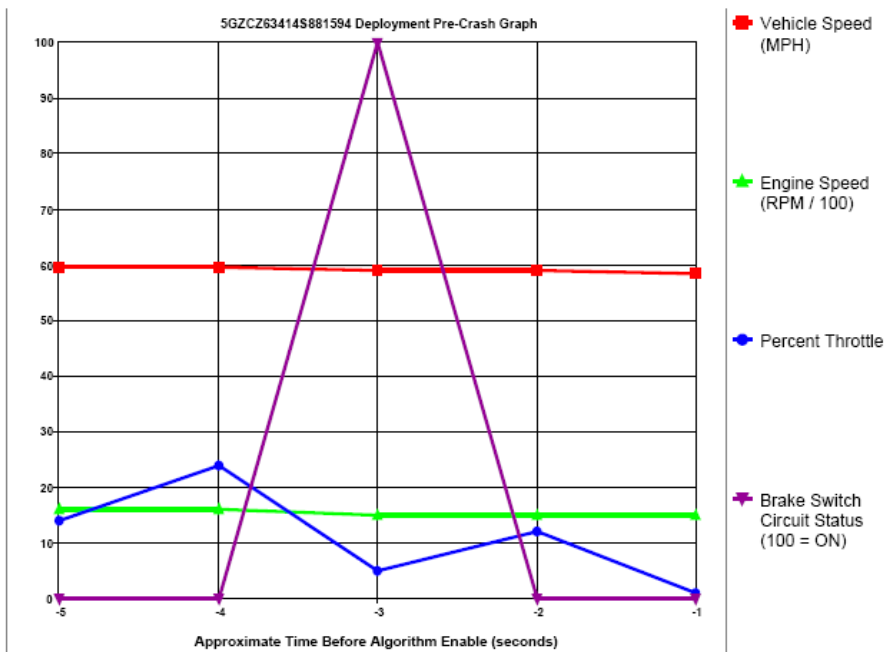
Attachment 2. Vetronix output

SIR Warning Lamp Status	OFF
Driver's Belt Switch Circuit Status	BUCKLED
Ignition Cycles At Deployment	1016
Ignition Cycles At Investigation	1017
Maximum SDM Recorded Velocity Change (MPH)	-31.43
Algorithm Enable to Maximum SDM Recorded Velocity Change (msec)	107.5
Driver First Stage Time Algorithm Enabled to Deployment Command Criteria Met (msec)	7.5
Driver Second Stage Time Algorithm Enabled to Deployment Command Criteria Met (msec)	10
Passenger First Stage Time Algorithm Enabled to Deployment Command Criteria Met (msec)	7.5
Passenger Second Stage Time Algorithm Enabled to Deployment Command Criteria Met (msec)	10
Event Recording Complete	Yes

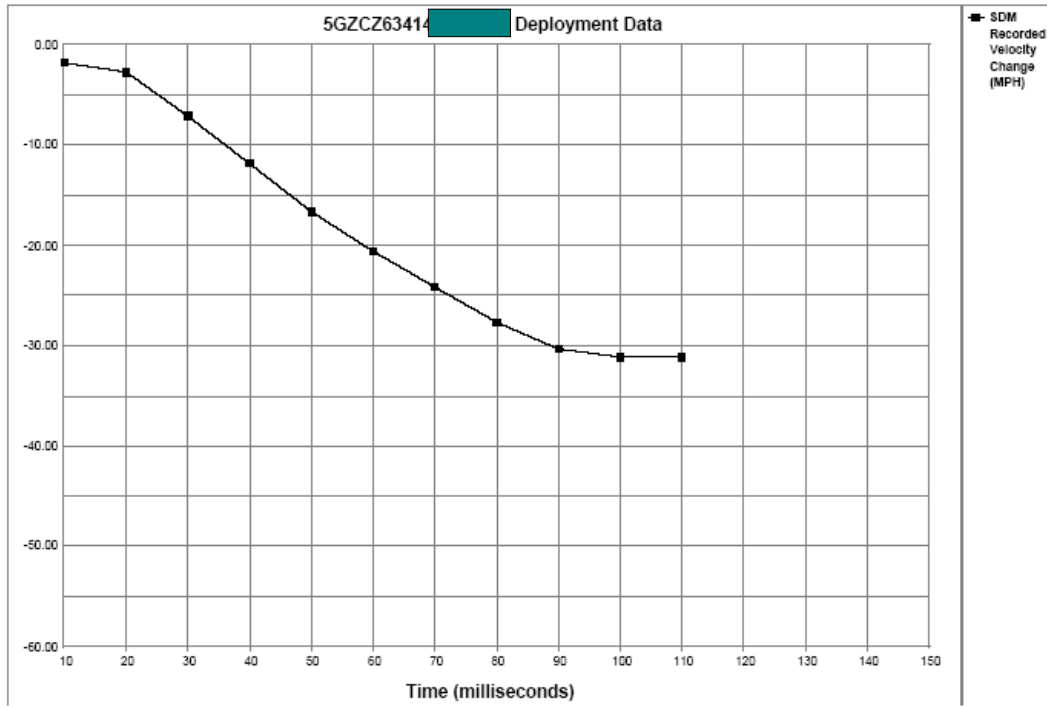
Time (milliseconds)	10	20	30	40	50	60	70	80	90	100	110	120	130	140	150
SDM Recorded Velocity Change	-1.76	-2.63	-7.02	-11.85	-16.67	-20.62	-24.13	-27.84	-30.28	-31.15	-31.15	N/A	N/A	N/A	N/A
