## ON-SITE SIDE IMPACT INFLATABLE OCCUPANT PROTECTION INVESTIGATION

CASE NUMBER - IN-04-026

VEHICLE - 2002 LEXUS IS 300

CRASH DATE - May 2004

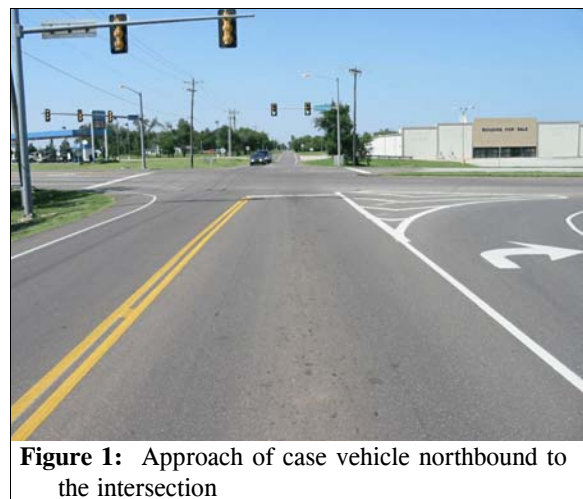
**Figure 1:** Approach of case vehicle northbound to the intersection

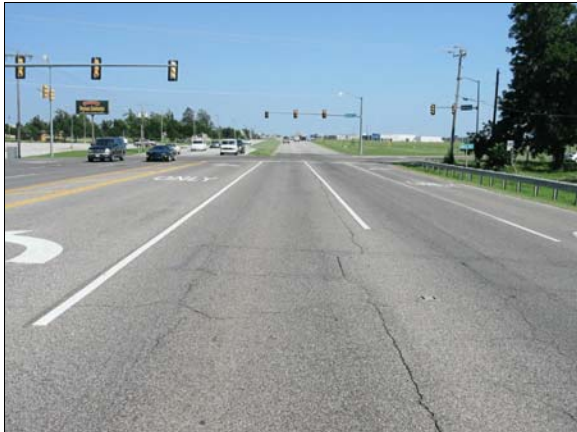
**Figure 2:** Approach of the Lexus LX 470 to the intersection, eastbound in the inside through lane

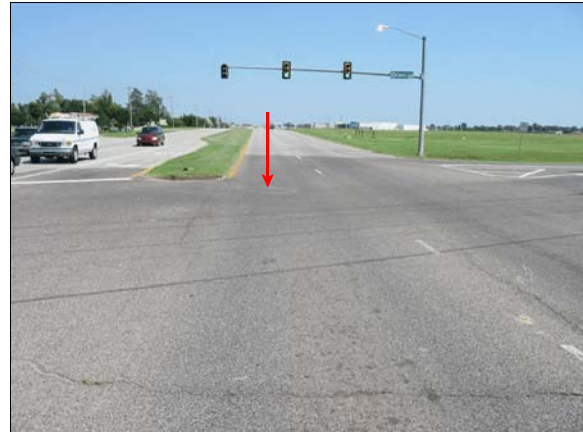
**Figure 3:** Overview of area of impact (arrow) from eastbound inside lane (approach of Lexus LX 470)

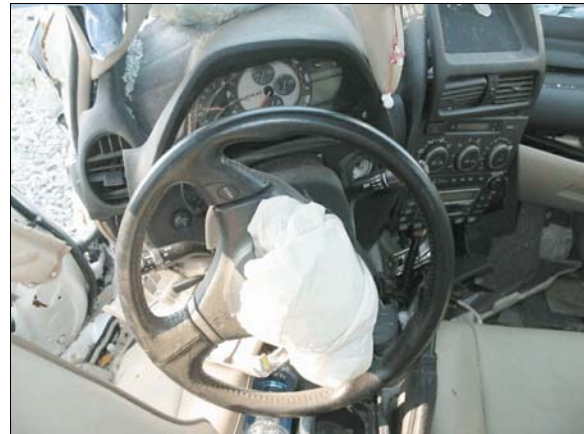
The case vehicle's driver air bag was located in the steering wheel hub. An inspection of the air bag module cover flaps and the air bag fabric revealed that the cover flaps opened at the designated tear points (**Figure 14** above and **Figure 15**). There was no evidence of damage during the deployment to the air bag module cover flaps or the air bag material. The air bag module cover consisted of three irregularly shaped cover flaps, each constructed of vinyl. The upper module cover flap was approximately 15 centimeters

**Figure 15:** Case vehicle's steering wheel, lower left air bag module flap and air bag, steering wheel rotated right about 90 degrees

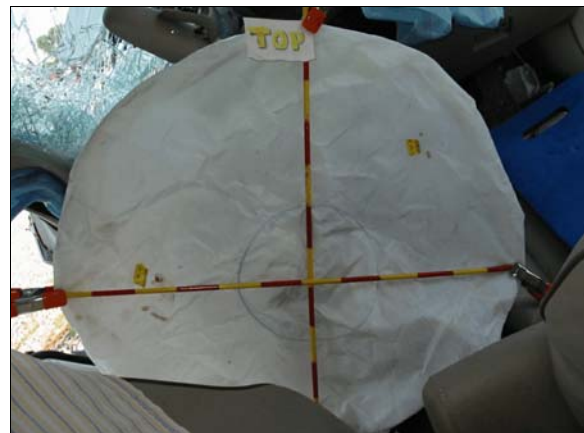
**Figure 16:** Case vehicle's driver air bag, camera rotated right to align with top of steering wheel

(5.9 inches) in width with a semi-circular center section that joined at the tear seam with two lower flaps, each 9 centimeters (3.5 inches) in width at their widest point. The deployed driver's air bag (**Figure 16** above) was round with a diameter of about 60 centimeters (23.6 inches). The air bag was designed with two tethers, each approximately 11 centimeters (4.3 inches) in width and had two vent ports (**Figure 17** above), each approximately 3 centimeters (1.2 inches) in diameter, located at about the 10 and 2 o'clock positions.

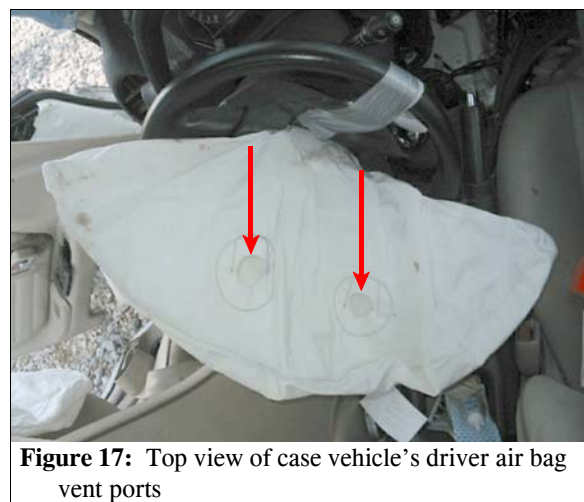
**Figure 17:** Top view of case vehicle's driver air bag vent ports

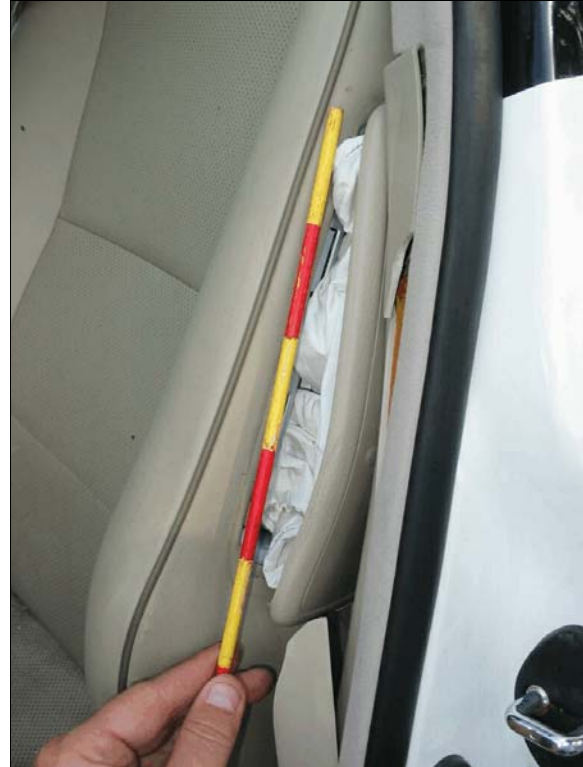
The case vehicle driver's seat back-mounted side impact air bag was located in the left side of the driver's seat back. Inspection of the seat back showed that the air bag module cover flap opened at its designated tear points, and there was no evidence of damage during the deployment to the air bag material or the cover flap. The cover flap (**Figure 18**) was rectangular in shape, constructed of vinyl and was 25.5 centimeters (10 inches) in height and 11 centimeters (4.3 inches) in width. The deployed seat-back mounted side impact air bag (**Figure 19**) was approximately 36 centimeters (14.2 inches) in width and 26 centimeters (10.2 inches) in height. No vent ports or tether straps were visible on the air bag.

**Figure 18:** Case vehicle driver's seat-mounted side air bag module flap; each increment on rod is 5 cm (2 in)

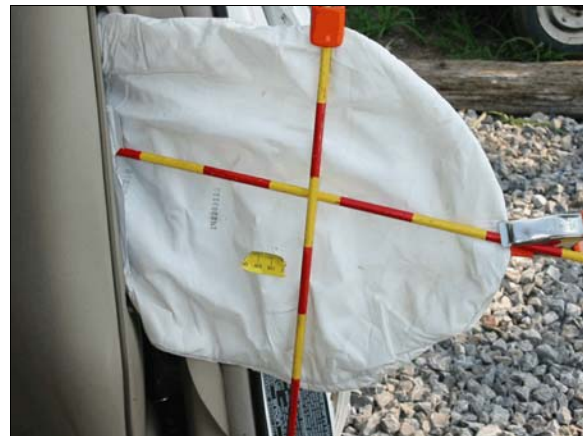
**Figure 19:** Case vehicle driver's seat-mounted side air bag

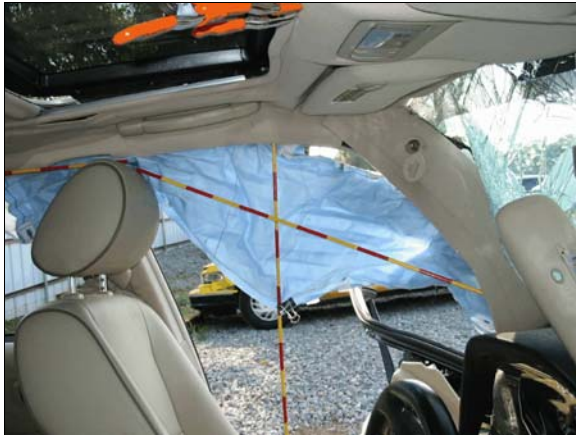
The case vehicle driver's side curtain air bag was located in the left roof side rail and "A"-pillar (**Figure 20** below). Inspection of the air bag revealed no evidence of damage to the air bag during the deployment. However, the evidence indicates the rear portion of the side curtain air bag was obstructed during its deployment by the driver's head restraint (**Figure 21** below), due to the outward (i.e., to the left) displacement of the driver's seat during the impact. The intrusion of the left front sill and floor pan tilted the driver's seat outward and completely closed the space between the B-pillar and the head restraint (**Figure 21** below). The displaced head restraint obstructed the deployment of the driver's side curtain air bag preventing it from fully extending down between the B-pillar and the driver's seat back (**Figure 22** below). The deployment of the side curtain air bag was obstructed to the extent that the air bag's rear anchor strap was prevented from fully deploying and separating from its rear two ties (**Figure 23** below), and the air bag bunched-up on top of the head restraint. The inflatable portion of the driver's side curtain air bag was approximately 88 centimeters (34.6 inches) in

**Figure 20:** Overview of case vehicle driver's side curtain air bag

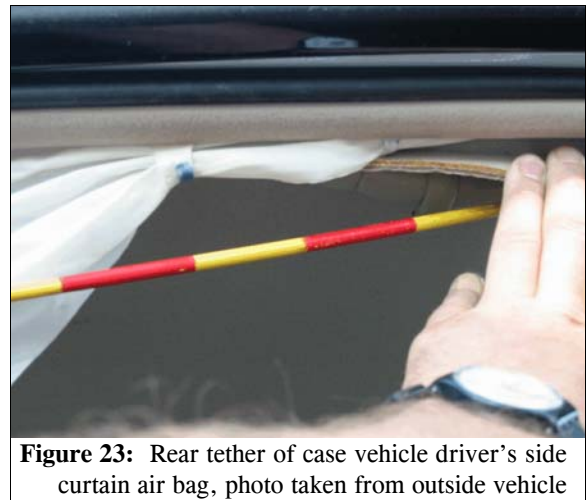
**Figure 23:** Rear tether of case vehicle driver's side curtain air bag, photo taken from outside vehicle

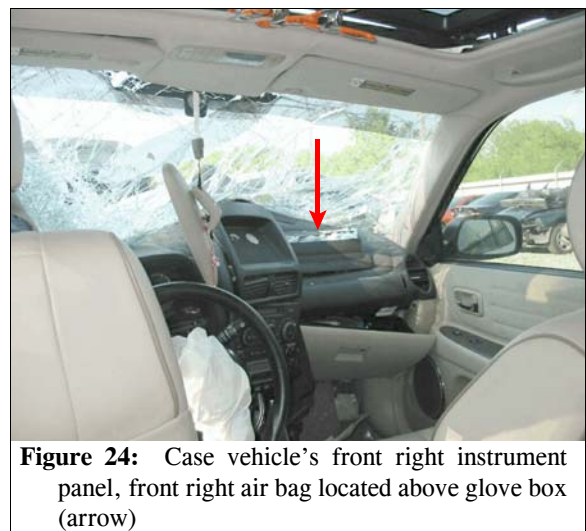
The front right passenger's air bag was located in the top of the instrument panel (**Figure 24**). Inspection of the air bag module cover flaps and the air bag fabric revealed that the cover flaps opened at the designated tear points. There was no evidence of damage during the deployment to the module cover flaps (**Figure 25** below) or the air bag material. However, several water stains were observed on the air bag material as a result of the vehicle being stored outdoors. The air bag module cover flaps were rectangular in shape and constructed of pliable vinyl. The upper module cover flap was 26 centimeters (10.2 inches) in width and 5 centimeters (2 inches) in height. The lower module cover flap was 26 centimeters (10.2

**Figure 24:** Case vehicle's front right instrument panel, front right air bag located above glove box (arrow)

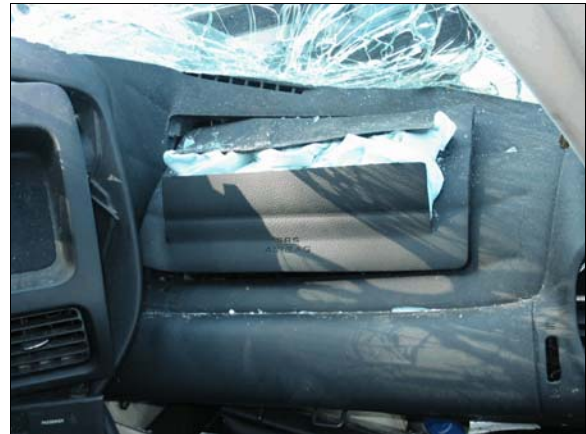
**Figure 25:** Case vehicle's front right air bag module flaps

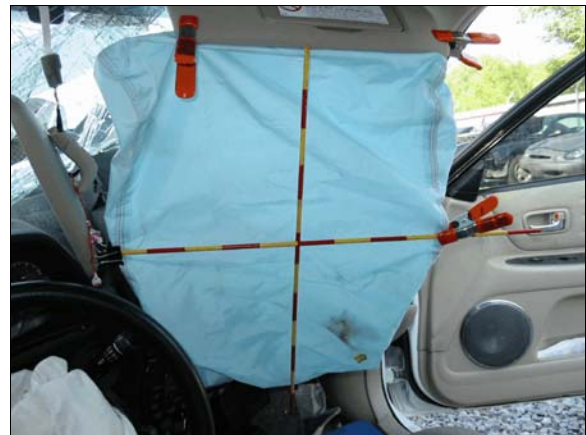
inches) in width and 6 centimeters (2.4 inches) in height. The deployed front right passenger air bag (**Figure 26**) was rectangular in shape and was approximately 60 centimeters (23.6 inches) in height and approximately 45 centimeters (17.7 inches) in width. The air bag was designed without tethers but had two vent ports, each approximately 6.5 centimeters (2.6 inches) in diameter located at approximately the 9 and 3 o'clock positions.

**Figure 26:** Case vehicle's front right air bag; each stripe on the rods is five centimeters (two inches)

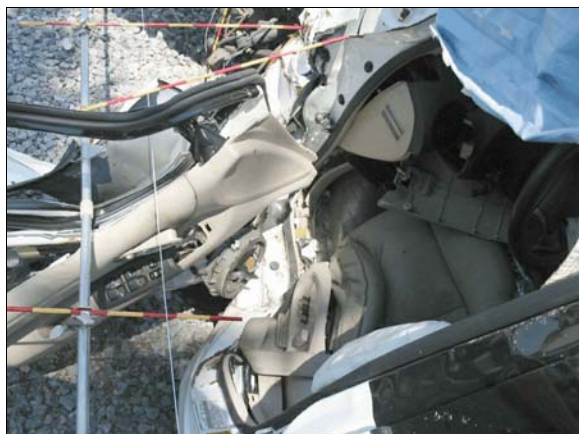
The case vehicle's first impact with the Lexus LX 470 caused the driver to continue forward and move to the left along a path opposite the case vehicle's 300 degree direction of principal force as the case vehicle decelerated longitudinally and accelerated latterly to the right. The driver loaded her safety belt causing an abrasion to her left chest and contusions across her hips. Her right thigh contacted the steering wheel bruising the thigh. Her right knee and shin contacted the knee bolster bruising the knee and shin. Her left upper torso contacted her deployed seat-back mounted side impact air bag causing superficial abrasions to her left upper arm and elbow and superficial lacerations to her left upper arm. The driver's left upper arm also contacted the left front door fracturing her upper arm. Her left thigh and shin contacted the left front door bruising the thigh and shin. The impact broke out the driver's door window glass, and the flying glass caused multiple lacerations to her face. As the front of the LX 470 crushed the driver's door to maximum engagement and the vehicle's rotated, the driver's head passed under her deployed side curtain air bag, through the driver's door window and contacted the LX 470's right fender and radio antenna base. The driver's head contact dented the fender and left a deposit of the driver's hair on the antenna base (**Figure 29**). The contact to the fender crushed the driver's skull and bruised her left eye and fractured her neck. In addition, she lacerated her larynx on the left front window sill. The driver's side curtain air bag was prevented from fully deploying as the driver's seat rotated outward (i.e., to the left) during the impact due to the crush of the driver's sill and floor pan. The space between the seat back and the "B" pillar was completely closed off, and the driver's head restraint blocked the full deployment of the driver's side curtain air bag. Following the initial impact, the driver most likely rebounded off the door to some degree, and the subsequent side-slap impact caused her to move to the left along a path opposite the case vehicle's 270 degree direction of principal force, and she most likely impacted her door again (**Figure 30** and **Figure 31** below).

**Figure 31:** Top view of driver’s door and driver’s seat

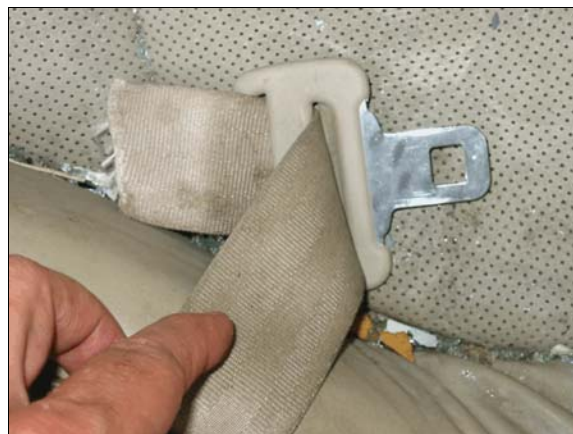
The driver then moved rearward into her seat back as the back of the case vehicle impacted the right rear corner of the LX 470. The case vehicle’s driver remained restrained in her seat as the case vehicle traveled to its final rest position She had to be extricated from her vehicle. Rescue personnel pried the case vehicle’s left front door open, cut the driver’s safety belt (**Figure 32**), and removed her from the case vehicle.

**Figure 32:** Case vehicle driver’s seat belt has been cut in two

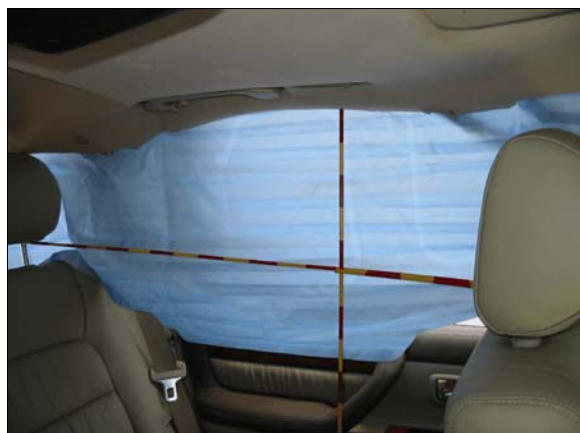
**Figure 33:** Back section of left side curtain air bag, each increment on rods is 5 centimeters (2 inches)
