CALSPAN ON-SITE FORD CVPI SEVERE REAR CRASH INVESTIGATION

CASE NO: CA04-037

VEHICLE: 2003 FORD CROWN VICTORIA POLICE INTERCEPTOR

CRASH DATE: AUGUST 2004

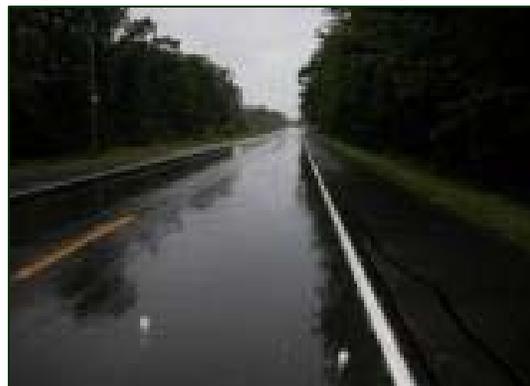
This crash occurred on a two-lane state route during nighttime hours (**Figure 2**). At the time of the crash, the conditions were dark and overcast with visibility estimated at 0.8 km (0.5 miles). The north/south asphalt roadway consisted of two travel lanes that were bordered by 2.7 m (8.9') wide paved

Figure 2. Overall view of the crash site.

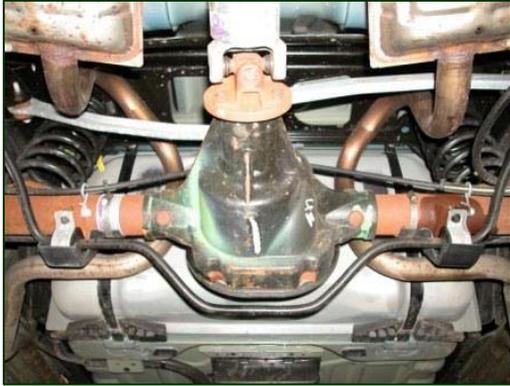
Figure 14. Exemplar CVPI without FirePanel.

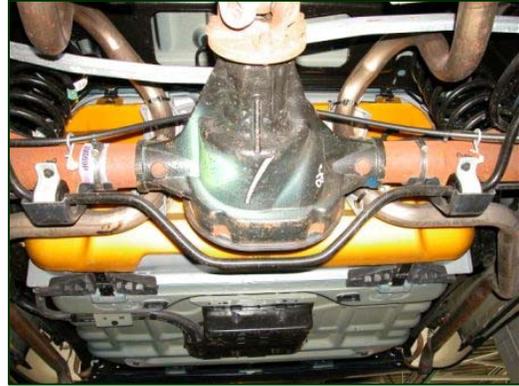
Figure 15. Exemplar CVPI with FirePanel installed.

The panel was designed to fracture when crushed against the tailpipes and the differential of the CVPI. This fracturing disbursts the fire retardant, which suppresses ignition in the event of a fuel leakage. Exemplar vehicles with and without a FirePanel are illustrated in **Figures 14 and 15**. Below in **Figure 17** is a comparison between an exemplar and the damaged FirePanel.

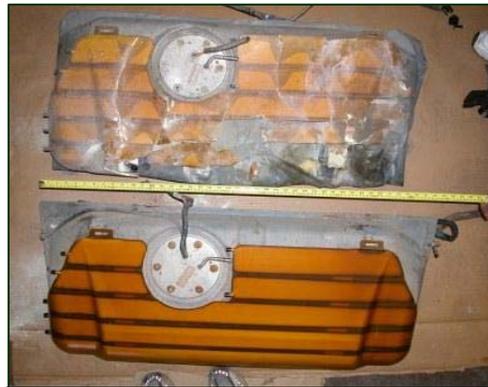
Figure 17. Exemplar FirePanel.

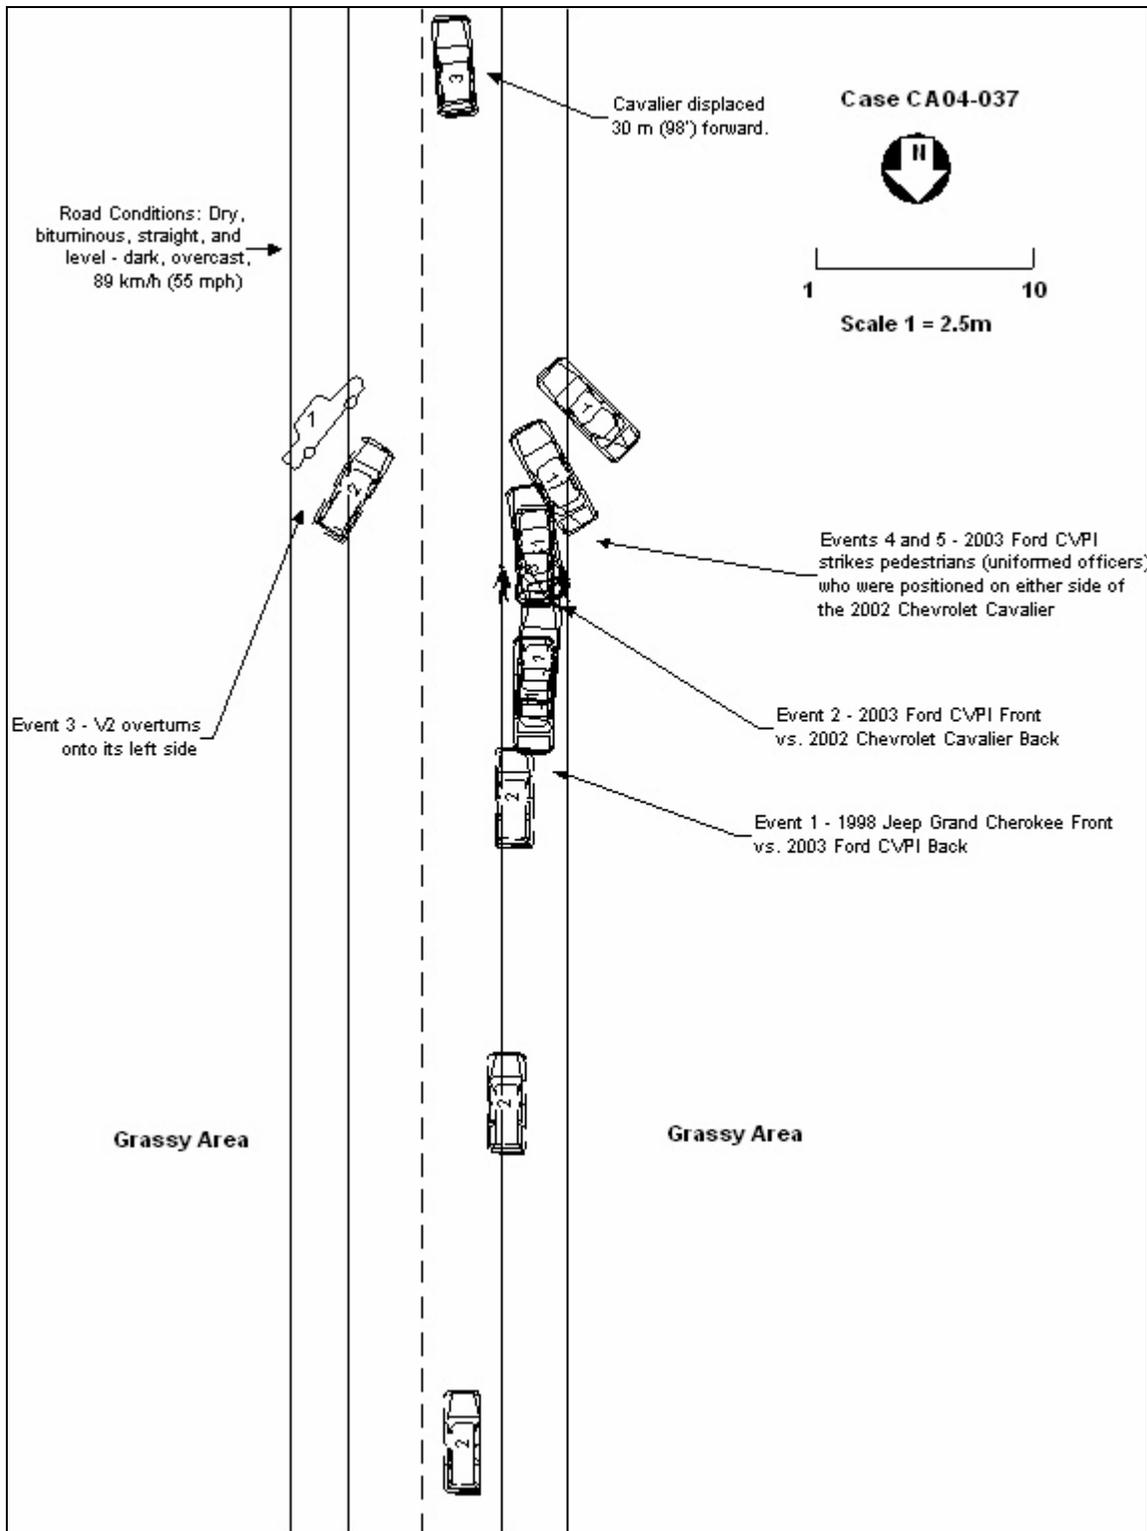
Figure 18. Scene Schematic

shoulders. A broken yellow centerline and solid white lane lines delineated the road. Adjacent to both shoulders was grass and a tree line. In the vicinity of the crash site, the roadway was straight and level. The posted speed limit was 89 km/h (55 mph). At the time of the SCI investigation, the physical evidence had eroded, or was masked by the wet environmental conditions. The scene schematic is included with this report as **Figure 18**.
