Child Safety Seat Investigation / Vehicle to Vehicle
Dynamic Science, Inc. / Case Number: DS05003
1991 Toyota Corolla
California
February, 2005

1. Report No. DS05003	2. Government Accession No.		3. Recipient Catalog No.	
4. Title and Subtitle Child Safety Seat Investigation		5. Report Date April 19, 2006

**Dynamic Science, Inc.
Accident Investigation
Case Number: DS05003**

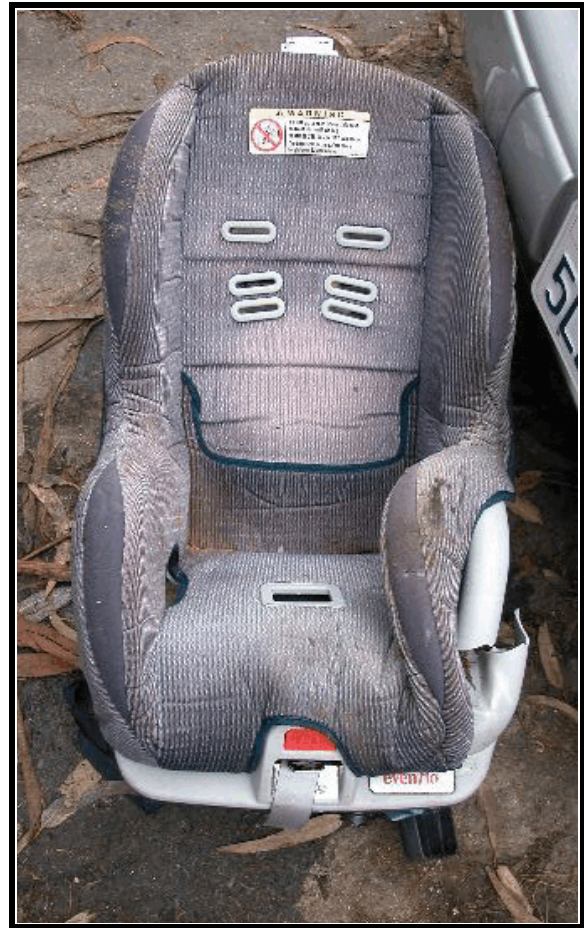
Figure 9. Evenflo Horizon convertible child safety seat

The Evenflo Horizon seat sustained considerable damage during the crash. The tray shield had been broken off at the seat back attachment points. There was a longitudinal fracture that begins at the front left and extends 15.5 cm (6.1 in) rearward into the rear facing belt path guide. The left side of the seat back had moved laterally to the right 3.0 cm (1.2 in). There were blood and hair transfers to the outer edge of the left portion of the tray shield. There was a fracture that ran from the forward facing belt path guide to the rear facing belt path guide. This was in an “L” configuration and measured 12.0 cm (4.7 in) vertically and 13.0 cm (5.1 in) laterally. There was a 14.0 cm (5.5 in) angled fracture in the seat bottom. The reclining base had been crushed

laterally and had broken away from its connection points. There was blood on both the top and bottom of the shield. There was also blood and hair transfers found on the outside portion of the left seat back. The crotch strap had been cut by emergency personnel 12.0 cm (4.7 in) from the attachment point.
