ON-SITE CHILD SAFETY SEAT INVESTIGATION

CASE NUMBER - IN-05-003

VEHICLE - 1999 HYUNDAI ELANTRA GL

CRASH DATE - December 2004

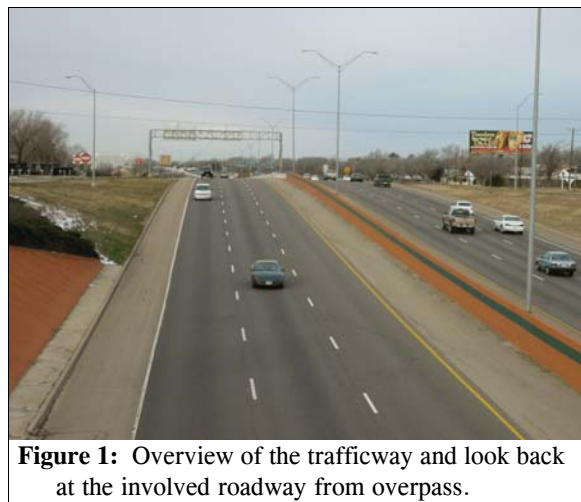
Crash Environment: The trafficway on which all vehicles were traveling was a straight, six-lane, divided Interstate highway (**Figure 1**), traversing in an east-west direction. Each travel direction contained three travel lanes bordered by wide inside and outside improved shoulders. Each travel lane was approximately 3.7 meters (12 feet) wide. Each shoulder was approximately 3.1 meters wide (10 feet). The trafficway was divided by a concrete median barrier. Roadway pavement markings consisted of broken white lane lines with solid white outside edge lines and solid yellow median edge lines. The roadway pavement was dry, travel polished bituminous with an estimated coefficient of friction of 0.70. The speed limit was 97 km.p.h. (60 m.p.h.), and the involved roadway had an approximate 4% negative grade. At the time of the crash the light condition was daylight and the atmospheric condition was clear.

Figure 1: Overview of the trafficway and look back at the involved roadway from overpass.

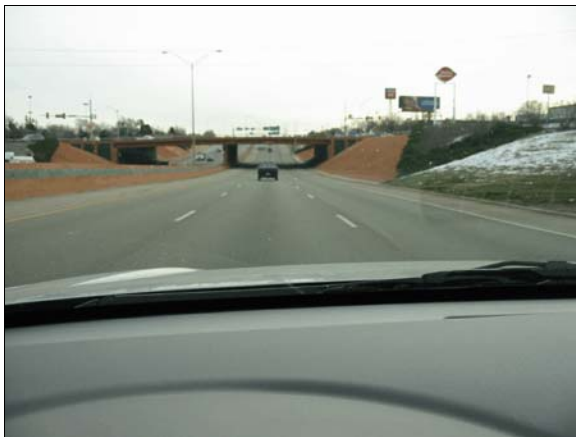
Pre-Crash: The case vehicle was traveling east in the center lane (**Figure 2**), and the driver was intending to continue straight ahead. The Freightliner was traveling east in the inside lane and was approaching the case vehicle. The Freightliner's driver was intending to continue straight ahead. The GMC was traveling east in the center lane in front of the case vehicle. The GMC's driver was intending to continue straight ahead. A non-contact vehicle was also traveling east in the center lane and was behind the case vehicle. According to the police crash report and a local newspaper article, a dog ran into the roadway from the right. Traffic in all three lanes began to slow and change lanes. The non-contact vehicle swerved left into the inside lane in front of the Freightliner. The Freightliner swerved to the right into the center lane to avoid the non-contact vehicle at the same time the case vehicle and GMC were braking hard for traffic slowing in front of them. The Freightliner began to close on the case vehicle. The crash occurred in the center lane of the roadway.

Figure 2: Approach of case vehicle and GMC eastbound in the center lane

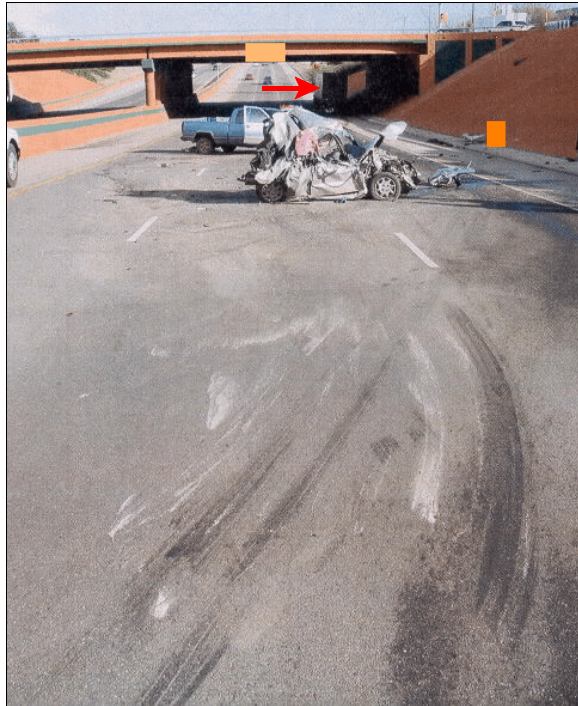
Post-Crash: The case vehicle rotated counterclockwise and came to rest partially across the center and outside travel lane facing south. The GMC rotated clockwise and came to rest in the center travel lane facing south with the back of the vehicle partially in the inside travel lane. The Freightliner continued east, pulled off the roadway and stopped on the outside shoulder (Figure 9 below).

Figure 9: View east to final rest position of case vehicle, GMC and Freightliner (arrow), impact tire marks and scratches on pavement in foreground
