Child Safety Seat Investigation/ Vehicle to Vehicle
Dynamic Science, Inc. / Case Number: DS05004
2000 Ford Expedition
California
March 2005

1. Report No. DS05004	2. Government Accession No.	3. Recipient Catalog No.	
4. Title and Subtitle Child Safety Seat Investigation		5. Report Date May 6, 2006

This on-site investigation focused on a forward facing child safety seat (CSS) that was installed in the second row left position of a 2000 Ford Expedition. The Ford Expedition was occupied by a restrained 29-year-old female driver and a 3-year-old female second row left seat passenger, who was restrained in a forward facing CSS. The CSS was anchored to the vehicle using the available lap and shoulder belt. The other vehicle was a 1984 GMC Vandura minivan driven by a 28-year-old male. The front of the Ford Expedition was struck by the GMC Vandura in a head-on configuration after the GMC crossed the center divider and traveled into the westbound

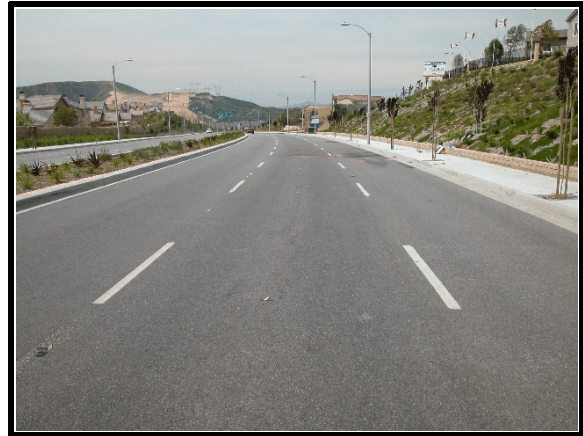
Figure 2. Approach to point of impact (west)

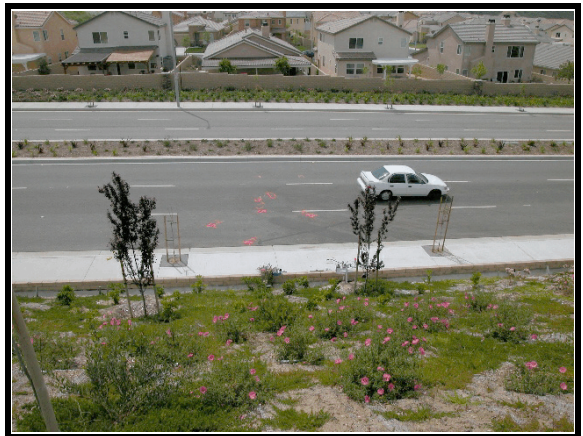
Figure 3. Overview of impact area and final rest (south)

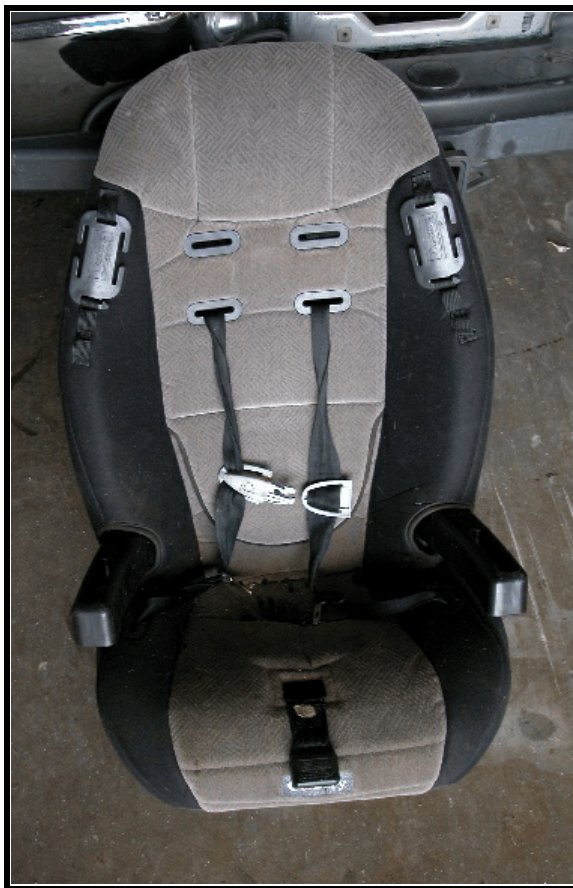
A Century Breverra Ascend SE 44892 forward facing CSS was positioned in the second row left seat of the Ford Expedition. The model number was 44892UH and the date of manufacture was August 21, 2002. The convertible CSS was configured with a five-point harness system and a two piece locking harness retainer clip. The seat was being used in the forward facing mode using the 5-point harness. The second row left safety belt was used to anchor the child safety seat. The safety belt was found still anchoring the child seat at the time of the inspection. There was approximately 45.0 cm (17.7 in) of scuffs from loading found on the belt. The manufacturer outlined recommended usage of the seat is as follows:

The child in this case met the “with harness system” height recommendation (91 cm/36 in) and the weight recommendation (18 kg/40 lbs). At the time of the CSS inspection, the harness straps were routed through the bottom set of harness slots. The seat was equipped with a tether attachment, which was not used.

Figure 12. Front of Century child seat after being removed from vehicle

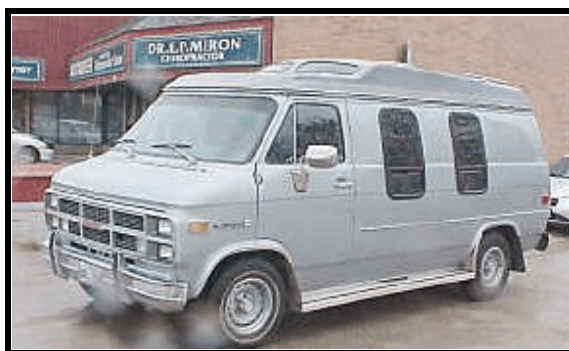
Description:	1984 GMC Vandura minivan	
VIN:	Unknown	
Odometer:	Unknown	
Engine:	Unknown	
Reported Defects:	None noted	
Cargo:	Unknown	
Damage Description:	Major front end damage. Vehicle towed from the scene.	
Delta V:	Total	95.5 km/h (59.3 mph)
	Longitudinal	-94.0 km/h (-58.3 mph)
	Latitudinal	-16.6 km/h (-10.3 mph)
	Energy	814,694 joules (600,887 ft-lbs)

Figure 13. Exemplar view of 1984 GMC Vandura

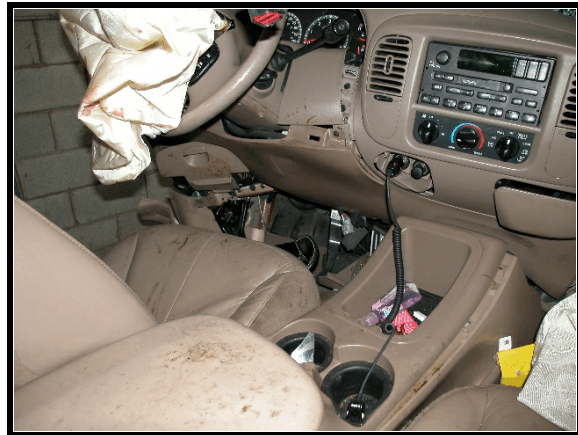
The 29-year-old driver of the Ford Expedition was seated in a forward facing fashion. The adjustable foot controls appear to have been in the fully rearward (toward driver) position. The driver was using the available lap and shoulder belt. Her right foot was on the accelerator, her left on the floor. There were no indications from any witness that the driver attempted any evasive maneuvers prior to the crash. At impact, the frontal air bags deployed and the safety belt pretensioner actuated. The female driver initiated a forward and slightly left trajectory. She loaded the safety belt. Her face and torso engaged the deployed air bag. The steering wheel rim was deformed forward. Both of her knees engaged the intruding knee bolster/instrument panel. Her left lower leg/ankle engaged the parking brake—depositing blood and tissue. Her right foot deformed the brake and accelerator pedals.

Figure 14. Overview of driver's seated position
