**ON-SITE CHILD SAFETY SEAT CRASH INVESTIGATION  
COSCO VISTA HIGH BACK BELT POSITIONING BOOSTER SEAT**

**CALSPAN CASE NO: CA05-005**

**VEHICLE: 1995 OLDSMOBILE CUTLASS SUPREME**

**CRASH DATE: DECEMBER, 2004**

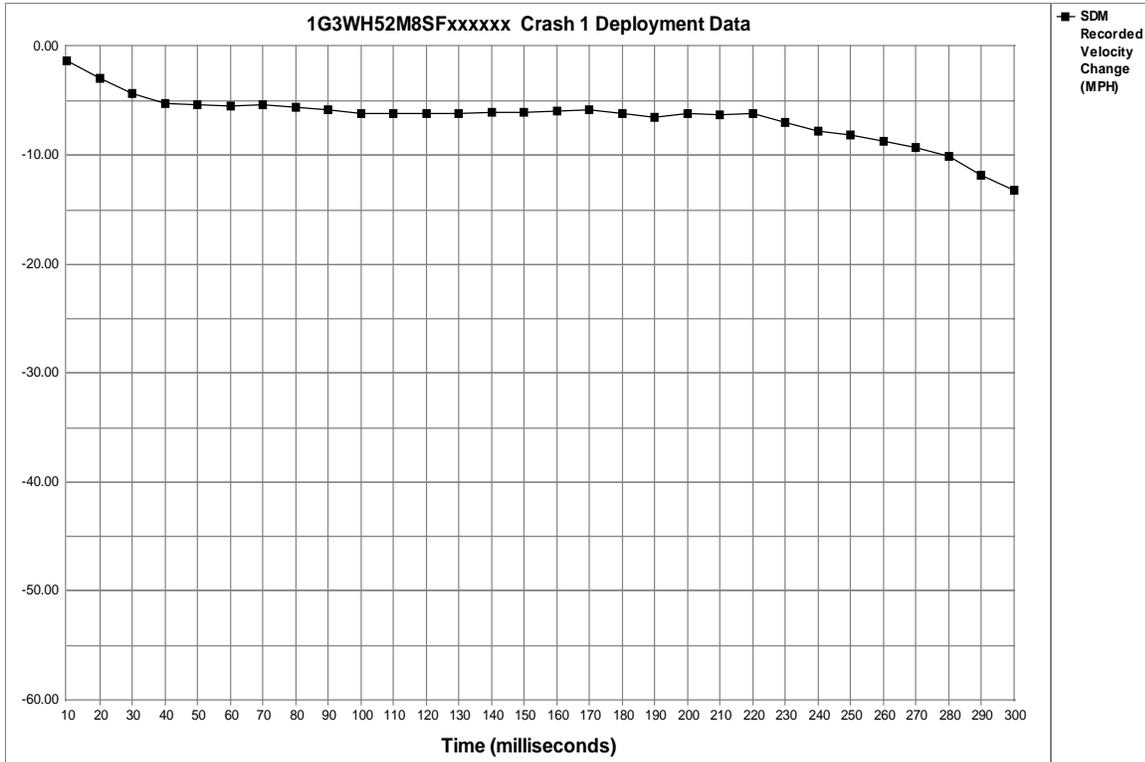
### System Status At Crash 1

SIR Warning Lamp Status	OFF
Driver's Belt Switch Circuit Status	UNBUCKLED
Ignition Cycles At Deployment	14440
Ignition Cycles At Investigation	14441
Time From Algorithm Enable to Deployment Command Criteria Met (msec)	31.25
Time Between Non-Deployment And Deployment Events (sec)	.03

Time (milliseconds)	10	20	30	40	50	60	70	80	90	100	110	120	130	140	150
Recorded Velocity Change (MPH)	-1.32	-2.85	-4.28	-5.16	-5.27	-5.49	-5.38	-5.59	-5.81	-6.14	-6.14	-6.14	-6.14	-6.03	-6.03
Time (milliseconds)	160	170	180	190	200	210	220	230	240	250	260	270	280	290	300
Recorded Velocity Change (MPH)	-5.92	-5.81	-6.14	-6.47	-6.14	-6.25	-6.14	-6.91	-7.79	-8.12	-8.67	-9.21	-10.09	-11.85	-13.16

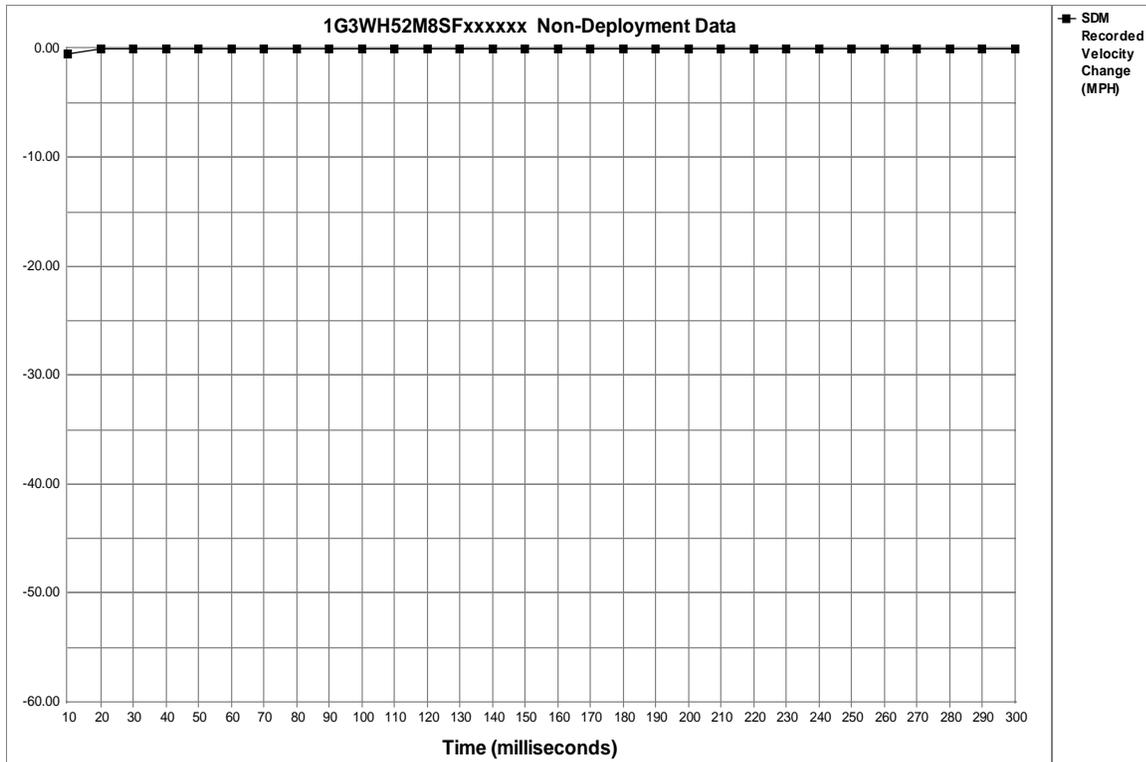
## System Status At Non-Deployment

SIR Warning Lamp Status	OFF
Driver's Belt Switch Circuit Status	UNBUCKLED
Ignition Cycles At Non-Deployment	14440
Ignition Cycles At Investigation	14441
Algorithm Enable to Maximum SDM Recorded Velocity Change (msec)	11.25
Maximum SDM Recorded Velocity Change (MPH)	-0.44
A Deployment was Commanded Prior to this Event	No

Time (milliseconds)	10	20	30	40	50	60	70	80	90	100	110	120	130	140	150
Recorded Velocity Change (MPH)	-0.44	0.00	0.00	0.00	0.00	0.00	0.00	0.00	0.00	0.00	0.00	0.00	0.00	0.00	0.00
Time (milliseconds)	160	170	180	190	200	210	220	230	240	250	260	270	280	290	300
Recorded Velocity Change (MPH)	0.00	0.00	0.00	0.00	0.00	0.00	0.00	0.00	0.00	0.00	0.00	0.00	0.00	0.00	0.00
