TRANSPORTATION RESEARCH CENTER

ON-SITE CERTIFIED ADVANCED 208- COMPLIANT VEHICLE INVESTIGATION

CASE NUMBER - IN-05-005
LOCATION - TEXAS
VEHICLE - 2005 CADILLAC CTS
CRASH DATE - December 2004

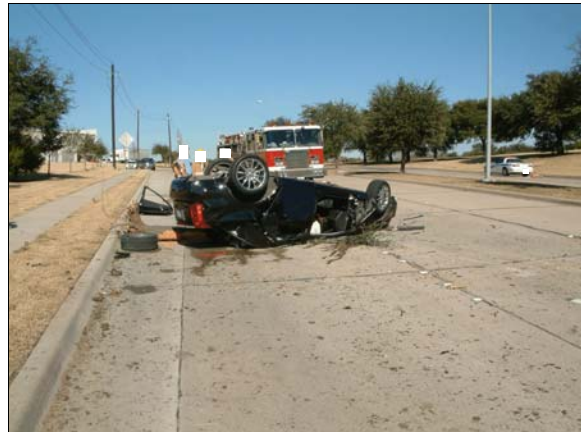
Post-Crash: The case vehicle slid across the southbound lanes on its roof. It rotated clockwise approximately 120 degrees and came to final rest across the outside and center southbound lanes facing northeast (Figures 8 and 9 below).

Figure 8: Police photo showing final rest position of case vehicle in southbound lanes facing northeast

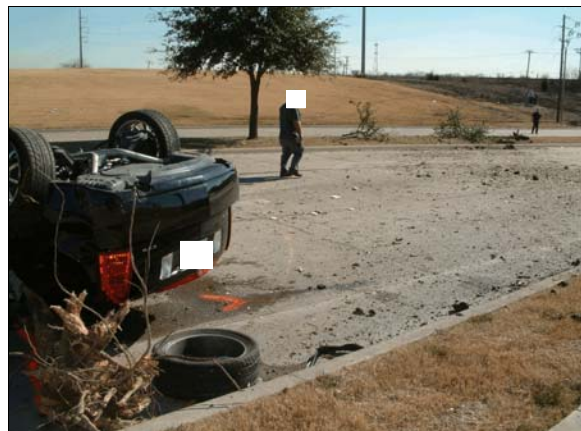
Figure 9: Police photo looking southeast back through case vehicle's rest position to impact

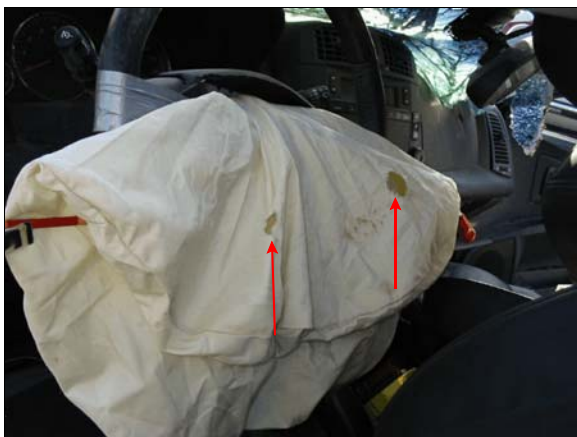
Figure 19: Driver's air bag vent ports (arrows)

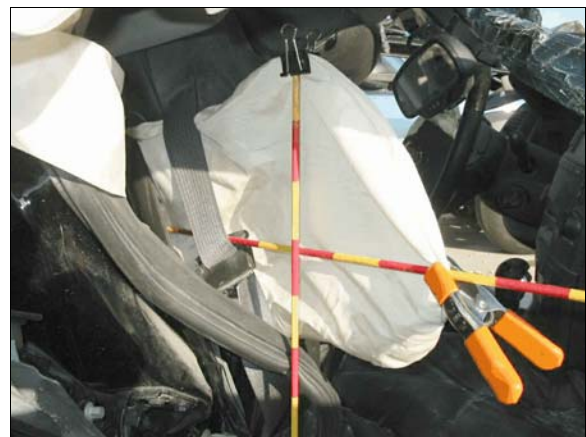
Figure 20: Right front, seat back-mounted, side impact air bag

The right front seat back-mounted side impact air bag was centrally located in the right side of the seat back. There was no evidence of damage during the deployment to the air bag or the single air bag module cover flap. The deployed side impact air bag (**Figure 20** above) was rectangular in shape and was approximately 39 centimeters (15.4 inches) in length and approximately 23 centimeters (9.1 inches) in width. The air bag was designed without vents or tethers. Inspection of the air bag was unremarkable. There was no occupant seated in the front right seat.

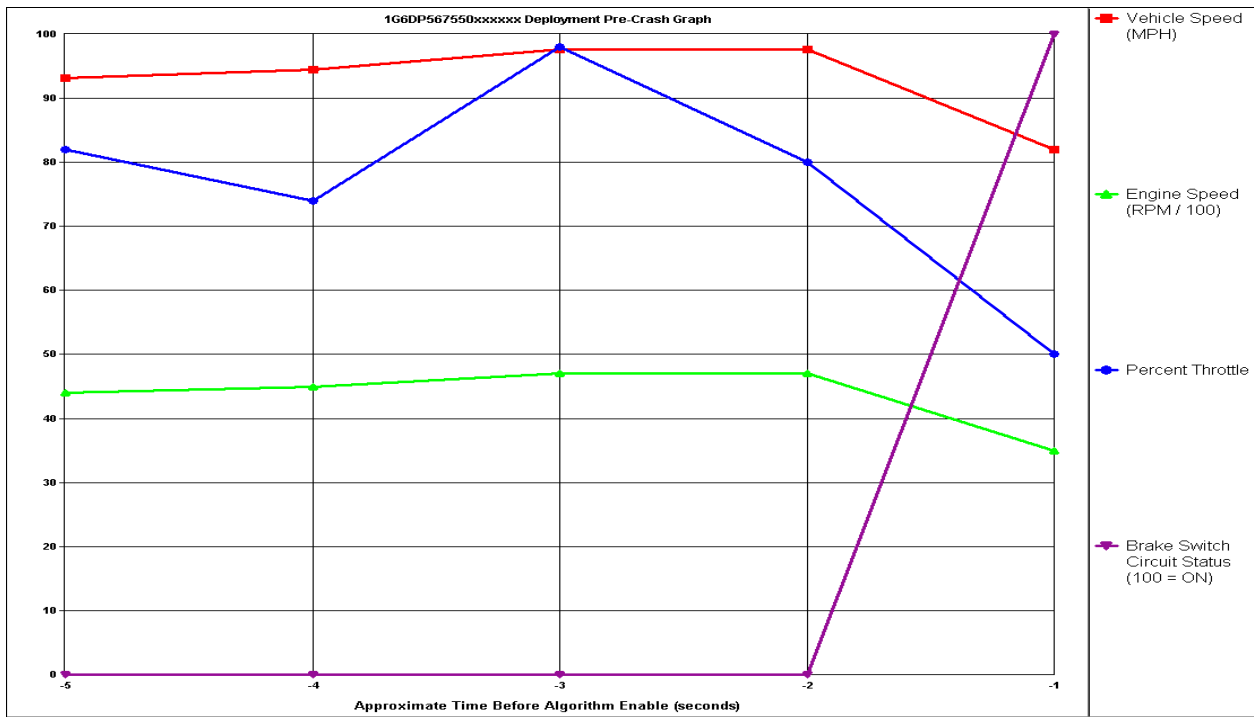
The pre-crash data indicates that five seconds prior to AE, the case vehicle was at 82% throttle traveling at 150 km.p.h. (93 m.p.h.), and the brake switch was recorded off. At three seconds prior to AE, the throttle increases to 98% with the speed recorded as 158 km.p.h. (98 m.p.h.), and the brake switch recorded off. The percent throttle falls to 80% at two seconds prior to AE, and to 50% at one second with the speed recorded as 132 km.p.h. (82 m.p.h.) and the brake switch recorded on. The graphs of the pre-crash data for the deployment and non-deployment events are presented in **Figures 26** and **29** at the end of this report.

Figure 26: Case vehicle's Deployment Pre-Crash Graph

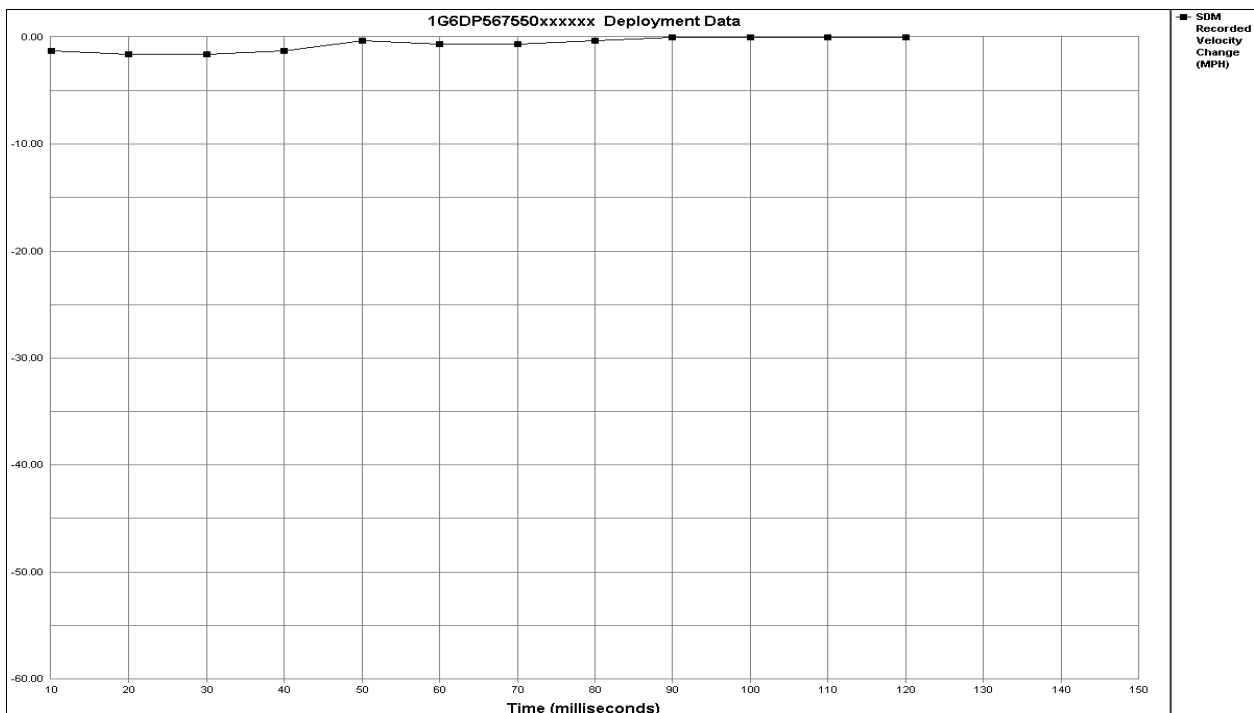
using the EDR data. The case vehicle's EDR recorded the maximum longitudinal component of Delta-V as -21.0 km.p.h. (-13.0 m.p.h) for this impact. Using a force angle of 70 degrees based on the approach path of the case vehicle's center of gravity (i.e., the slip angle), the total and lateral components of Delta-V were calculated respectively as 61.2 km.p.h (38 m.p.h) and -57.5 km.p.h. (-35.7 m.p.h). The case vehicle was towed due to damage.

Figure 27: Case vehicle's deployment SDM Recorded Velocity Change graph

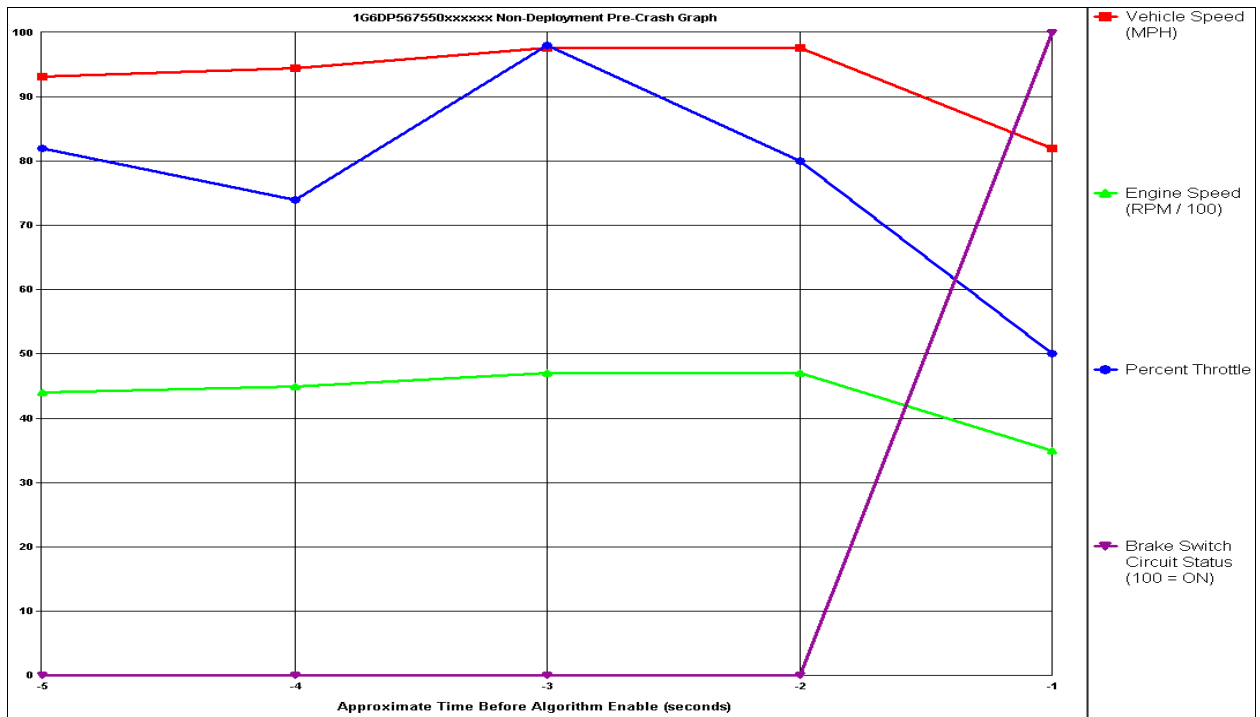
Figure 29: Case vehicle's Non-Deployment Pre-Crash Graph

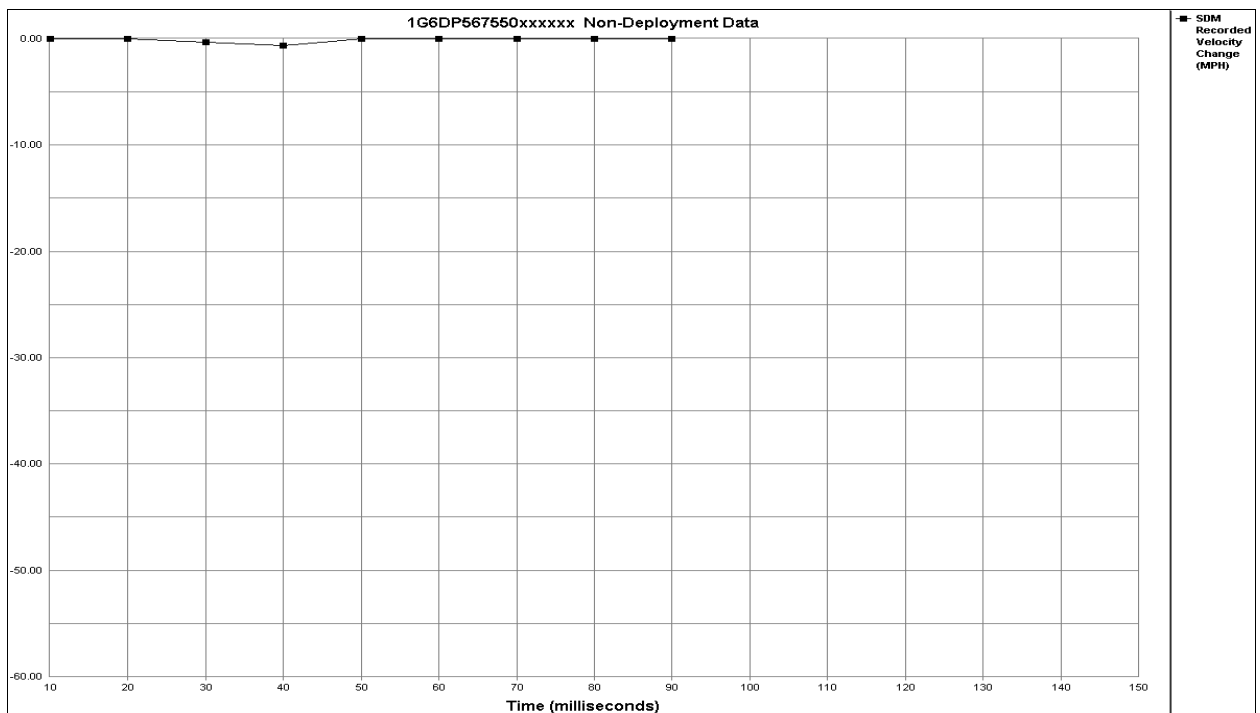
Figure 30: Case vehicle's non-deployment SDM recorded velocity change graph
