**CALSPAN ON-SITE CERTIFIED ADVANCED 208-COMPLIANT
VEHICLE CRASH INVESTIGATION**

CASE NO: CA05-008

VEHICLE: 2004 CHEVROLET AVALANCHE

CRASH DATE: DECEMBER 2003

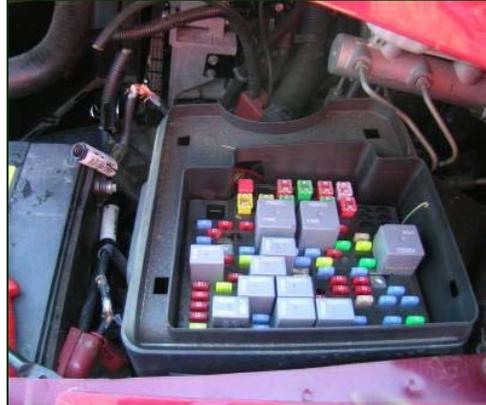
The Event Data Recorder (EDR) in the 2004 Avalanche was downloaded through the J1962 connector that was located under the knee bolster. Power was applied to the vehicle by reconnecting the cut battery cables (**Figure 10**). The EDR was downloaded using the Vetronix Crash Data Retrieval tool and software version 2.5.

Figure 10. Reconnected battery cables and engine compartment fuse box.
