**CALSPAN ON-SITE CERTIFIED ADVANCED 208-COMPLIANT  
VEHICLE CRASH INVESTIGATION**

**CASE NO: CA05-011**

**VEHICLE: 2004 CHEVROLET SUBURBAN**

**CRASH DATE: DECEMBER 2004**

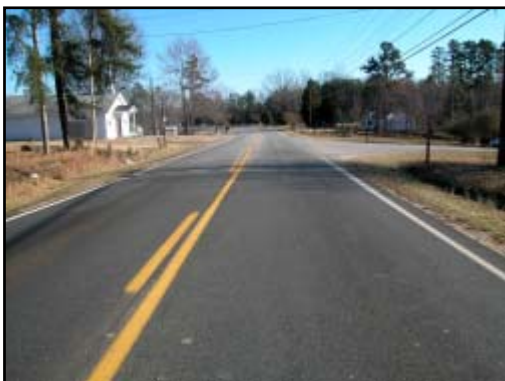
**Figure 2. Southbound approach for the Chevrolet Suburban**

The 50-year-old male driver of the Chevrolet Suburban was operating the vehicle in a southbound direction on the state roadway on approach to the 3-leg intersection (**Figure 2**). The EDR output showed the Suburban was traveling at 87 km/h (54 mph) 5 seconds prior to impact. A non-contact vehicle was reported by police to have stopped in the northbound lane of the intersection and was waiting to initiate a left turn onto the local roadway. The 83-year-old driver of the Buick Century was operating the vehicle in a northbound direction and detected the stopped non-contact vehicle as the Century exited the right curve. The driver of the Buick Century steered left to avoid a collision with the stopped non-contact vehicle, crossed the centerline into the southbound lane (**Figure 3**), and entered the intersection into the path of the oncoming Suburban. Based on the EDR output, the driver of the Suburban applied the brakes two seconds prior to impact.

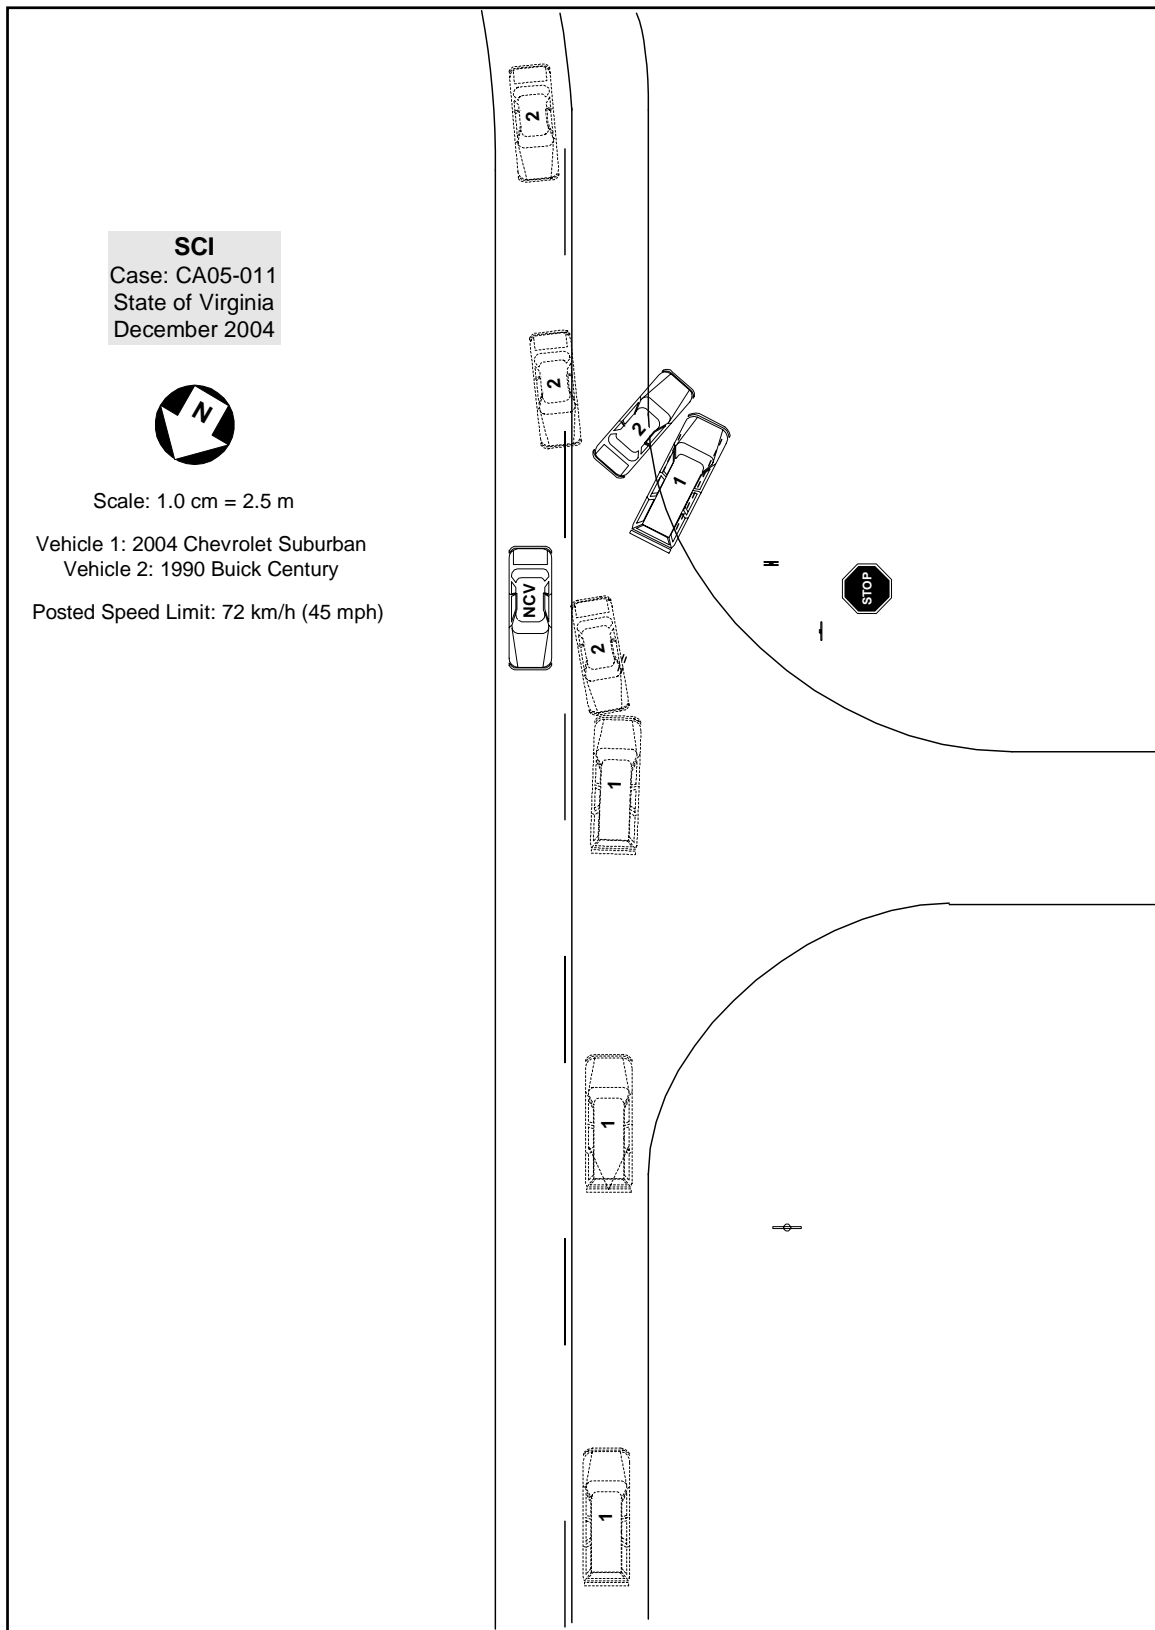
*Figure 13. Scene schematic*

southbound traffic and a broken yellow centerline for northbound traffic. The roadway was straight and level at the crash site, and exhibited a southbound left curve beyond the crash site. At the time of the crash, the weather was clear and the asphalt roadway surface was dry. White fog lines on the outboard edges bordered the roadway, and the roadside generally consisted of grassy fields. The east/west local roadway intersected the state roadway on the west aspect, and traffic flow through the intersection was controlled by a stop sign for eastbound traffic. The posted speed limit for the state roadway was 72 km/h (45 mph). The scene schematic is included as **Figure 13** at the end of this narrative report.
