Child Safety Seat Fatality/ Vehicle to Object
Dynamic Science, Inc. / Case Number: DS05011
2000 Toyota Celica
California
June 2005

1. Report No. DS05011	2. Government Accession No.		3. Recipient Catalog No.	
4. Title and Subtitle Child Safety Seat Fatality Investigation		5. Report Date May 15, 2006

Dynamic Science, Inc.
Crash Investigation
Case Number: DS05011

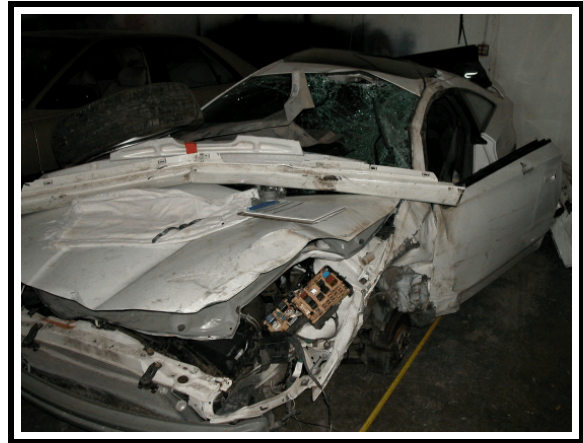
Figure 1. Front left, 2000 Toyota Celica

The 2000 Toyota Celica sustained moderate front/left side damage from the impacts with the guardrail and moderate roof damage from the rollover. The direct frontal damage began at the left bumper corner and extended laterally 21.0 cm (8.3 in). Direct damage extended down the left side for 85.0 cm (33.5 in). The left front tire was knocked off and the left wheelbase was shortened by 8.0 cm (3.1 in). The front left rim was abraded and the wheel was flat. There was direct contact damage along the left side of the hood that extended rearward and included the A pillar and the left roof rail and roof area. The mirrors on both sides were broken off. There was direct road surface contact along the right front fender. The front right tire rim was abraded and the tire was flat. Both front doors and the hatch remained closed and operational. The windshield was fractured during the rollover. The right rear window and the backlight glazing disintegrated. The roof glass was cracked and out of place.

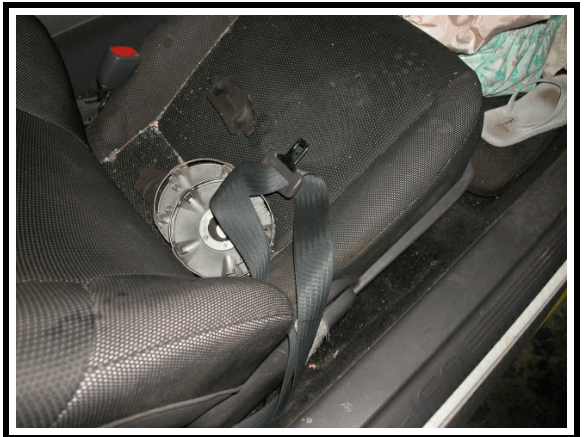
The front right seat safety belt was being used by the female occupant in that position. The safety belt was found in the extended position at the time of the inspection.

Figure 6. Front right passenger seat belt

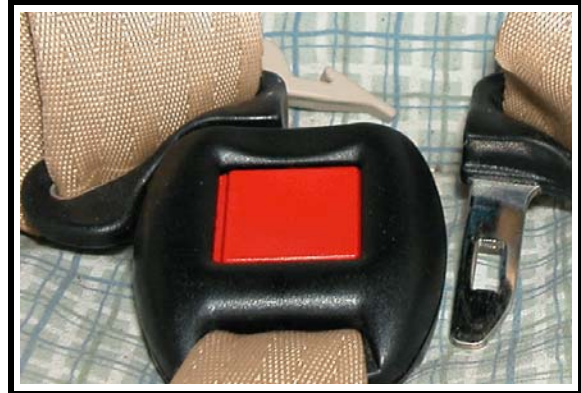
There was no damage to the seat. There were no indications of stress or loading to the vehicle's seat belt. There were faint scuff marks found on the left portion of the harness webbing near the upper left slot.

Figure 12. Child safety seat latch tongue

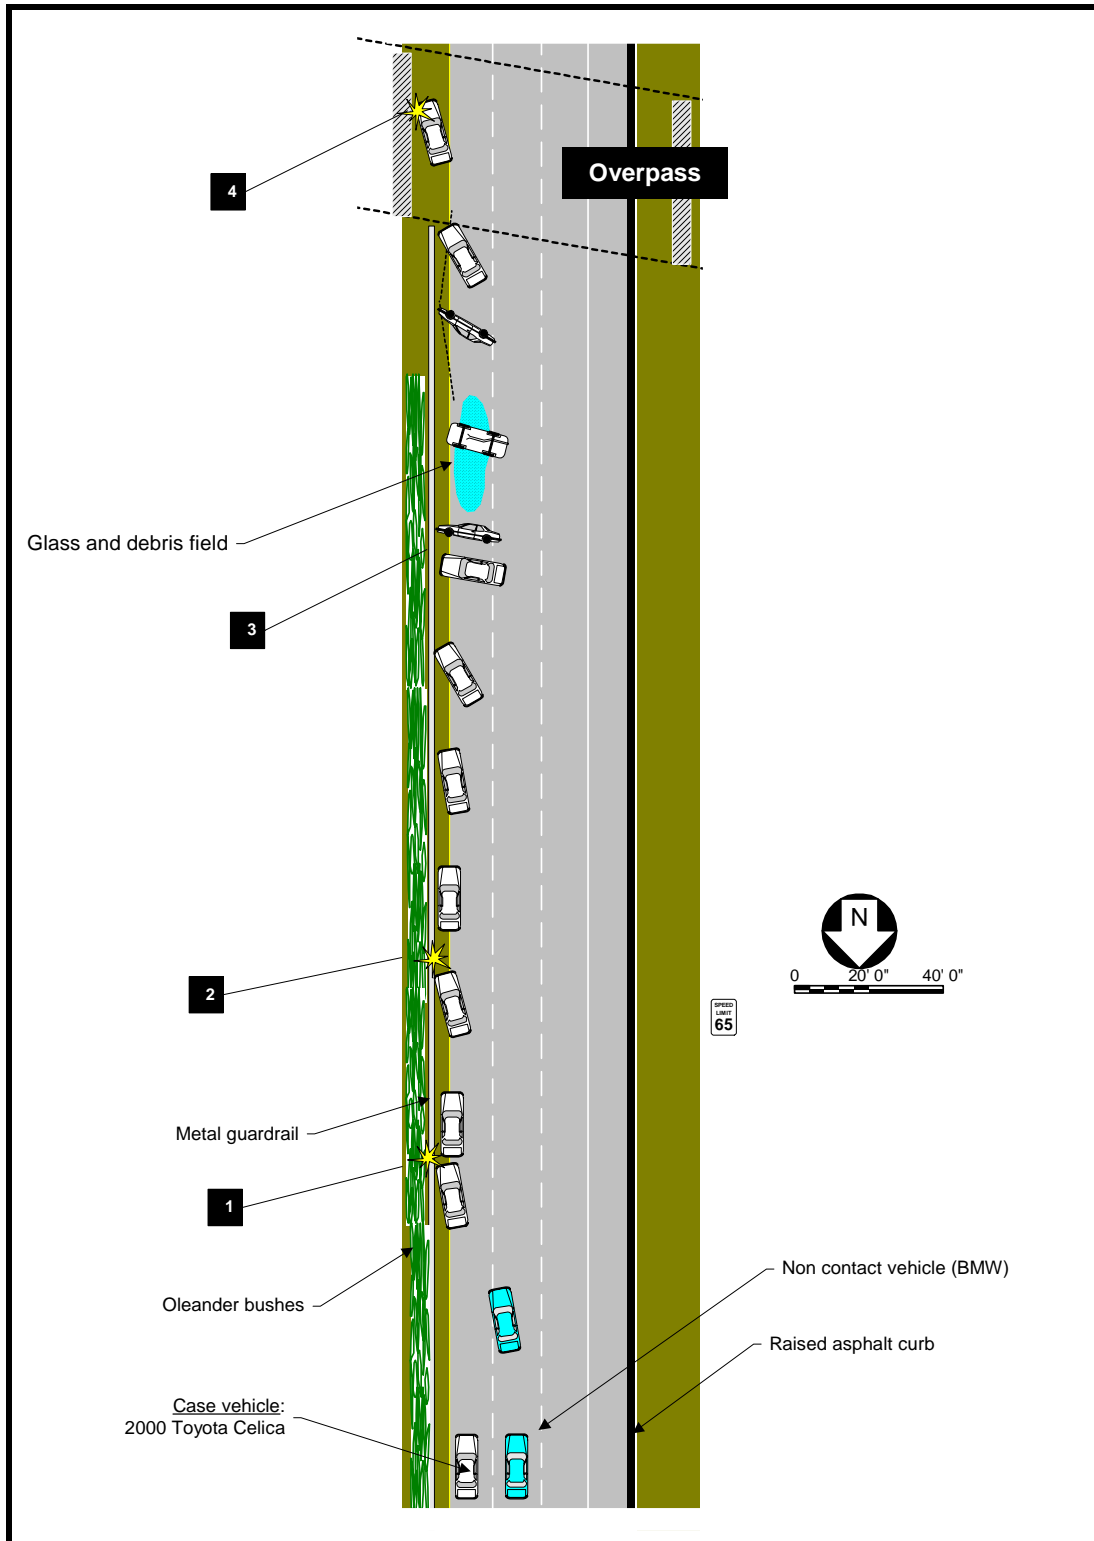
Attachment 1. Scene Diagram

The BMW reportedly cut in front of the Celica causing the driver to brake and swerve hard to the left. The driver of the Celica lost control of his vehicle as it veered to the left. The Celica struck the metal guardrail with its front end (12FLEE4). Both frontal air bags in the Celica likely deployed at this time. The Celica was redirected back to the right to some degree, but the damage to the front left wheel caused the vehicle to begin a counterclockwise rotation. The Celica again struck the guardrail and continued its rotation. It appears that the Celica had rotated approximately 90 degrees before it tripped and began overturning with its right side leading (00TDD02). The Celica rolled at least four quarter turns. Prior to coming to final rest the Celica contacted one of the overpass support beams. At some point during the rollover sequence the infant in the Celica was ejected through the backlight.
