CALSPAN ON-SITE SCHOOL BUS CRASH INVESTIGATION

CASE NO: CA05-012

VEHICLE: 1996 INTERNATIONAL CHASSIS BLUE BIRD SCHOOL BUS

CRASH DATE: FEBRUARY 2005

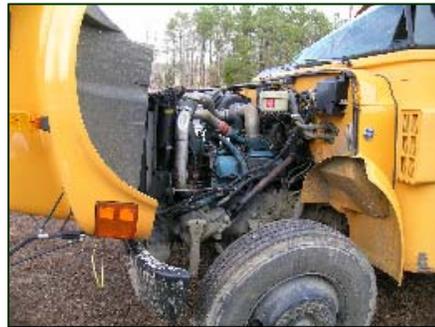
The involved school bus was owned and operated by a rural county school district. The bus was built on a 1996 International 3800 conventional chassis (**Figure 3**) with a 645 cm (254") wheelbase. The chassis was identified by Vehicle Identification Number 1HVBBABP1TH (production number deleted). At the time of the SCI inspection, the odometer read 215,482.4 km (133,898.2 miles). The chassis was manufactured on May 13, 1996 and was configured with a 7.3 liter, V-8 turbo diesel engine that was linked to a 5-speed Spicer manual transmission with a floor mounted shifter. The service brakes were hydraulic 4-wheel disc with electric boost and 2-piston calipers. The Gross Vehicle Weight Rating was placarded as 12,474 kg (27,500 lb) with a front axle rating of 4,536 kg (10,000 lb) and a rear axle rating of 7,938 kg (17,500 lb). The

Figure 3. Engine compartment of the conventional chassis bus.

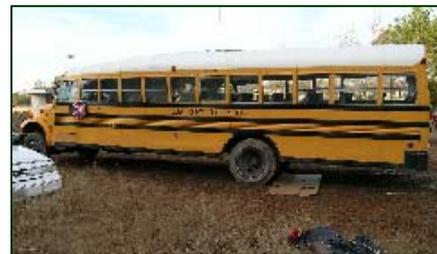
The school bus body was a Blue Bird 64 passenger (Figure 4). The unit was manufactured in Lafayette, Georgia on 6/96 and was identified by Body No. L021511 and a Body Service No. of L00 21690. The body was constructed of aluminum side and roof panels that were riveted and screwed to a continuous formed wall/roof bow. The bus was configured with a manually operated, two-panel right side door that closed to the mid point and a rear emergency door that was hinged at the right side. A single roof emergency exit was centered in the roof between the G- and H-pillars. The 58 cm (22.75") square hatch-type exit was removed from the vehicle at the time of the inspection. Two window emergency exits were located at the G- and H-pillar locations. Both window exits were closed pre-crash and were closed the time of the inspection.

Figure 4. Left side view of the Blue Bird bus body.

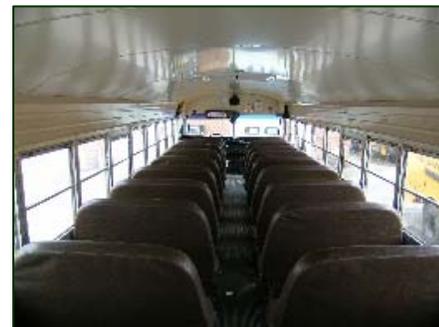
The interior was configured with the driver's compartment and a passenger area that was comprised of eleven rows of seats with a center aisle (Figure 5). The driver's compartment consisted of a pedestal mount low-back seat with vertical and fore and aft seat adjustments. A continuous loop three-point lap and shoulder belt system provided the manual restraint for the driver. The belt system consisted of a sliding latch plate and a retractor that was mounted to the left roof side rail. The retractor was in a locked position with the webbing fully retracted at the time of the inspection. The buckle of the safety belt system was mounted on a two-piece

Figure 5. View of an exemplar school bus looking forward in the passenger compartment.

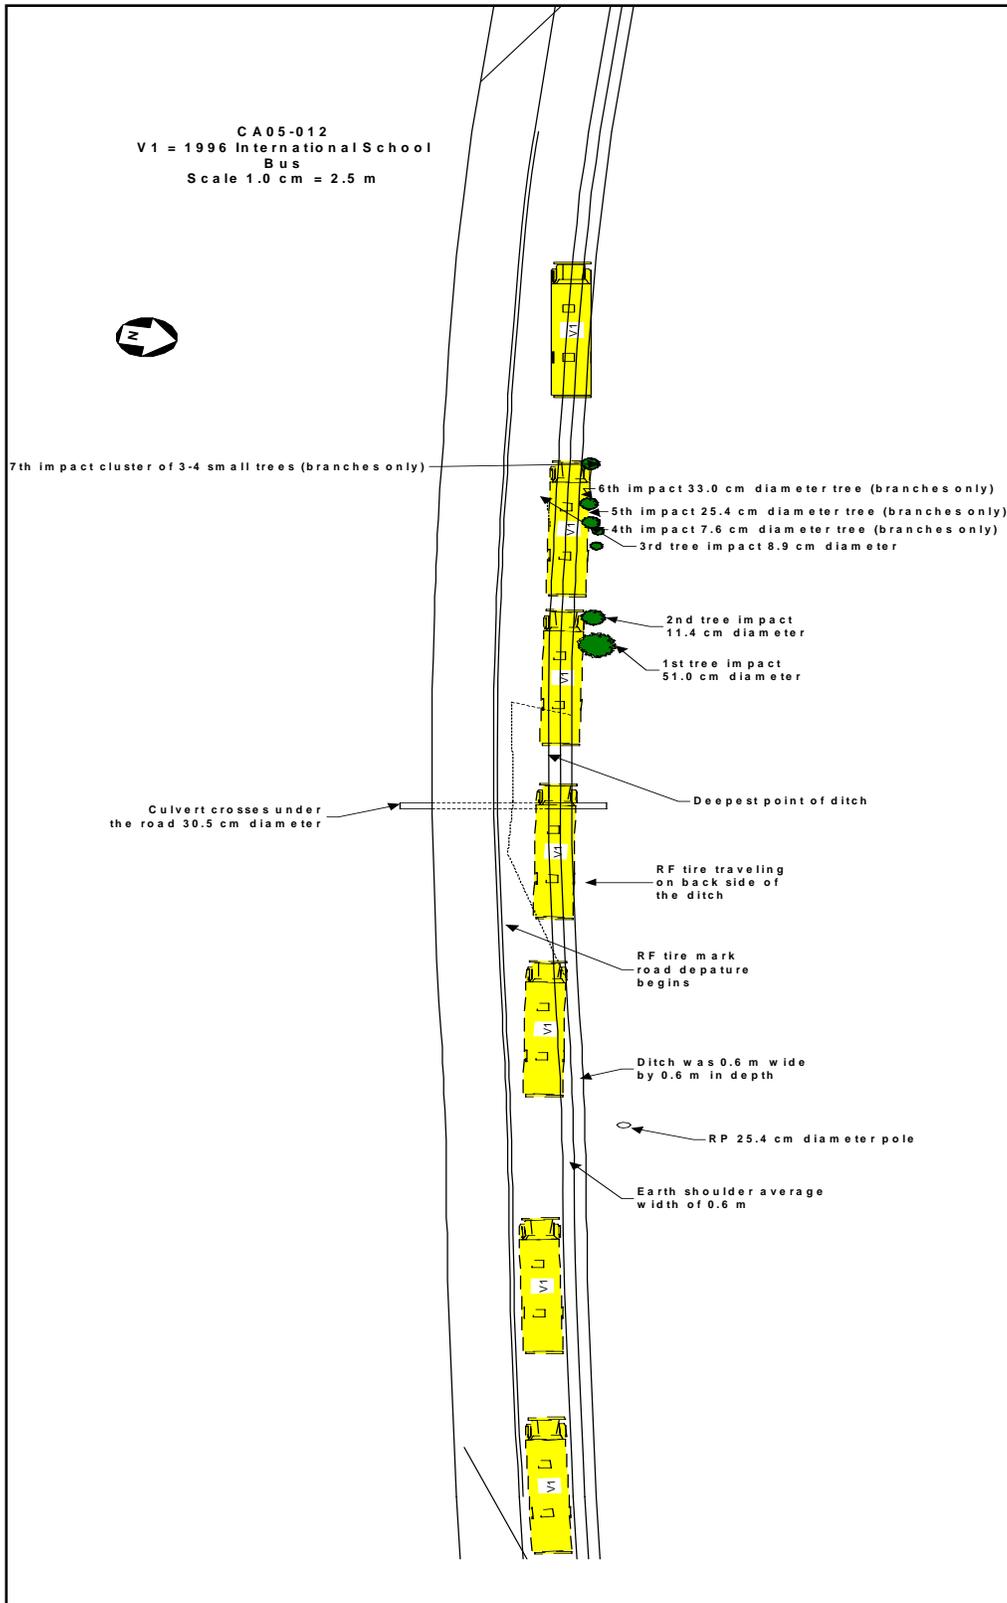
Figure 20 – SCI Crash Schematic

A tree line was located at the backside of the ditch bank, beginning 13 m (42') west of the referenced culvert pipe. The single line of trees consisted of three deciduous trees followed by a line of conifers (cedar). The bus impacted the trunks of the first three trees and contacted the branches of four additional trees as it re-entered the roadway prior to coming to rest. The first struck tree was 51 cm (20") in diameter with 11 and 9 cm (4.5" and 3.5") diameter trees located to the west. The single row of cedar trees continued in a westerly direction along the backside of the ditch bank. The posted speed limit in the vicinity of the crash site was 56 km/h (35 mph). The Crash Schematic is included as **Figure 20** of this report.
