Certified Advanced 208 Compliant Vehicle Investigation / Vehicle to Vehicle
Dynamic Science, Inc. / Case Number: DS05016
2005 Buick Rendezvous
Oregon
August 2005

1. Report No. DS05016	2. Government Accession No.	3. Recipient Catalog No.	
4. Title and Subtitle Certified Advanced 208 Compliant Vehicle Investigation		5. Report Date May 3, 2006

This on-site investigation focused on the performance of the side and front air bag systems in a Certified Advanced 208-Compliant (CAC) vehicle (2005 Buick Rendezvous CXL). The multi-stage air bags were certified by the manufacturer to meet the advanced air bag requirements of Federal Motor Vehicle Safety Standard No. 208. This two vehicle crash occurred in August 2005 at 2002 hours in an urban area of Oregon. The crash occurred within the confines of a four-leg intersection. The case vehicle was a 2005 Buick Rendezvous being driven by a restrained 36-year-old female. There were two additional passengers in the vehicle. The other vehicle was a 1997 Ford Econoline van being driven by a 29-year-old male. The Buick Rendezvous was traveling west on a two lane, two-way roadway with no traffic controls. The Ford van was traveling north on a two lane

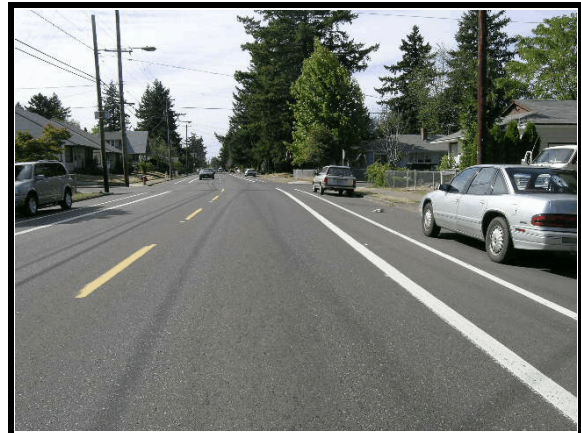
Figure 3. Approach of case vehicle to intersection-west

The 2005 Buick Rendezvous was being driven by a restrained 36-year-old female (163 cm/64 in, 59 kg/130 lbs). There were two other passengers in the vehicle. The front right seat was occupied by a restrained 13-year-old female (150 cm/59 in, 48 kg/105 lbs) and the second row right seat was occupied by a restrained 11-year-old female (145 cm/57 in, 39 kg/85 lbs). The Buick Rendezvous was traveling west in the westbound lane of the two lane, two-way roadway and had no traffic controls.

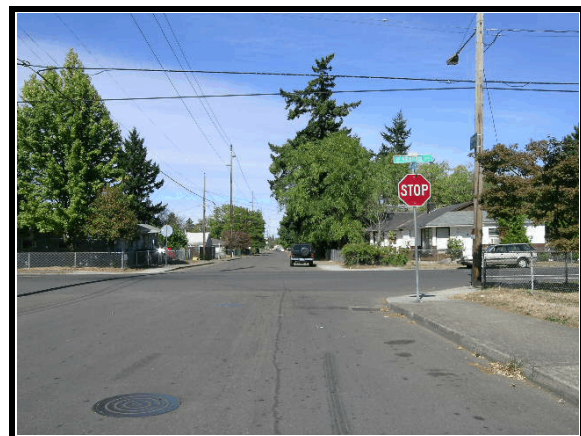
Figure 4. Approach of other vehicle to intersection-north

The other vehicle was a 1997 Ford Econoline van being driven by a 29-year-old male. The van was traveling north on the two lane, two-way roadway. According to the police report, this vehicle was involved in two hit and run accidents prior to this crash. The two hit and run crash configurations are unknown. At the intersection there are stop signs posted for north and southbound traffic. The van did not stop at the posted stop sign and entered the intersection, crossing in front of the case vehicle.

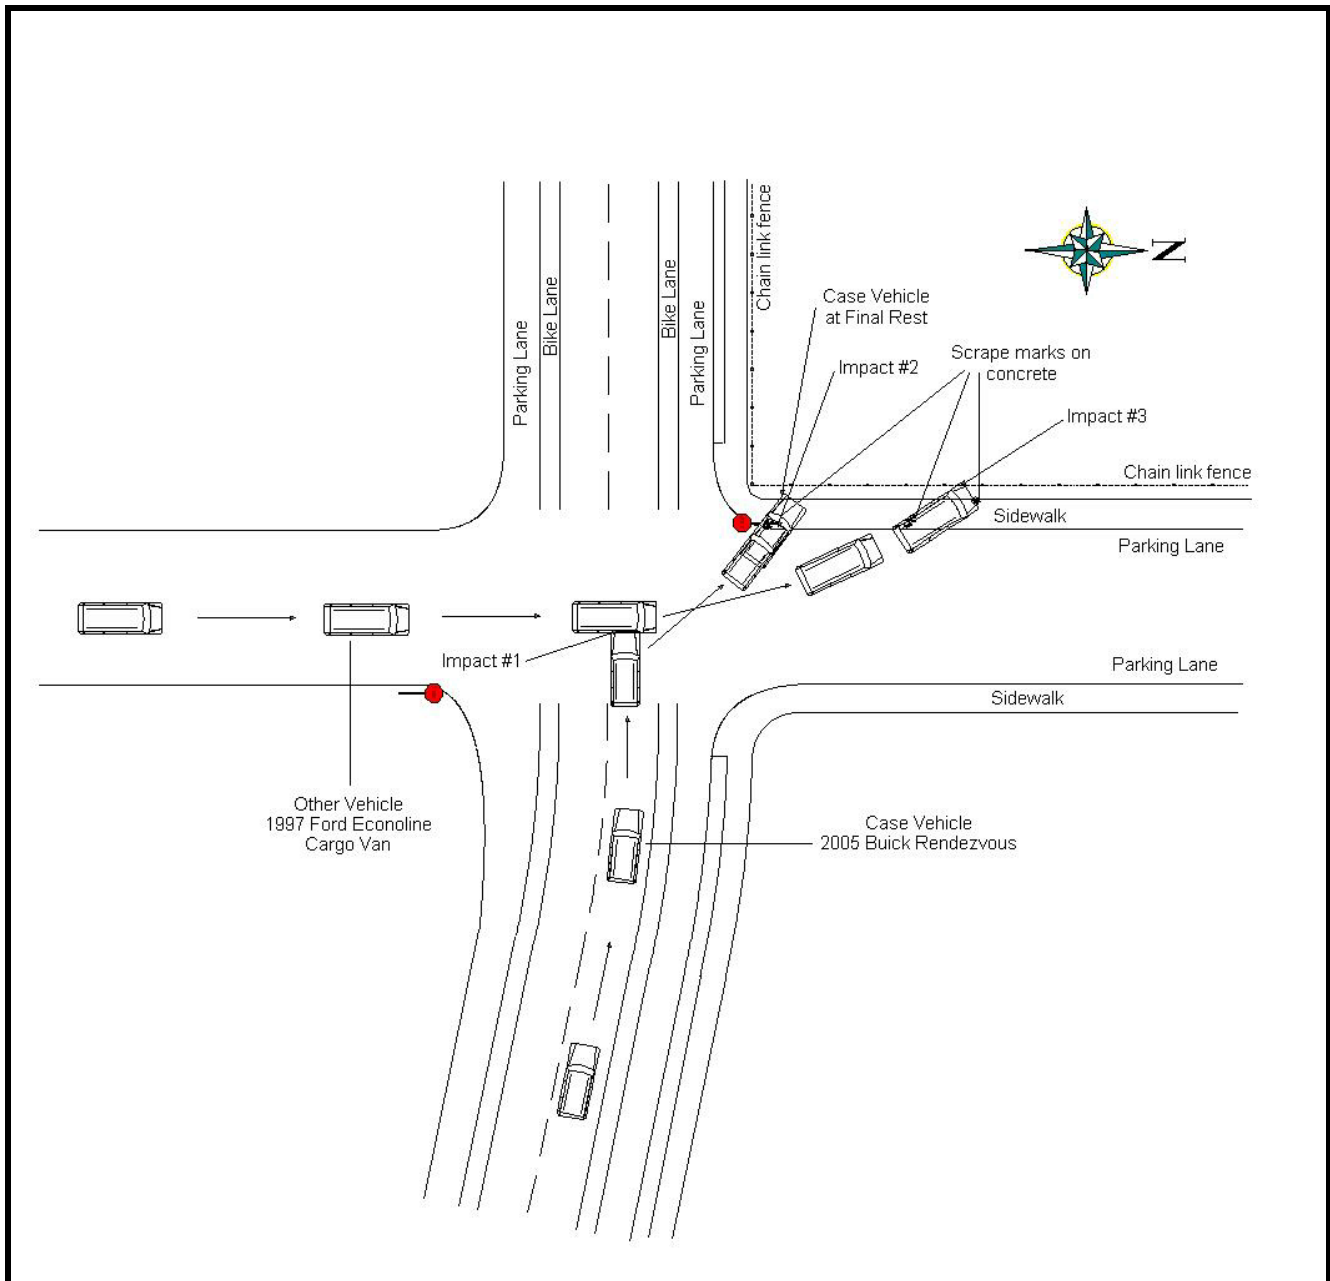
Attachment 1. Scene Diagram

The driver of the Buick Rendezvous braked but could not stop in time and the front of the case vehicle (71FDEW2) struck the right side of the van (01RYEW2). The impact severity was moderate, and resulted in the deployment of the Buick's left side air bag and both front air bags. The EDR-reported longitudinal delta V was -25.2 km/h (-15.66 mph), 107.5 milliseconds into the crash. The missing vehicle routine of the WinSmash program computed a total delta V of 19.0 km/h (11.8 mph). The longitudinal and lateral components were -14.6 km/h (-9.1 mph) and 12.2 km/h (7.6 mph), respectively.

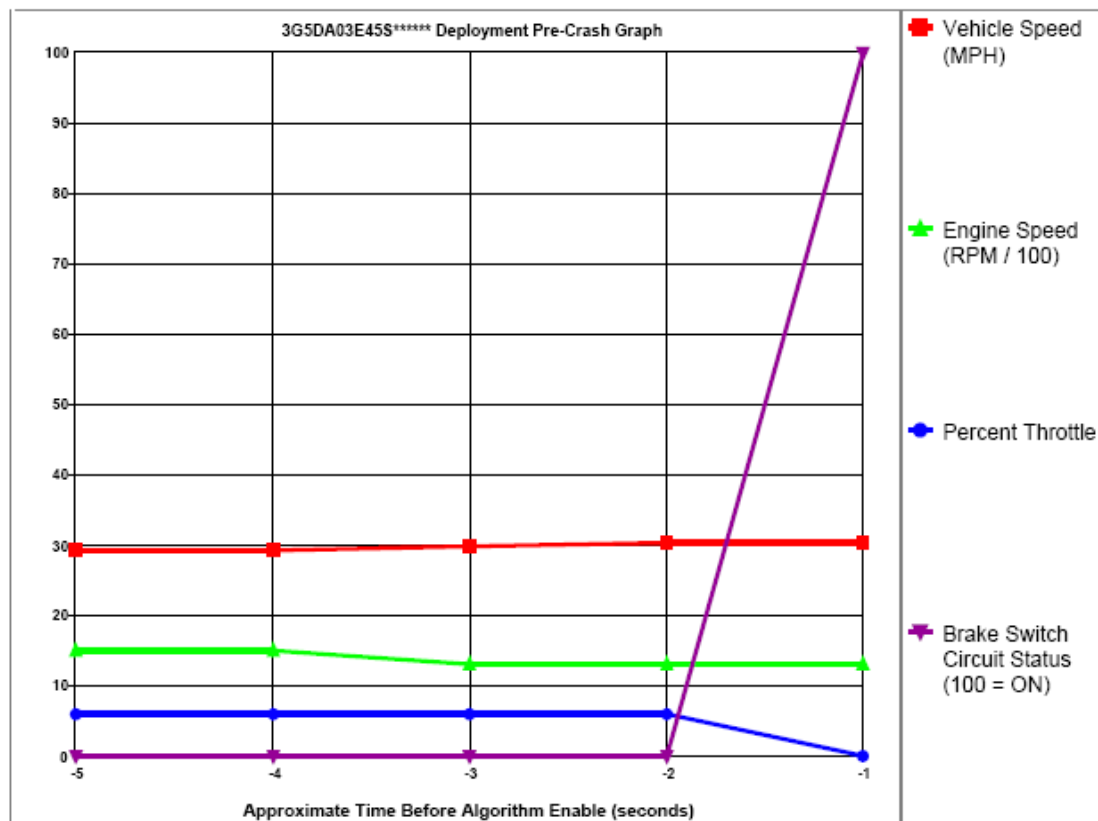
Seconds Before AE	Vehicle Speed (MPH)	Engine Speed (RPM)	Percent Throttle	Brake Switch Circuit Status
-5	29	1472	6	OFF
-4	29	1472	6	OFF
-3	30	1280	6	OFF
-2	30	1280	6	OFF
-1	30	1344	0	ON

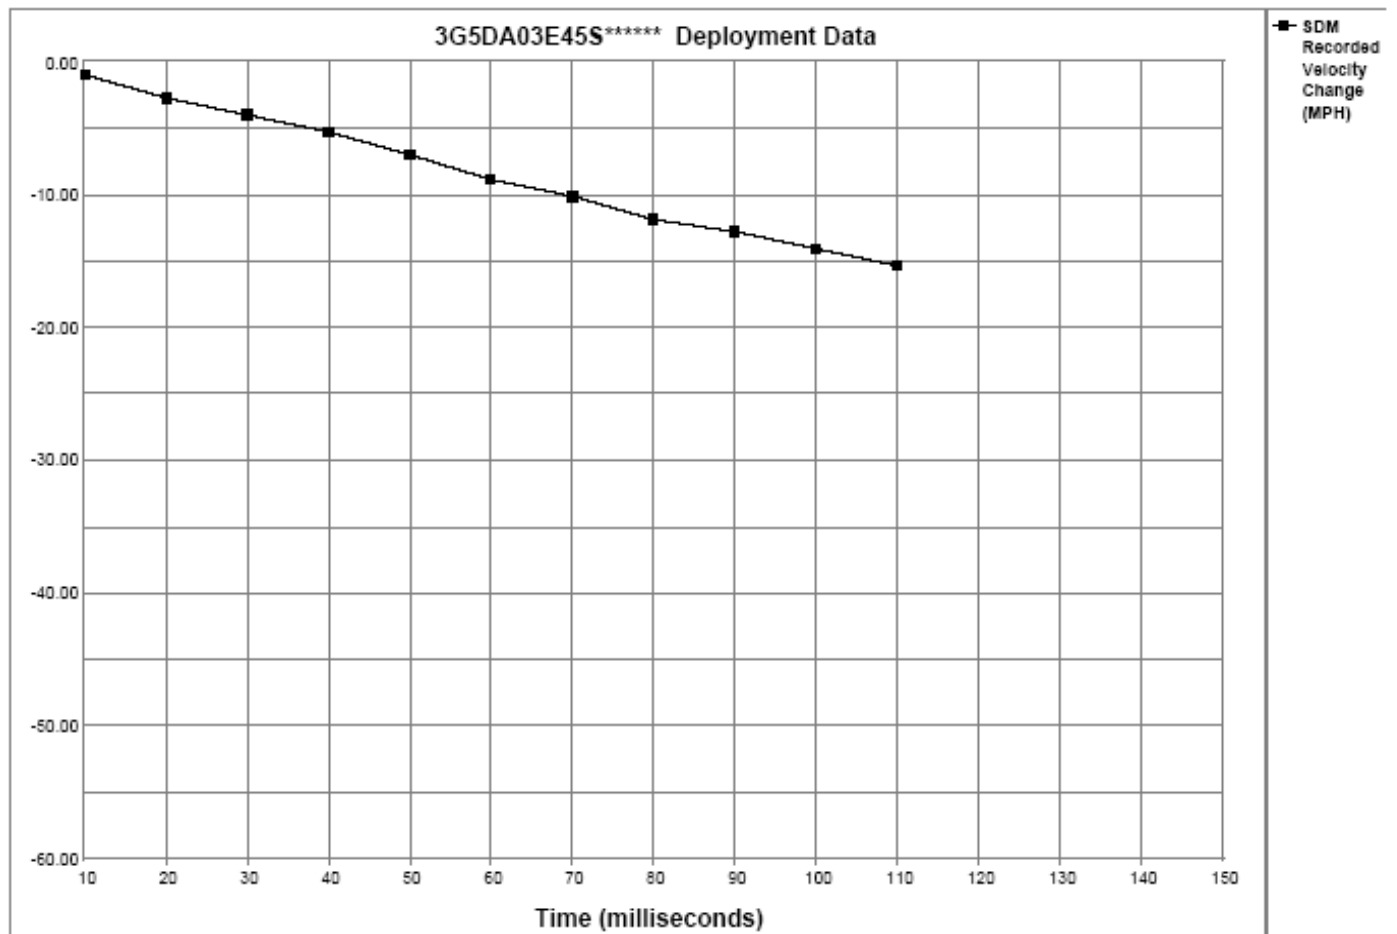
SIR Warning Lamp Status	OFF
Driver's Belt Switch Circuit Status	BUCKLED
Ignition Cycles At Deployment	1001
Ignition Cycles At Investigation	1006
Maximum SDM Algorithm Forward Velocity Change (MPH)	-15.66
Algorithm Enable to Maximum SDM Recorded Velocity Change (msec)	107.5
Driver First Stage Time Algorithm Enabled to Deployment Command Criteria Met (msec)	12.5
Driver Second Stage Time Algorithm Enabled to Deployment Command Criteria Met (msec)	N/A
Passenger First Stage Time Algorithm Enabled to Deployment Command Criteria Met (msec)	12.5
Passenger Second Stage Time Algorithm Enabled to Deployment Command Criteria Met (msec)	N/A
Time Between Non-Deployment And Deployment Events (sec)	N/A
Event Recording Complete	Yes

Time (milliseconds)	10	20	30	40	50	60	70	80	90	100	110	120	130	140	150
SDM Recorded Velocity Change	-0.88	-2.63	-3.95	-5.27	-7.02	-8.78	-10.09	-11.85	-12.73	-14.04	-15.36	N/A	N/A	N/A	N/A

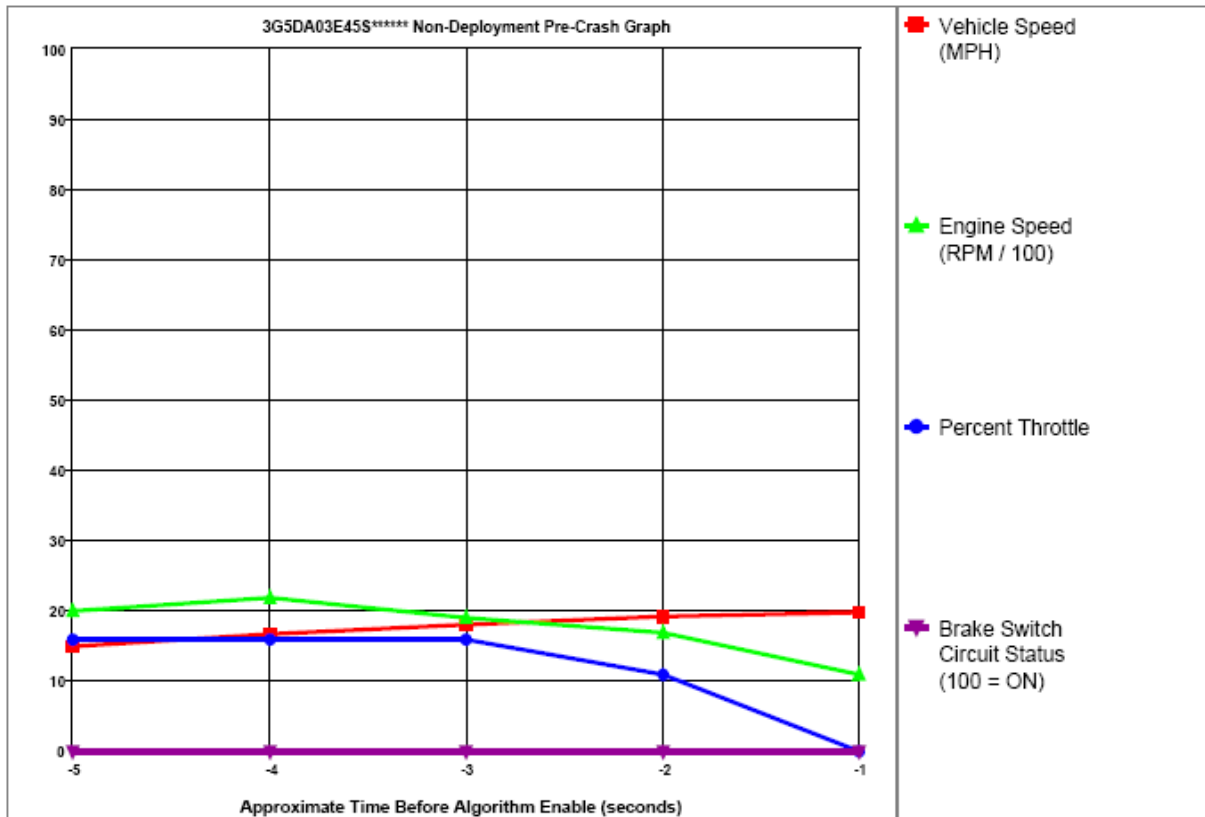
Seconds Before AE	Vehicle Speed (MPH)	Engine Speed (RPM)	Percent Throttle	Brake Switch Circuit Status
-5	15	2048	16	OFF
-4	17	2240	16	OFF
-3	18	1856	16	OFF
-2	19	1664	11	OFF
-1	20	1088	0	OFF

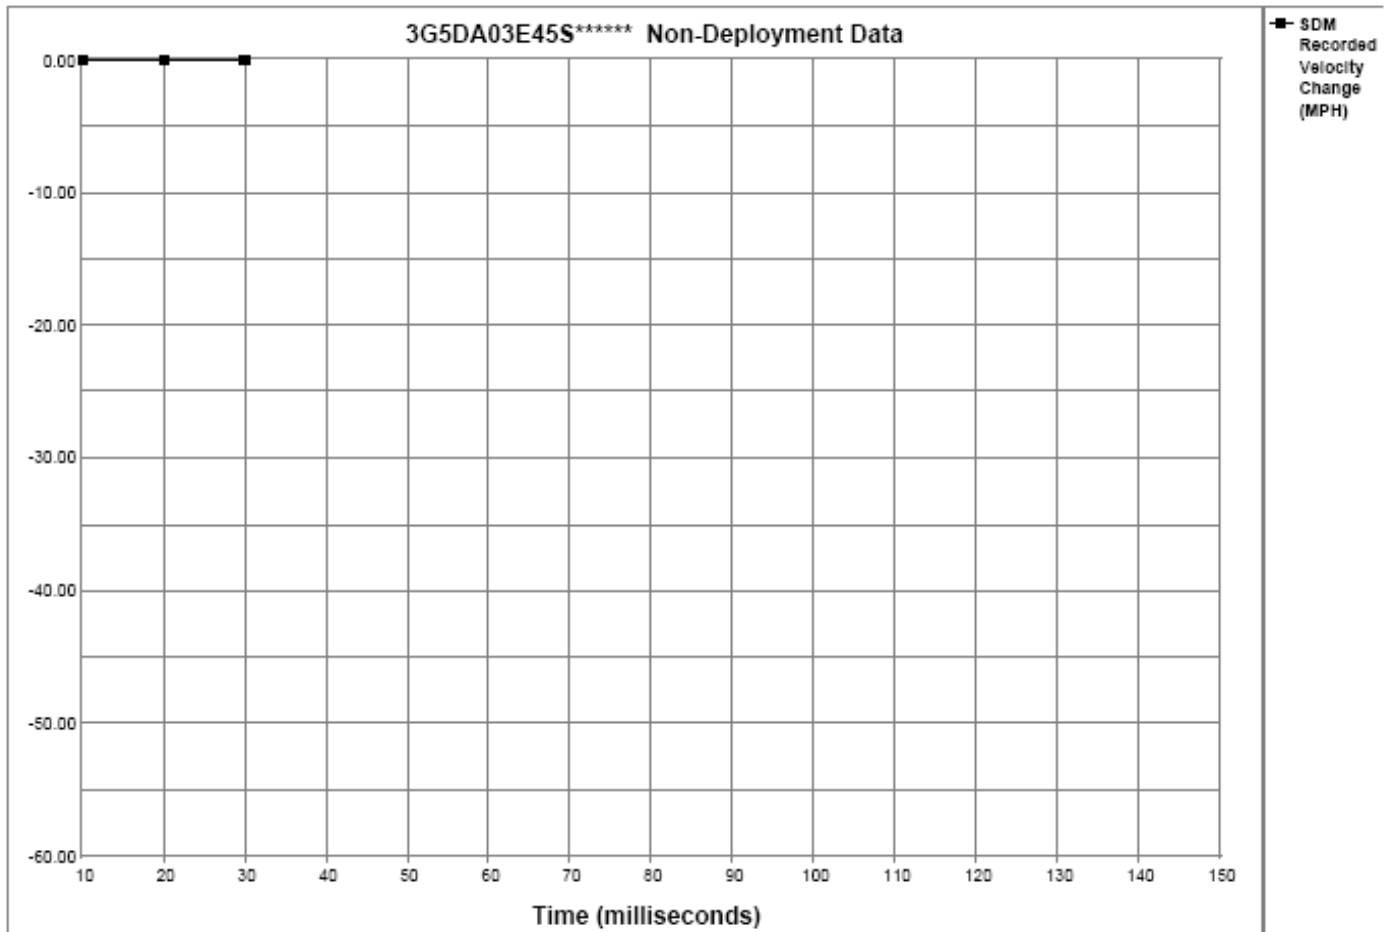
SIR Warning Lamp Status	OFF
Driver's Belt Switch Circuit Status	BUCKLED
Ignition Cycles At Non-Deployment	846
Ignition Cycles At Investigation	1006
Maximum SDM Algorithm Forward Velocity Change (MPH)	-0.18
Algorithm Enable to Maximum SDM Recorded Velocity Change (msec)	30
A Deployment was Commanded Prior to this Event	No

Time (milliseconds)	10	20	30	40	50	60	70	80	90	100	110	120	130	140	150
SDM Recorded Velocity Change	0.00	0.00	0.00	N/A	N/A	N/A	N/A	N/A	N/A	N/A	N/A	N/A	N/A	N/A	N/A
