Gas/Electric Hybrid Vehicle Investigation/Vehicle to Vehicle
Dynamic Science, Inc./Case Number: DS05017
2005 Toyota Prius
California
July 2005

1. Report No. DS05017	2. Government Accession No.		3. Recipient Catalog No.	
4. Title and Subtitle Gas/Electric Hybrid Vehicle Investigation			5. Report Date June 8, 2006

This on-site investigation focused on the gas/electric hybrid system in a 2005 Toyota Prius, as well as conformance to Federal Motor Vehicle Safety Standard, Section 571.305, Standard No.305 (Electric-powered vehicles: electrolyte spillage and electrical shock protection).

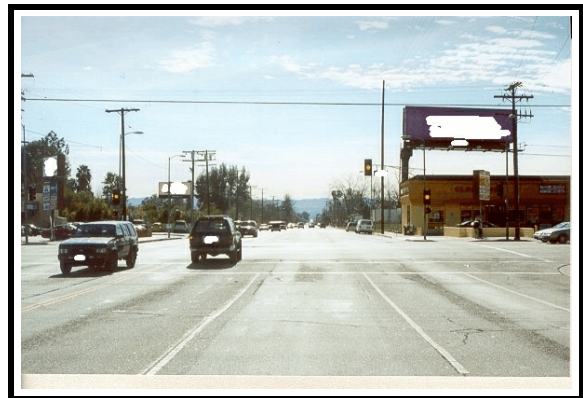
Figure 3. Approach of case vehicle - south

The Toyota Prius was traveling south on a seven lane, two way, undivided roadway (Figure 3). The north/south roadway was comprised of three northbound lanes, three southbound lanes, and a left-turn only lane on both sides of the intersection. Northbound traffic is separated from southbound traffic by double solid yellow lane lines and the left turn only lanes are delineated by solid white lane lines. The east/west intersecting roadway was also comprised of seven lanes, including three eastbound lanes, three westbound lanes and one left turn only lane on both sides of the intersection. The other vehicle, a 2004 Toyota Sequoia was traveling north in the left-turn only lane, intending to make a left-turn onto the intersecting street (Figure 4).

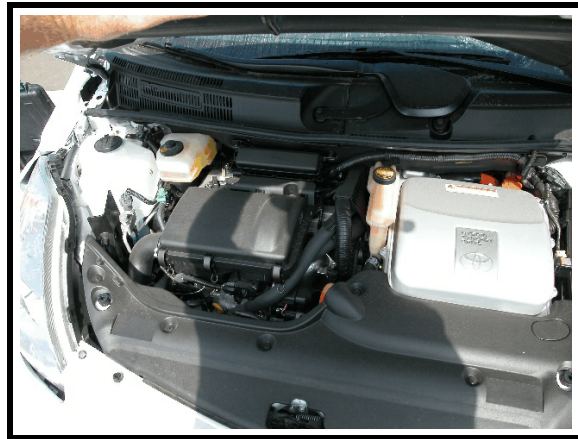
Figure 13. Engine compartment

- There were no indications of electrolyte spillage from the propulsion battery.
- There was no movement of the battery module.
- The electrical isolation test was not conducted. There was no power available.
- There were no indications of any arcing, fire or component meltdown.

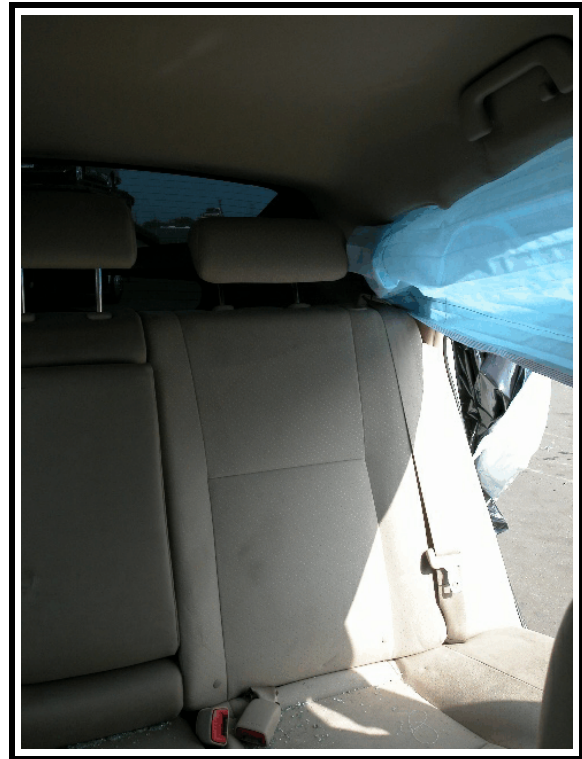
Figure 16. Second row left seating position

lap and shoulder belt (Figure 16). The seat back was reclined at a 68 degree angle and the seat bottom had a 12 degree angle. During the initial left side impact, the left side curtain deployed and this passenger initiated a forward and slightly lateral trajectory towards the 11 o'clock direction of force. It is likely that she struck the intruding left B pillar (covered by the deployed left curtain) with the left side of her face. After the initial impact, the Prius was redirected towards the southwest corner of the intersection, traveled over the curb and struck a wall with its right front, causing this occupant to initiate a forward and slightly lateral trajectory towards the 1 o'clock direction of force. According to the driver, this occupant was unconscious for a few minutes after the crash, but regained consciousness prior to the arrival of the paramedics. She was removed from the vehicle by rescue personnel and was transported by ambulance to an area hospital for treatment. She sustained a laceration to the top of her left hand that was deep enough to sever the tendon. She also sustained a forehead laceration, which began near her hairline and extended diagonally across the left side of her head to just above her left ear. This passenger also had severe bruising to both of her legs. The driver reported that this occupant was hospitalized for 4-5 days, but the official medical records show that this passenger was treated and released on the day of the crash.

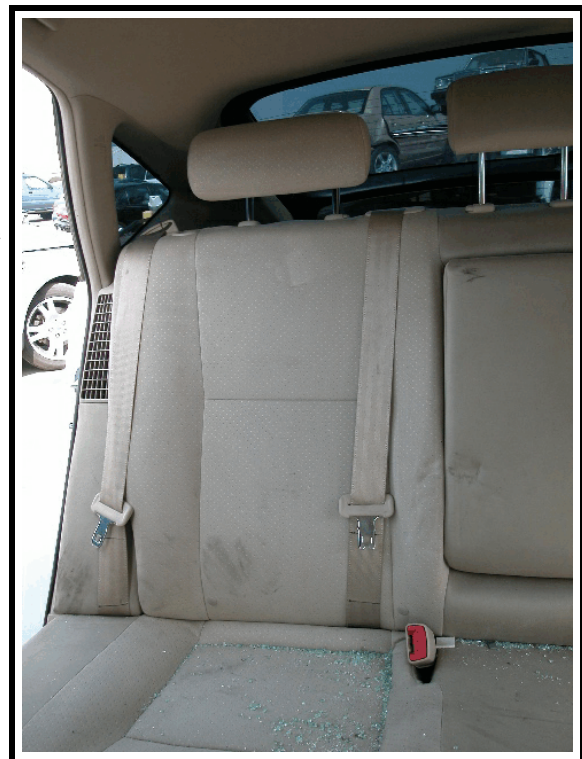
Figure 17. Second row right seating area

The 3-year-old second row right female passenger was secured in a Britax Roundabout forward facing child safety seat that was secured to the vehicle with the available manual lap and shoulder belt (Figure 17). This child was secured within the CSS with the internal harness and retainer clip. The seat back cushion was reclined at a 68 degree angle and the seat bottom had a 12 degree angle. During the initial left side impact, this passenger initiated a forward and slightly lateral trajectory towards the 11 o'clock direction of force, likely engaging the

harness with her chest and both sides of her neck. After the initial impact, the Prius was redirected towards the southwest corner of the intersection, traveled over the curb and struck a wall with its right front, causing this occupant to initiate a forward and slightly lateral trajectory towards the 1 o'clock direction of force. This passenger was removed from the vehicle by bystanders and was checked at the scene by paramedics, but they did not render any medical treatment. Her father took custody of the child at the scene. She sustained neck abrasions from the internal CSS harness.

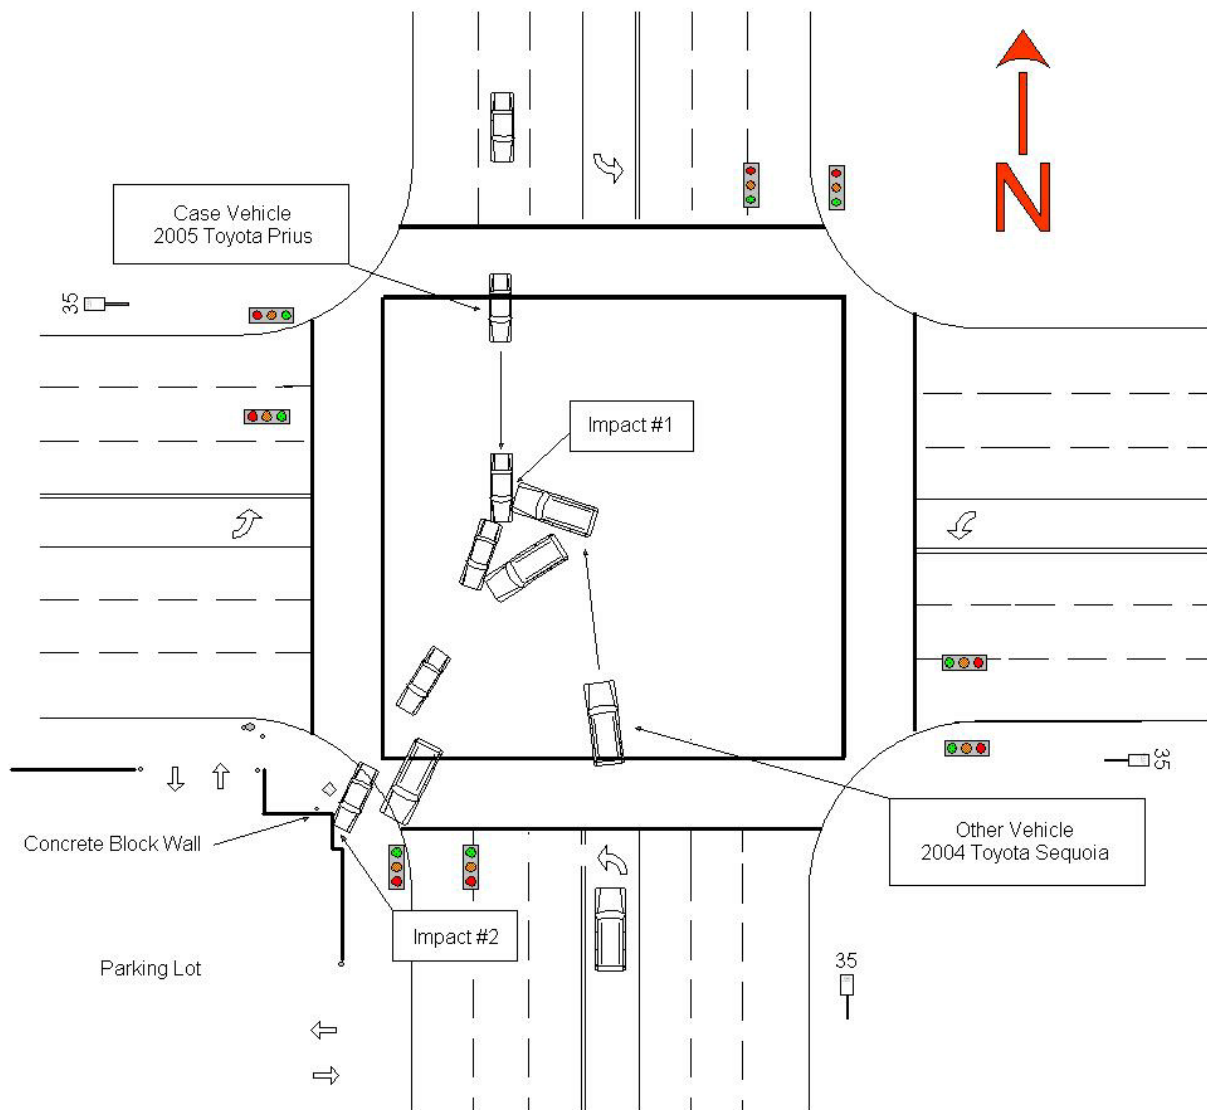
Attachment 1. Scene Diagram

The Toyota Sequoia turned left as the Prius was crossing through the intersection and the front of the Sequoia struck the left side of the Prius (11LDEW3). The impact severity was moderate and resulted in the deployment of the case vehicle's driver's seat back mounted side air bag and left side curtain. The missing vehicle routine of the Winsmash program, computed a total delta V of 40.0 km/h (24.9 mph). The longitudinal and lateral components were -34.6 km/h (-21.5 mph) and 20.0 km/h (12.4 mph), respectively. The Prius continued south, traveled over the southwest corner of the intersection and struck a wall (01FREE6) that was adjacent to the sidewalk (Figure 6). Per the police report, both vehicles came to final rest near the southwest corner of the intersection.
