CALSPAN ON-SITE CHILD SAFETY SEAT INVESTIGATION

SCI CASE NO. – CA05-023

SUBJECT VEHICLE – 2001 MITSUBISHI MONTERO

CRASH DATE – APRIL 2005

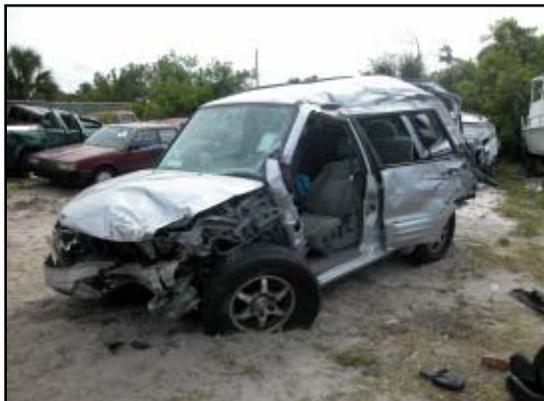
Figure 1. Subject vehicle 2001 Mitsubishi Montero.

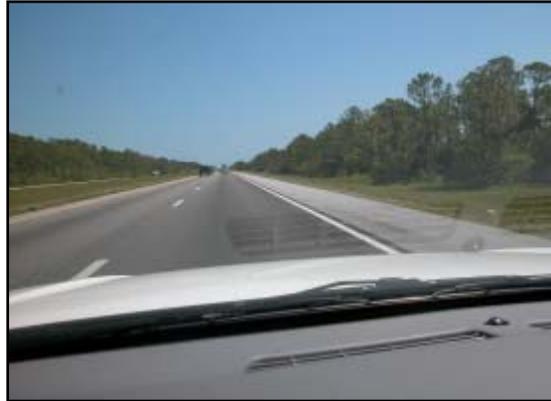
Figure 2. Overall view of the crash from the southbound travel lanes.

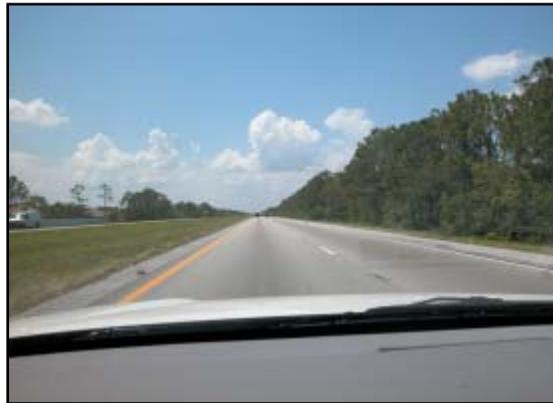
The restrained 29-year-old female driver was operating the 2001 Mitsubishi Montero northbound on the inboard lane of the interstate (**Figure 3**). A non-contact vehicle was traveling northbound adjacent to the Mitsubishi. A 46-year-old male operated the 1995 Ford Econoline, which was towing a trailer southbound on the outboard lane. Based on the on-scene police images, the trailer appeared to contain landscape tools and machinery. A 45-year-old male was operating the 2003 Volvo tractor with a 1999 Lufkin trailer southbound ahead of the Ford.

Figure 3. Mitsubishi's northbound travel.

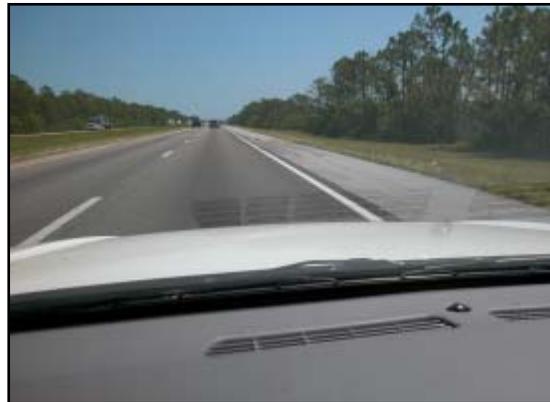
As the Mitsubishi entered the outboard southbound lane, the left passenger compartment area impacted the left rear corner of the Lufkin trailer. The direct contact damage began forward of the left B-pillar and extended 236 cm (93") rearward to the left D-pillar. This impact resulted in a slight clockwise rotation; therefore the Mitsubishi began to travel in a northbound direction on the inboard southbound lane. The Volvo tractor and Lufkin trailer continued southbound and came to rest on the right shoulder. **Figure 4** is an overall view of the area of impact and final rest. Note: The tow operator stated to the SCI investigator that another crash occurred at the same location, therefore there's overlapping physical evidence at the crash site.

Figure 4. Area of impact and final rest from the southbound lanes.

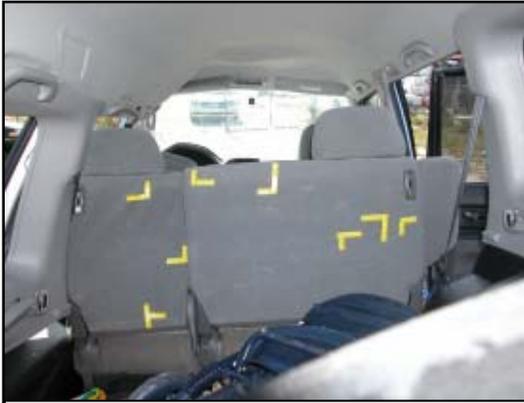
The Lufkin trailer penetrated the passenger compartment during the initial impact. The penetration occurred at the second row where the rear left corner of the trailer contacted the outboard aspect of the rear left seatback resulting in a vertical tear approximately 8 cm (3.1”) in height. A double stroller that weighed approximately 14 kgs (30 lbs) was located in the rear cargo area of the vehicle. At impact, the stroller loaded the rear of the second row seatback, which resulted in four tears to the cloth, and forward displacement of the seatback (**Figures 10 and 11**). The longitudinal distance between the front left seat back and the left rear CSS seatback was 27 cm (10.6”) and the front seatback to the CSS cushion was 9 cm (3.5”). The second row center and right seatbacks were also displaced forward. The infant CSS was not with the vehicle at the time of the SCI inspection, therefore the longitudinal distance between the CSS and front right seatback was unknown. The passenger compartment intrusions are listed in the table below:

Figure 10. Stroller to the rear of the second row seatbacks of the Montero.
