**CALSPAN ON-SITE CHILD SAFETY SEAT CRASH INVESTIGATION**  
**GRACO SNUG RIDE REAR-FACING CHILD SAFETY SEAT**  
**SCI CASE NO: CA05-024**

**VEHICLE: 2004 NISSAN QUEST**  
**LOCATION: CONNECTICUT**  
**CRASH DATE: MARCH, 2005**

Contract No. DTNH22-01-C-17002

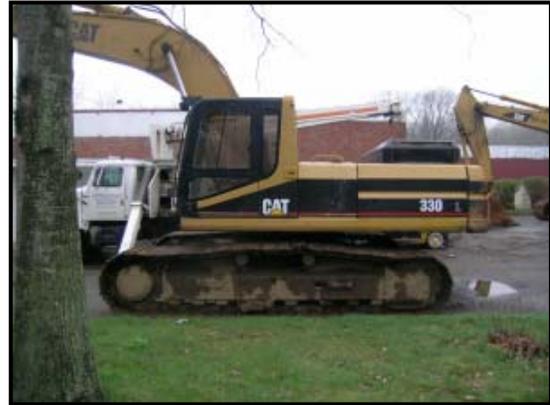
**Figure 4: View of an exemplar excavator.**

The Caterpillar excavator was under repair at the time of the crash. The excavator was designed with the cab, boom, engine, and hydraulics housed in a pivoting turret above the track drive. The base of the turret was located 118 cm (46.5 in) above the ground. A counterweight was attached to the back aspect of the turret. In the excavator's parked position, the aft aspect of the track drive was located 91 cm (36 in) forward of the counterweight. This position of the turret created an overhanging structure. **Figure 4** is a view of an exemplar excavator located at the crash site at the time of the SCI scene inspection.

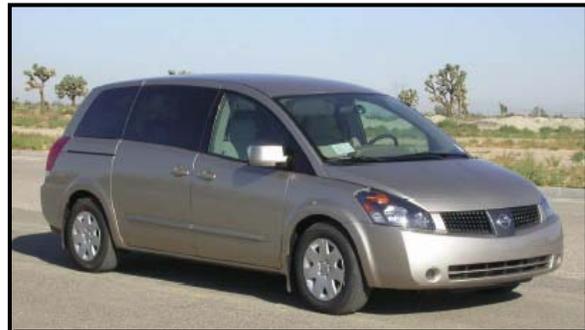
**Figure 6: Front right view of an exemplar Nissan Quest.**

The 2004 Nissan Quest was identified by the Vehicle Identification Number (VIN): 5N1BV28UX4N (production sequence deleted). **Figure 6** is the front right view of an exemplar Nissan Quest. The four-door, seven passenger minivan had a 315 cm (124 in) wheelbase and a Gross Vehicle Weight Rating (GVWR) of 2600 kg (5732 lb). The subject vehicle was equipped with SE level trim. The power train consisted of a 3.5 liter/V6 engine linked to a 5-speed automatic transmission. The service brakes were a four-wheel disc system with ABS. The seating configuration consisted of captain’s chairs in the first and second row, and a third row bench seat. The vehicle was manufactured in December 2003. The digital odometer could not be read at the time of the inspection due to impact damage to the electrical system. The Nissan was equipped with a CAC frontal air bag system (driver and front right passenger air bags) that was certified by the manufacturer to have met the requirements of the advanced Federal Motor Vehicle Safety Standard (FMVSS) 208 ruling. The supplemental inflatable side impact protection system consisted of seat-back mounted thorax air bags in the front seats and roof rail mounted side curtains for all three rows. The frontal air bags and left side impact air bags deployed as a result of the impact. The Nissan was equipped with Goodyear Eagle P225/60R17 tires on OEM alloy wheels. The recommended tire pressure was 240 kPa (35 PSI). The specific measured tire data was as follows:

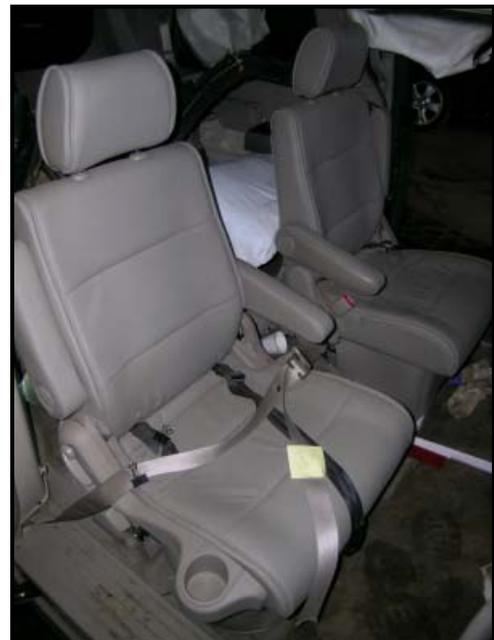
**Figure 12: View of the second row.**

The Nissan Quest's second row of seats consisted of two captain's chairs, **Figure 12**. The chairs had a fixed track position. The seat back recline angle of both the left and right chair measured 15 degrees. The antisubmarine angle of both chair cushions measured 4 degrees.

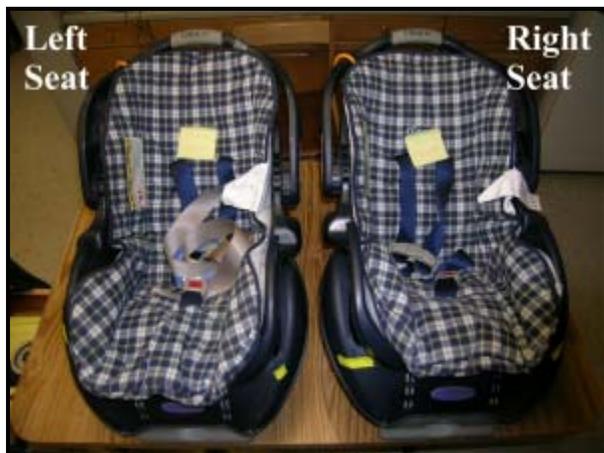
Figure 19: View of the Graco CSS's.

The 8 month old male twins were restrained within identical Graco Snug Ride rear-facing Child Safety Seats (CSS's), **Figures 19 and 20**. Each seat consisted of a carrier shell with a five-point harness and a detachable base. The CSS was designed and equipped with a LATCH webbing that was used in conjunction with the vehicle's seat belt at the time of the crash. The seat was labeled for use by infants who weigh less than 9 kg (20 lb) and are less than 66 cm (26 in) in height. The twins were at the weight limit for the CSS and had outgrown the height limit of the CSS based on the reported demographics of the fatally injured infant.

The left CSS was manufactured on November 14, 2003 and was designated with the following Model and Serial numbers: 8643 HMP, PO 133A. The five point harness was adjusted to the top slots. The length of the left and right harness strap each measured 51 cm (20.0 in). There was a double twist of the inboard strap. There was no evidence of occupant loading. The chest retainer clip was present and was located 24 cm (9.3 in) below the top slots. The left detachable base was manufactured November 15, 2003. The CSS base was designed with an adjustable foot to control the recline angle of the CSS. The base was adjusted to the mid-position. In this base adjustment, the recline angle of CSS shell (at the top slots) measured 50 degrees from vertical.

The right CSS was manufactured on November 15, 2003 and was designated with the following Model and Serial numbers: 8643 HMP, PO 133D. The five point harness was adjusted to the top slots. The length of the left and right harness strap each measured 51 cm (20.0 in) (similar to the left seat). There was a single twist of the outboard strap. No evidence of occupant loading was identified. The chest retainer clip was present and was located 26 cm (10.3 in) below the top slots. The right detachable base was manufactured November 14, 2003. The adjustable foot of the right base was adjusted to the most-reclined position. With this base adjustment, the recline angle of CSS shell (at the top slots) measured 55 degrees from vertical.
